## **Volunteer Fire Fighter Found Unresponsive With His Facepiece Off Dies Eight Days Later – Maryland**

### **Executive Summary**

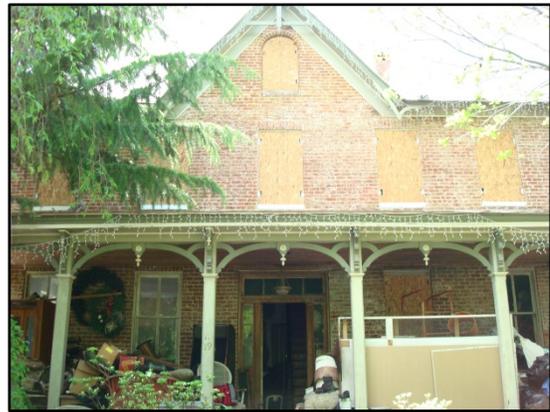
**Residential Structure**  
*(NIOSH Photo)*

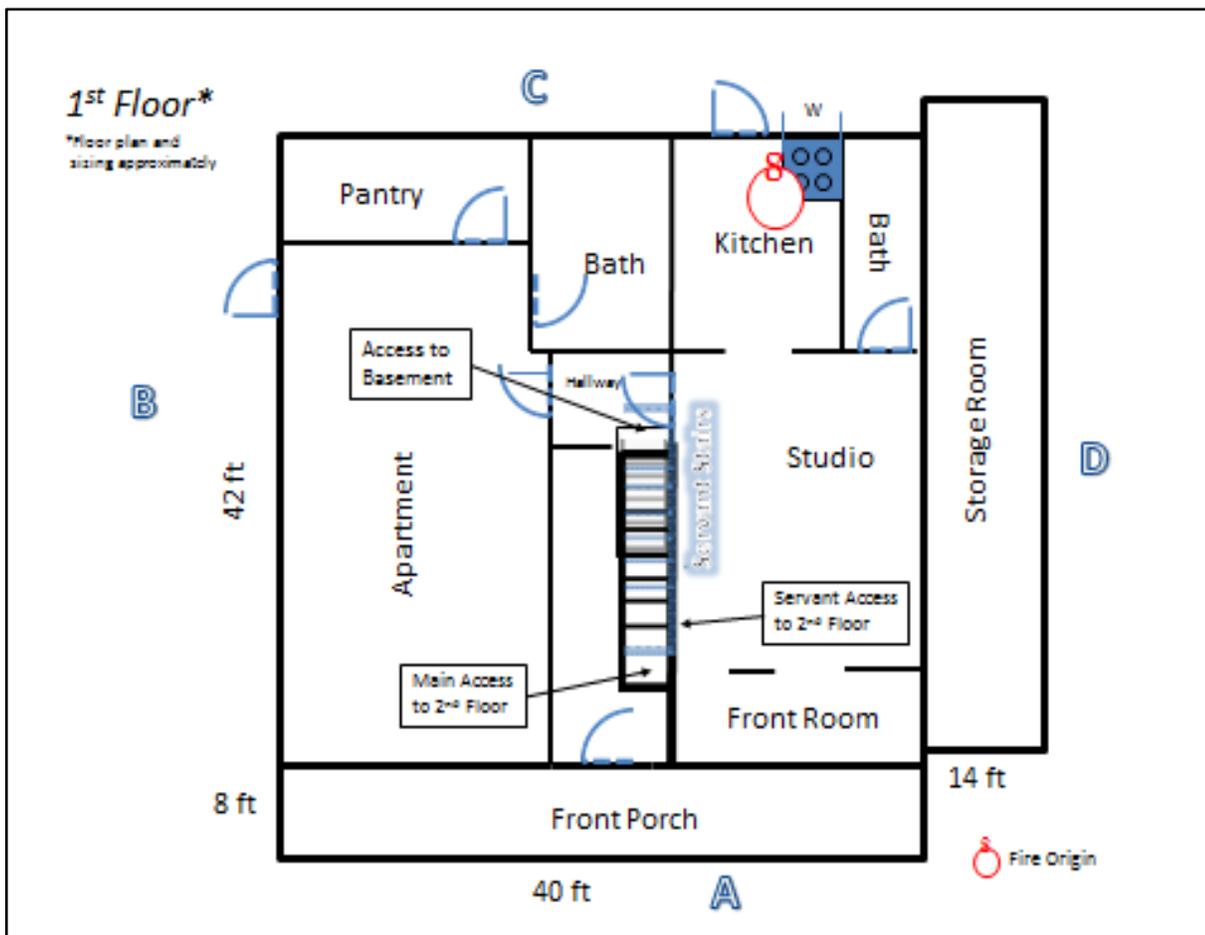
The residential structure was a three story brick and wood exterior Victorian style home built in the late 1800's with a pitched roof consisting of wooden rafters and metal sheeting over wooden lath boards. The structure was approximately 3100 square feet that comprised 3 floors plus a partial basement (see **Diagram 1**, **Diagram 2**, and **Diagram 3**). The structure had a staircase just inside the main entry door to the 2<sup>nd</sup> floor. The house was built with a second staircase, referred to as a servant's staircase, off the 1<sup>st</sup> floor studio (original dining room) which went to the 2<sup>nd</sup> floor just adjacent to the main staircase. This was a multi-family structure with the 1<sup>st</sup> and 2<sup>nd</sup> floors set-up to be individual apartments. The 3<sup>rd</sup> floor consisted of a large bedroom and storage area. The structure had a basement with access on the 1<sup>st</sup> floor underneath the main stairway. The basement was used primarily for storage. The utilities were both natural gas and electric.

**Diagram 1. Fire structure's 1<sup>st</sup> floor layout and approximate location of fire origin. Servant stairway is in light blue and are partially underneath main first floor stairway to 2<sup>nd</sup> floor. The servant stairway accesses the 2<sup>nd</sup> floor just several feet from the main stairs. Note: All areas were extremely cluttered (hoarding condition) to the point of limited access. (Courtesy of the Fire Department)**

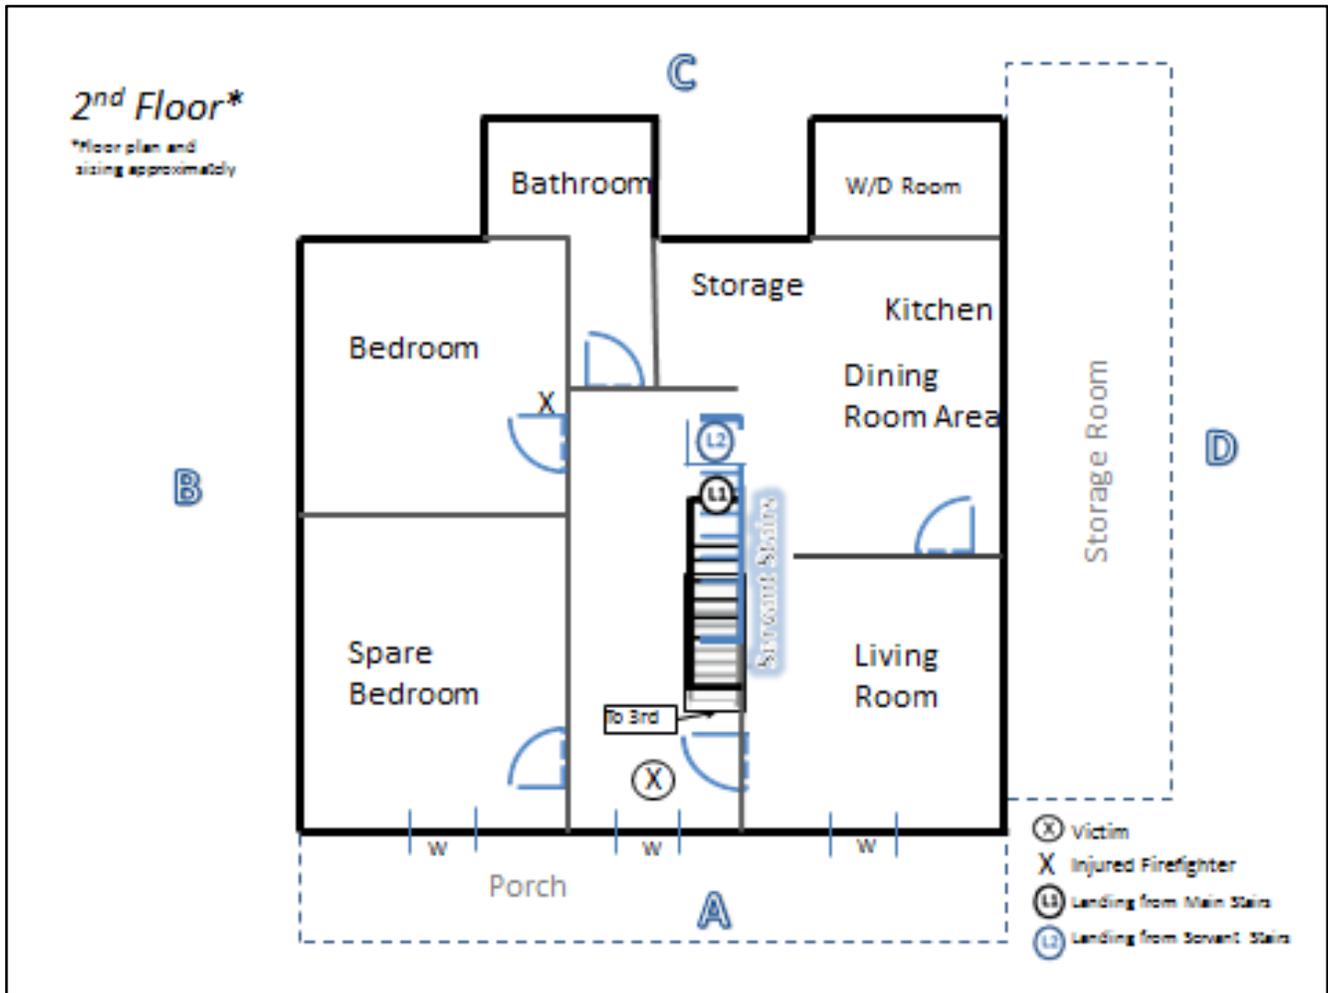
**Diagram 2. Fire structure’s 2<sup>nd</sup> floor layout. Approximate location of injured fire fighter and civilian victim marked with an “X”.**

*Note: All areas were extremely cluttered (hoarding condition) to the point of limited access. A fire fighter from E56 stated he could not advance down the hallway on the 2<sup>nd</sup> floor due to furniture and other clutter.*

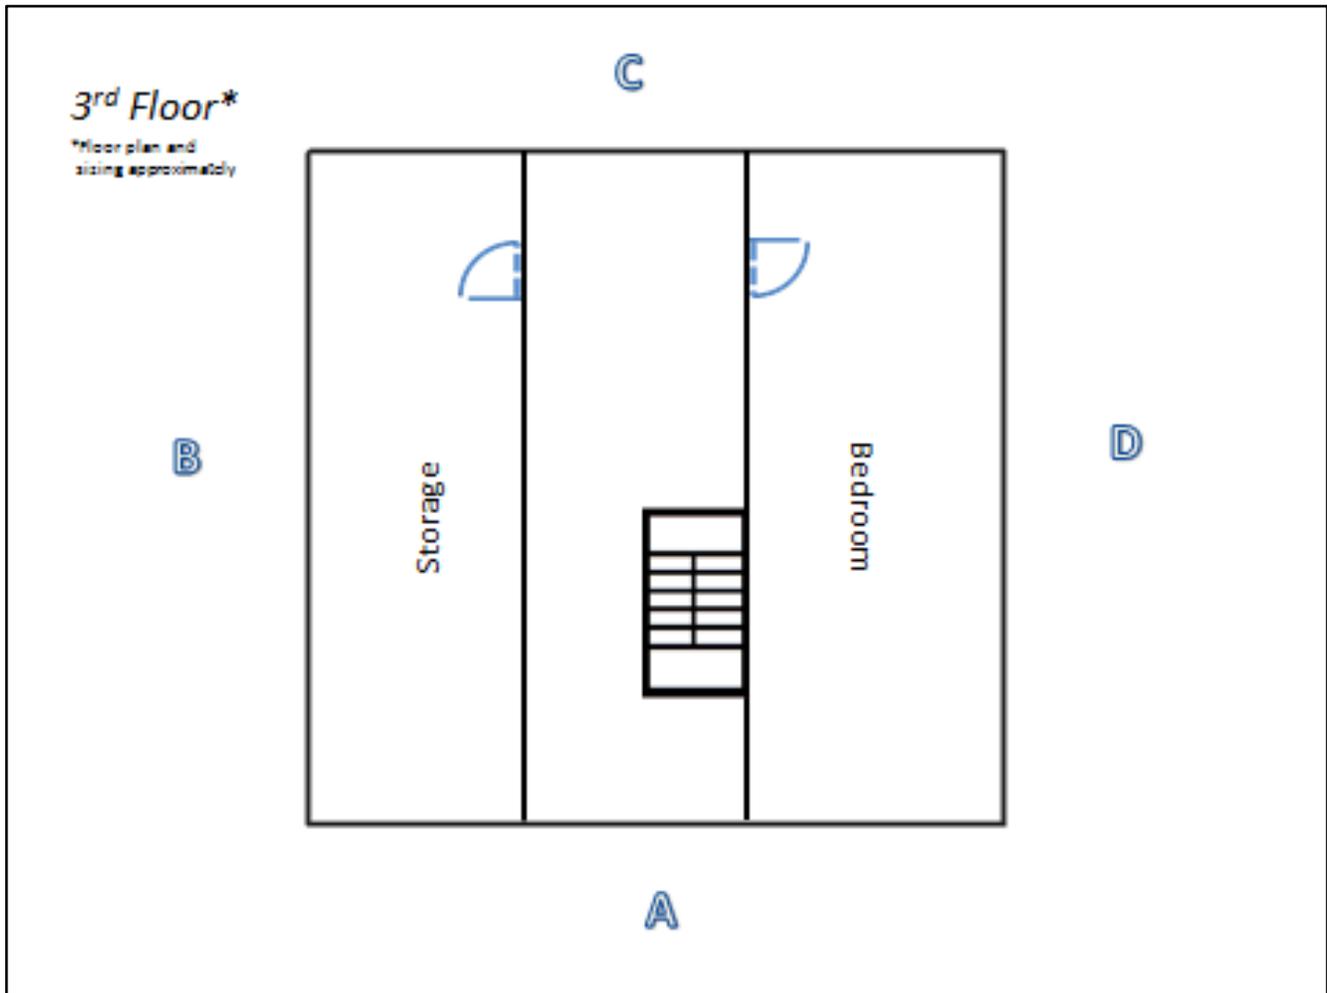
**Diagram 3. Fire structure’s 3<sup>rd</sup> floor layout and the bedroom where the civilian victim was prior to the fire.**

*Note: All areas were extremely cluttered (hoarding condition) to the point of limited access.  
(Courtesy of the Fire Department)*

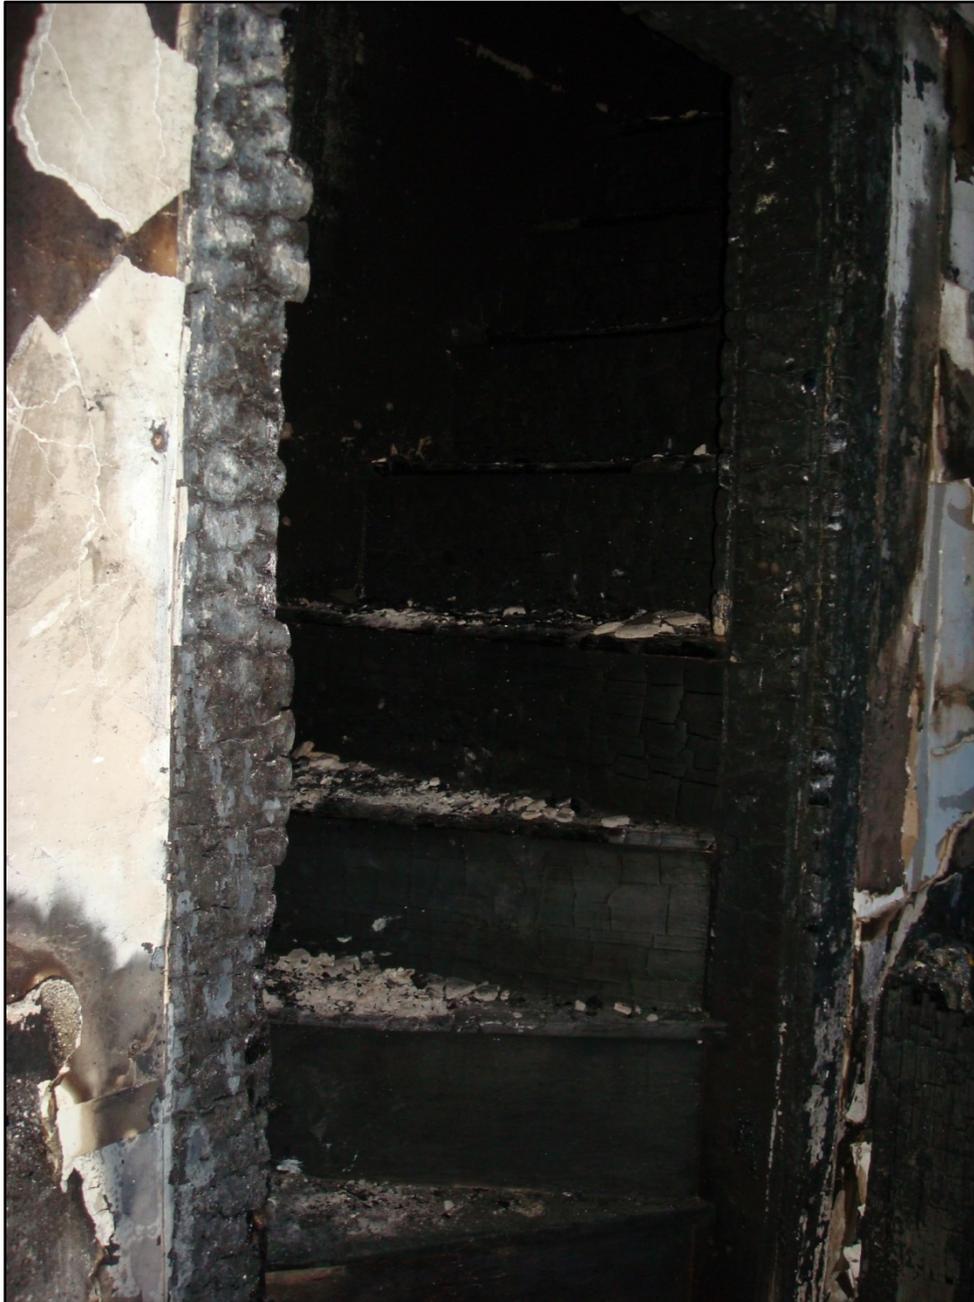
**Photo 1. The servant's stairwell, off the dining, near the origin of the fire in the kitchen which provided a chimney effect for the heat and smoke to the 2<sup>nd</sup> floor where the fire fighters were conducting their search.**

***Recommendation #8: Fire departments should ensure that fireground operations are coordinated with consideration given to the effect of ventilation.***

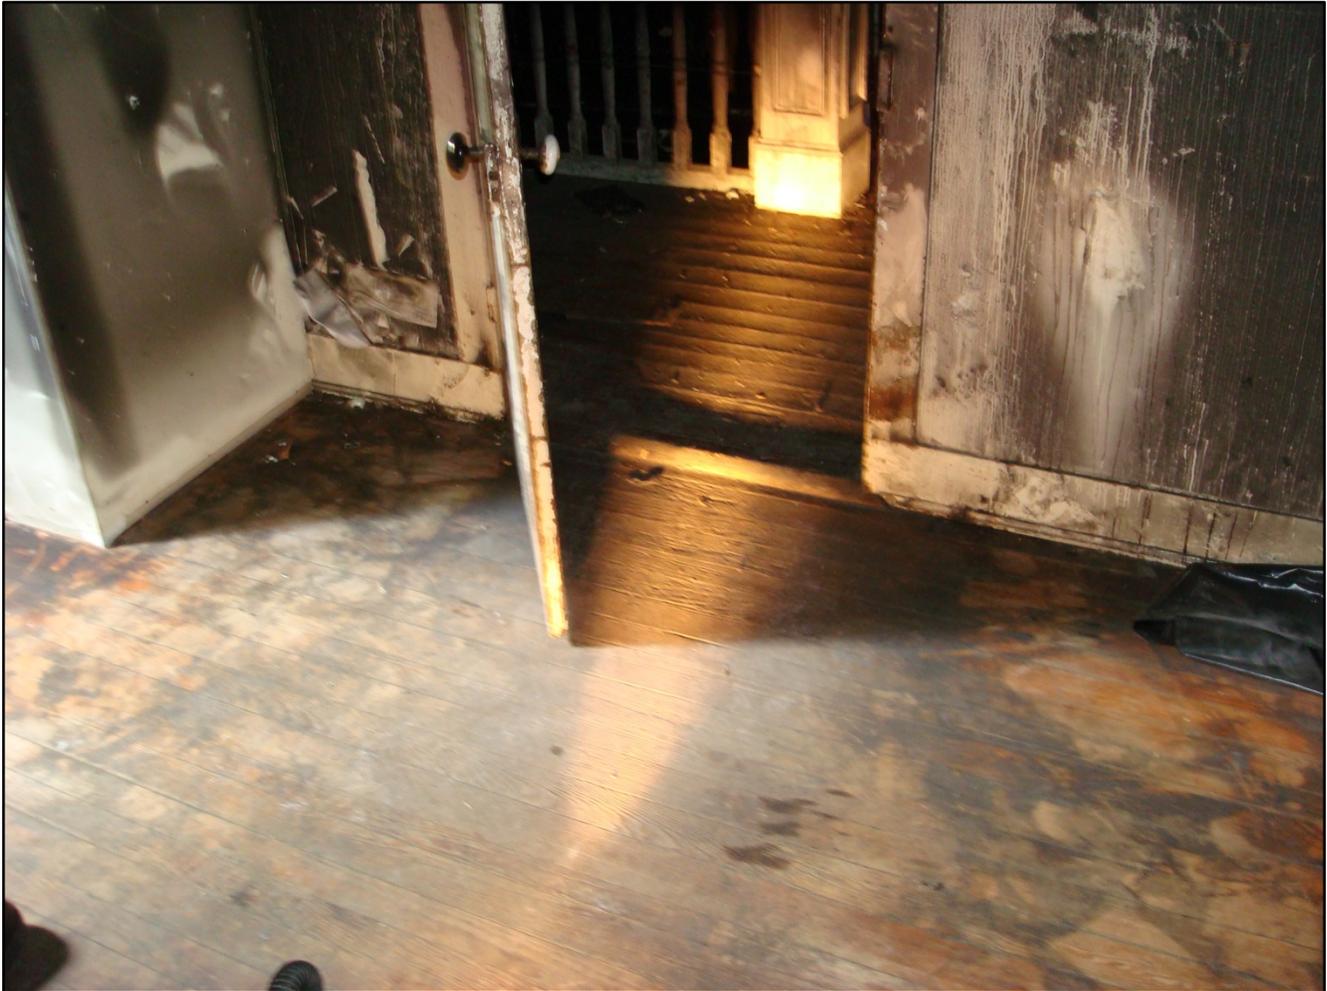
At 0127 hours, BC22 assumed command and re-affirmed the Mayday with the county dispatch center and activated the RIT. The E56 backup man went around the nozzleman towards the sound of the PASS. After pushing the door open to a bedroom located on the B/C corner of the house, he crawled into the bedroom and found/felt a fire fighter who was standing up. This fire fighter, from SU418, was pointing to a fire fighter on the floor behind the door (**see Photo 2 and diagram 2**). The fire fighter was face down with no helmet, hood, facepiece, or gloves. These items were later recovered from the bedroom. The E56 fire fighter reached around and pulled the unconscious fire fighter up and yelled to the nozzleman that he had the downed fire fighter. With the help of the fire fighter from SU418, the E56 crew got the unresponsive fire fighter down the stairs. They were met just inside the door by the E19 RIT, who then helped get the fire fighter to the porch. The RIT captain removed the fire fighter’s SCBA and noticed the cylinder valve was in the closed position. At approximately 0129 hours, the victim was put on a backboard and taken to Medic 56 that was staged at a commercial building just south of the fire structure. Paramedics were able to re-establish a pulse and respiration. At approximately 0134 hours, the fire fighter was transported to a local hospital and then transferred to a metropolitan trauma center. Unfortunately, he passed away from his injuries eight days later.

**Photo 2. The bedroom where the downed fire fighter was found behind the door.  
This post-incident photo is absent of the clutter that existed.  
(NIOSH Photo)**

In this incident, the victim apparently experienced an SCBA emergency and went into a near-by room to try and fix the issue by removing his facepiece without the knowledge of his partner. It is assumed this is where they became separated. The victim was overcome by the toxic conditions and his PASS device was heard by the engine crew at the top of the stairwell. The victim's external exhalation valve was later recovered in the bedroom.
