## **Career Fire Fighter Killed by Structure Collapse While Conducting Interior Search for Occupants Following 4<sup>th</sup> Alarm – Texas**

### **Executive Summary**

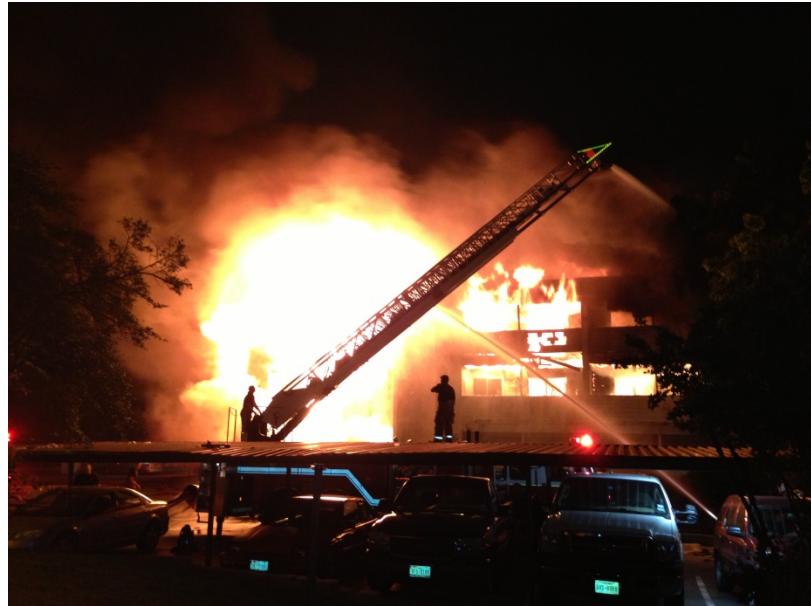
**Fire conditions at Side C prior to collapse**  
*(Photo courtesy of fire department)*

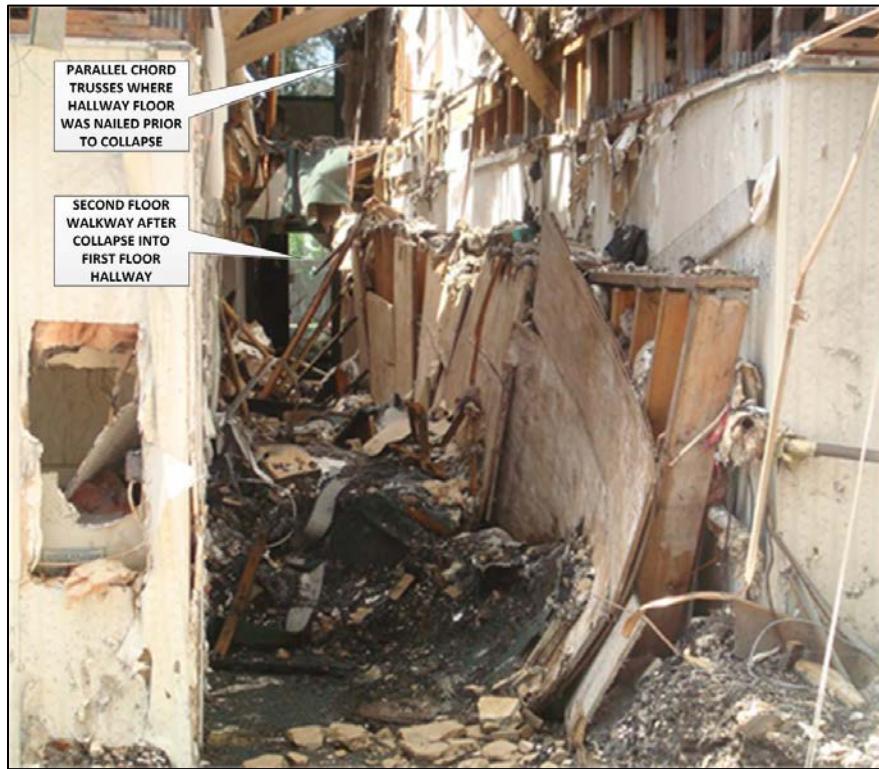
**Photo 1.** Hallway support construction in collapse area.  
(NIOSH Photo)

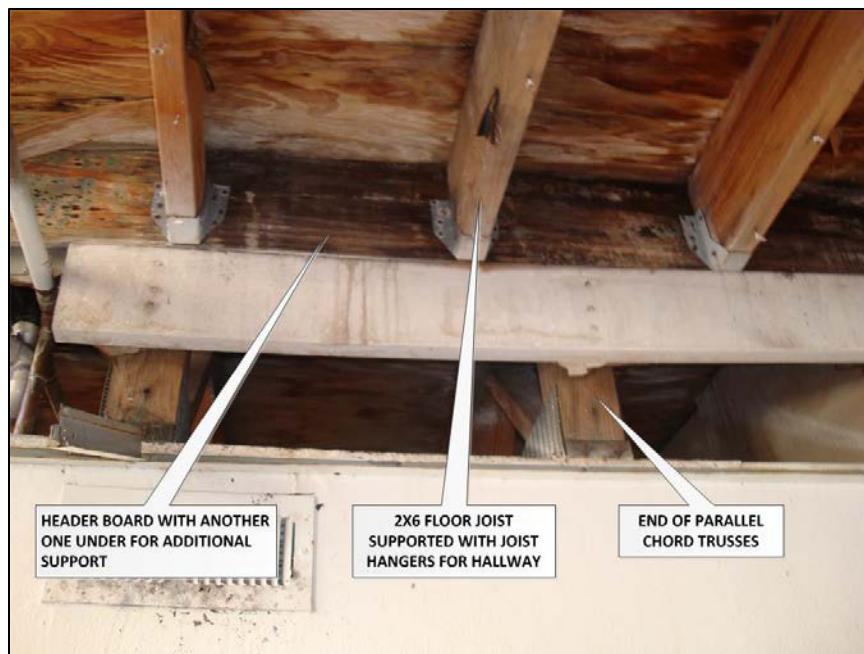
**Photo 2.** Close-up detail of hallway support construction.  
(NIOSH Photo)

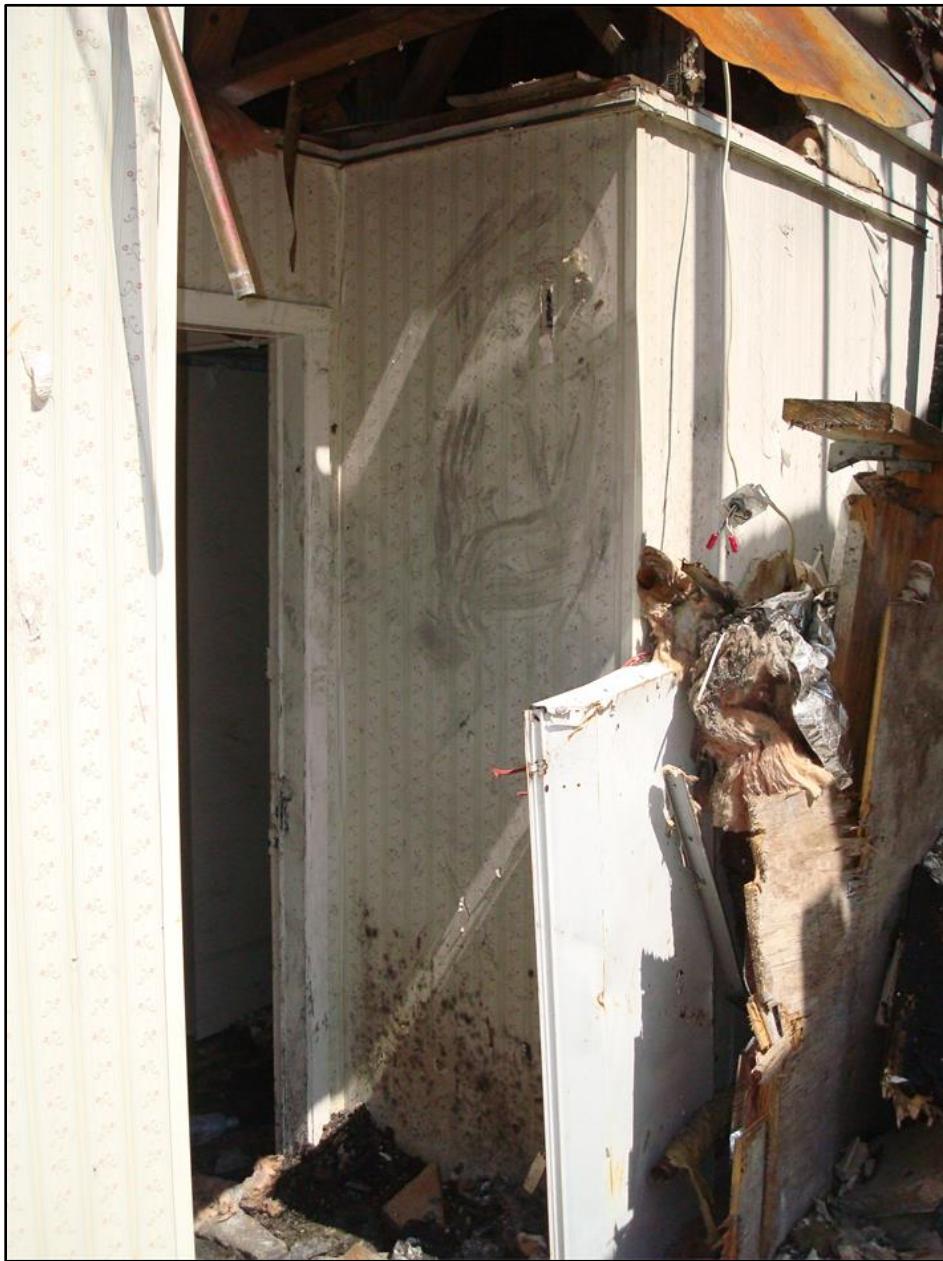
**Photo 3. Apartment entrance recessed where victim's partner was trapped after collapse.  
(NIOSH Photo)**

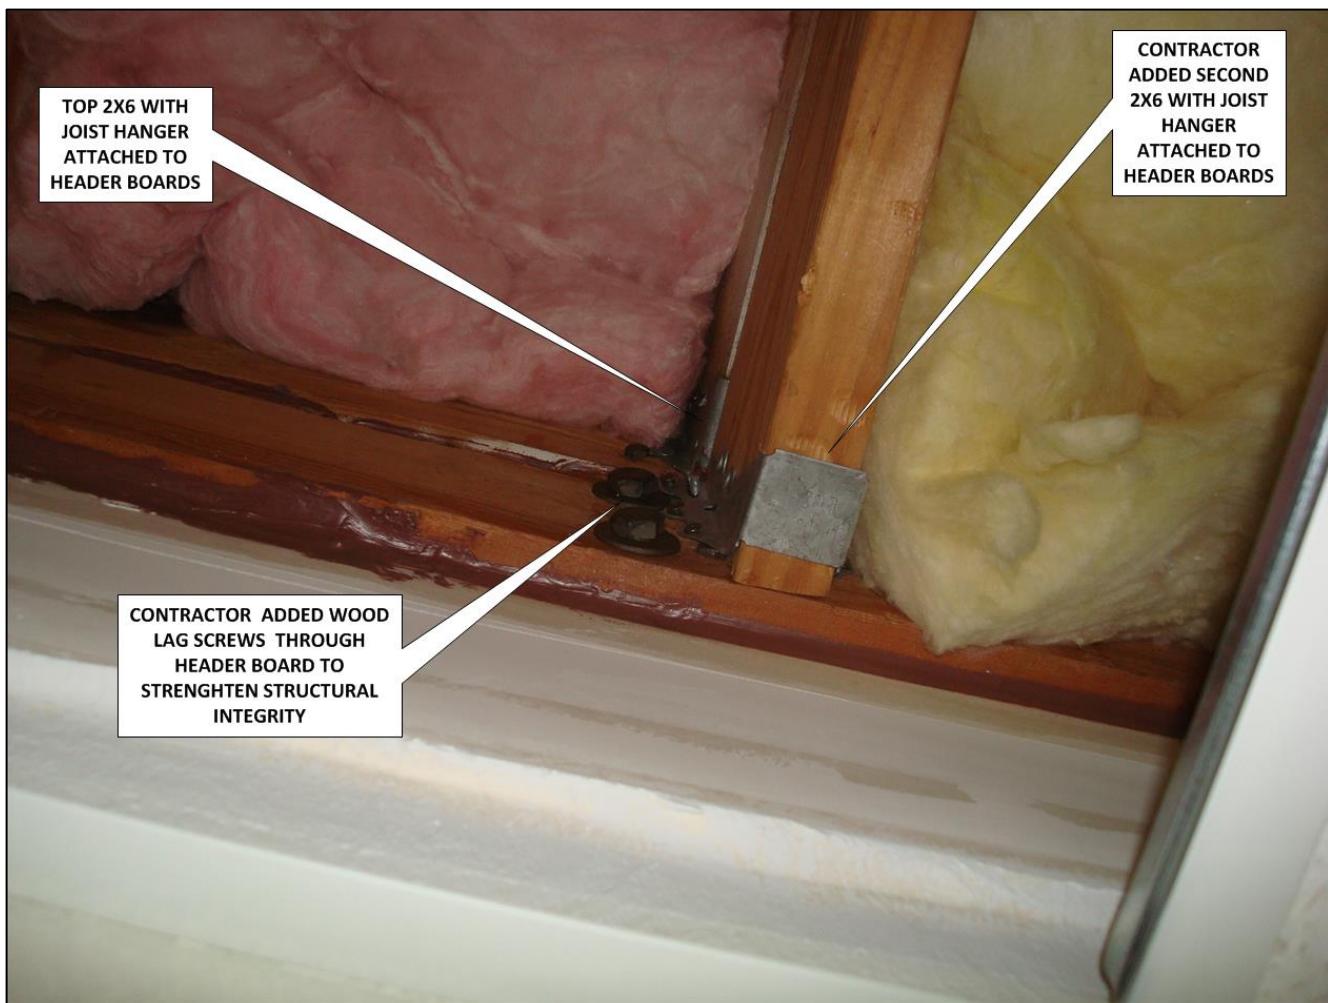
**Photo 4. Double 2x6 floor joists and lag screws added by contractor in an attempt to improve structural integrity within the apartment complex.**

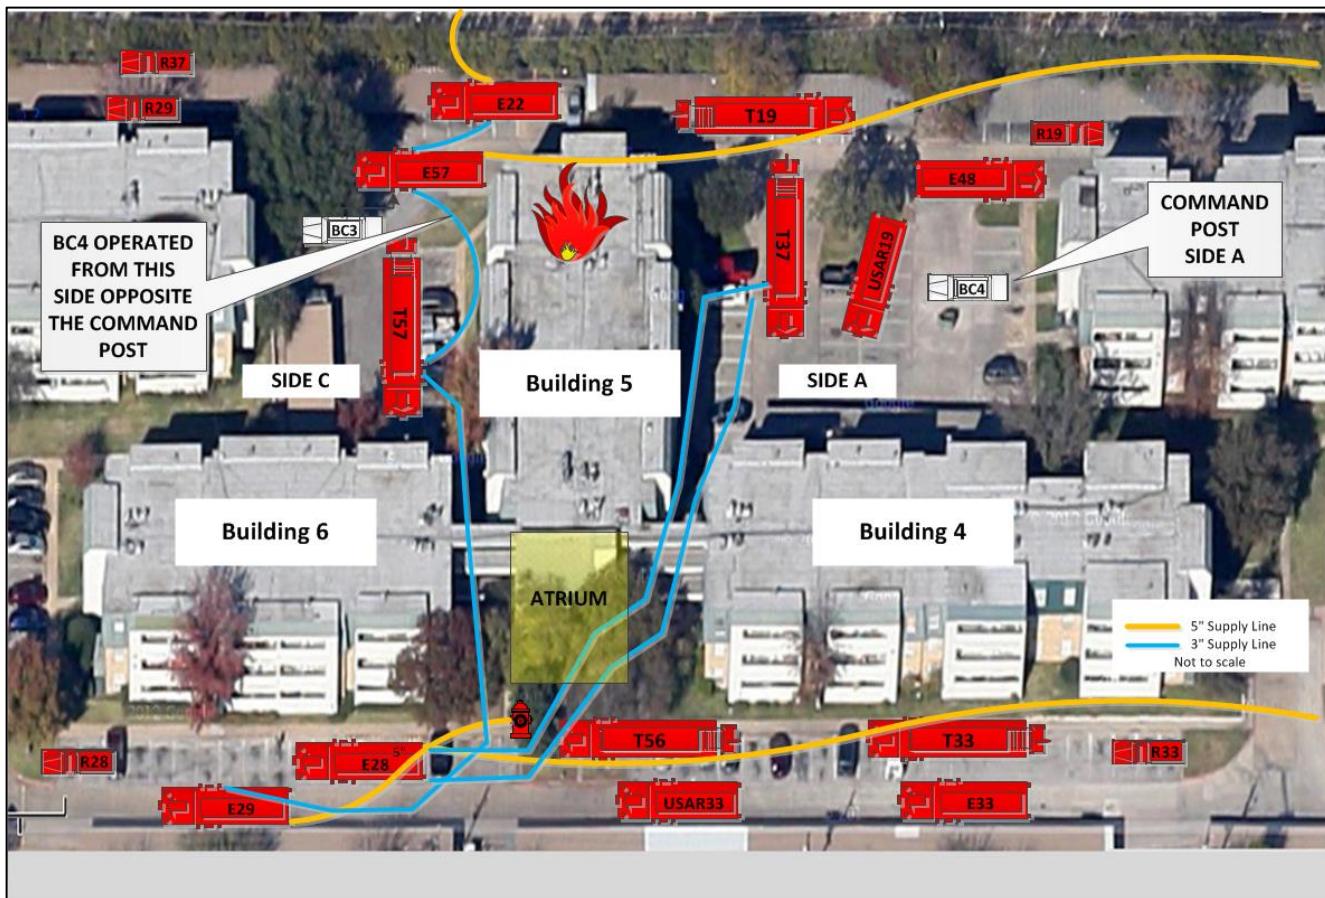
**Photo 5. Aerial View of incident scene.**  
(Photo - Google Maps)

The E29 crew stretched a 3-inch supply line to their engine and prepared to stretch a line into a glass atrium common area where three apartment buildings joined (see Photo 5). Battalion Chief 4 (BC4) was the first due chief officer to arrive on scene at 0305 hours. BC4 entered through the south entrance and drove past the E29 crew to the fire building. The BC4 Command Tech (CT4) dropped BC4 off at the A/B corner of the apartment complex where fire was extending through the roof. BC4 told his CT4 to park the vehicle and set up the command board while he donned his gear. The driveway to the north of Side B had a carport adjacent to it across from the fire building. The height of the carport was too low to allow the command board to be set up with the BC4's vehicle. CT4 pulled the vehicle to Side C of the apartment complex and set up the command board in the back of the vehicle in a parking lot facing the fire building (see Photo 5). BC4 remained on Side A to direct the fire attack. CT4 was a back-up driver and only drove once or twice a month. For most of the initial response, he was alone in the parking lot without supervision or communication as to where units were located, or knowledge of their operating instructions. As other Battalion Chiefs arrived on scene, they began to fill the roles of Division and Group Commanders to oversee fire operations. *Note: Setting up the Command Post on Side C caused confusion since the command post and the Incident Commander typically set up the stationary command post on Side A (see Photo 5).*

At approximately 0310 hours, a Deputy Chief arrived, reported to the Command Post, and assumed Incident Command (IC). He immediately noticed that there was no chief officer present at the Command Post and that the Command Board was not completed. He ordered a third alarm. There was also a discrepancy as to the division designations. He conducted a 360-degree size-up and spoke face-to-face with the battalion chiefs in each division and told them their new divisions and responsibilities. *Note: Side A and Side C were switched to ensure Side A corresponded with the location of the Command Post as shown in Photo 5.*

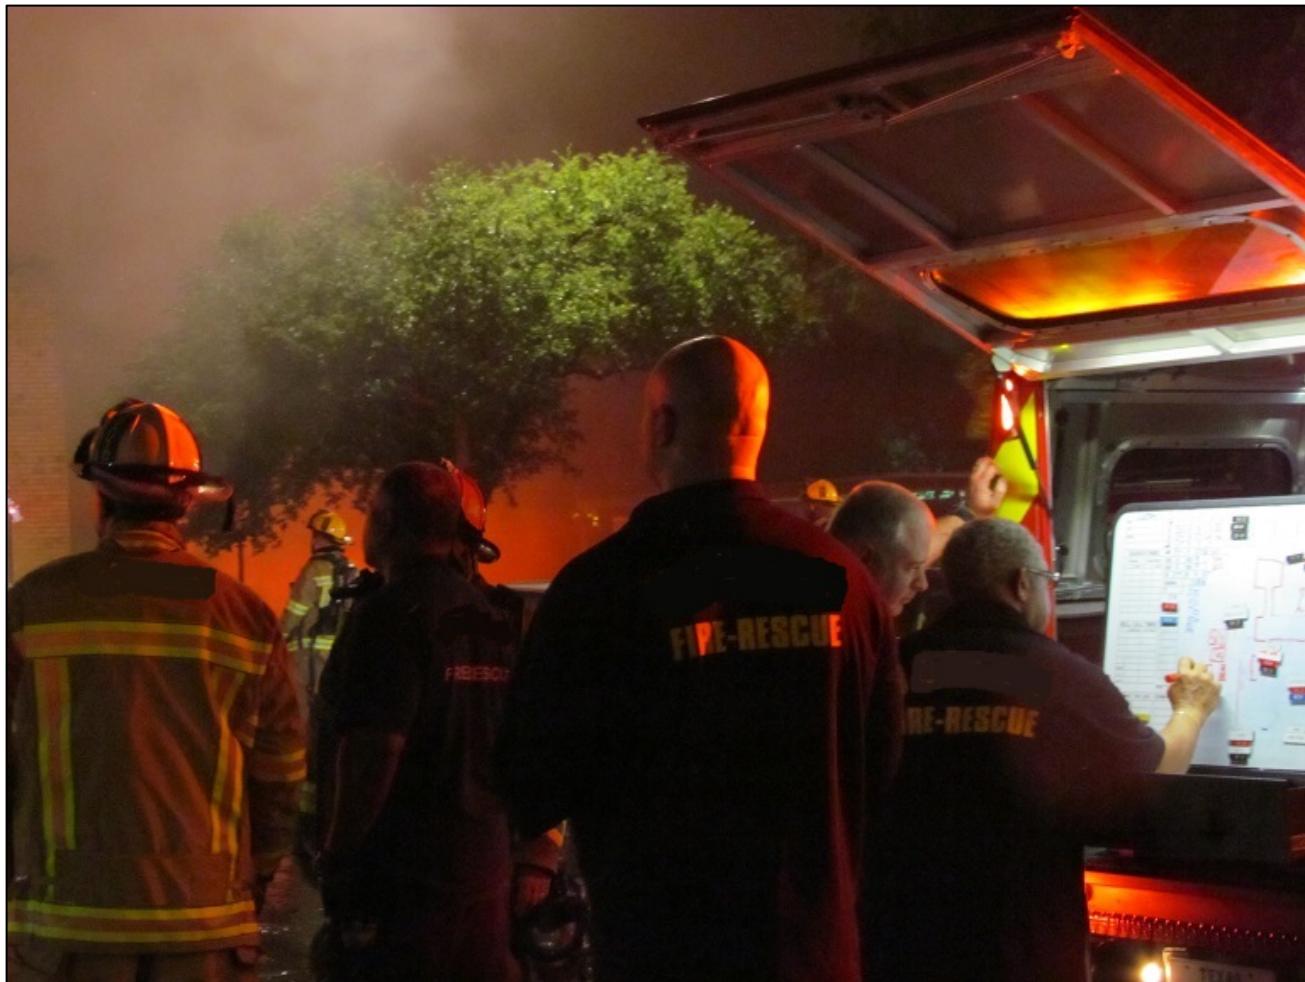
**Photo 6. Command Tech trying to fill in the command board at the back of the command vehicle (BC4) at approximately 0354 hours.**

The IC moved to the Command Post, which was still in the process of identifying all of the operating units, their company locations and functions (see Photo 5 and Photo 6). He called for an emergency evacuation, a personnel accountability report (PAR), and for defensive operations. He ordered that master streams be deployed and T37, T57, and Truck 19 (T19) began flowing water from their ladder pipes.

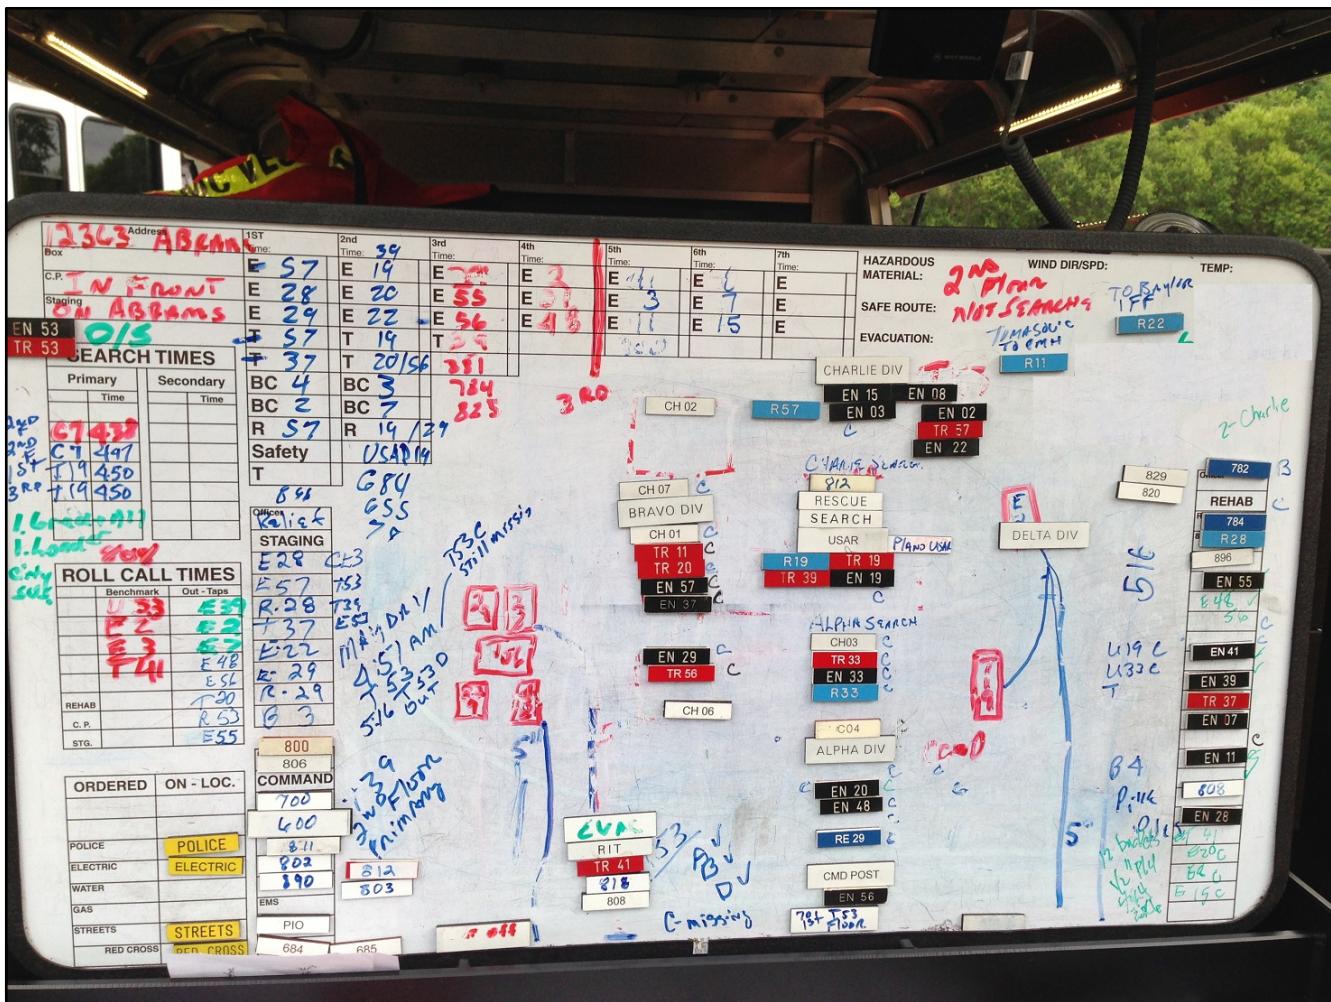
**Photo 7. Finished command board, which was photographed the day after the fire.**  
*(Photo courtesy of fire department)*

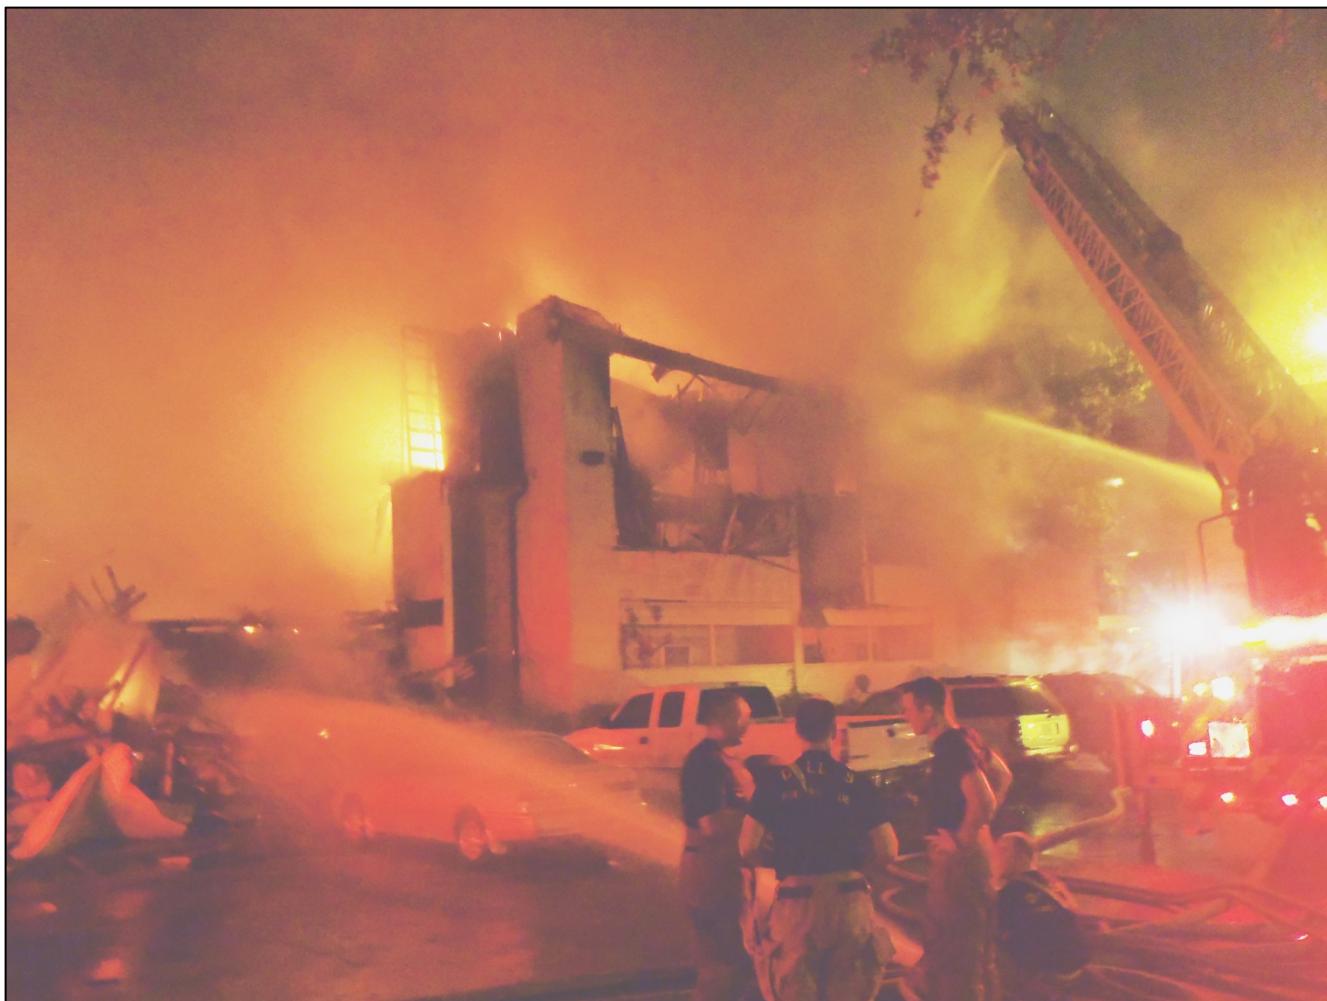
**Photo 8. Defensive fire conditions on Side C at approximately 0428 hours.  
(Photo courtesy of fire department)**

Fourth alarm companies were reporting to staging and the Command Post for assignments. Truck 53 (T53) arrived on the scene at approximately 0411 hours and reported to the staging area, however, the staging area was not staffed. The T53 officer radioed the IC who told him to report to the Command Post with his crew. T53 arrived at the Command Post at approximately 0420 hours and the IC ordered him to take his crew and evacuate Building 4. *Note: There were reports being relayed over the radio of crew members still removing occupants from the buildings other than the fire building. There weren't any crews operating in the fire building at this time due to the operations still being defensive (Photo 8).*

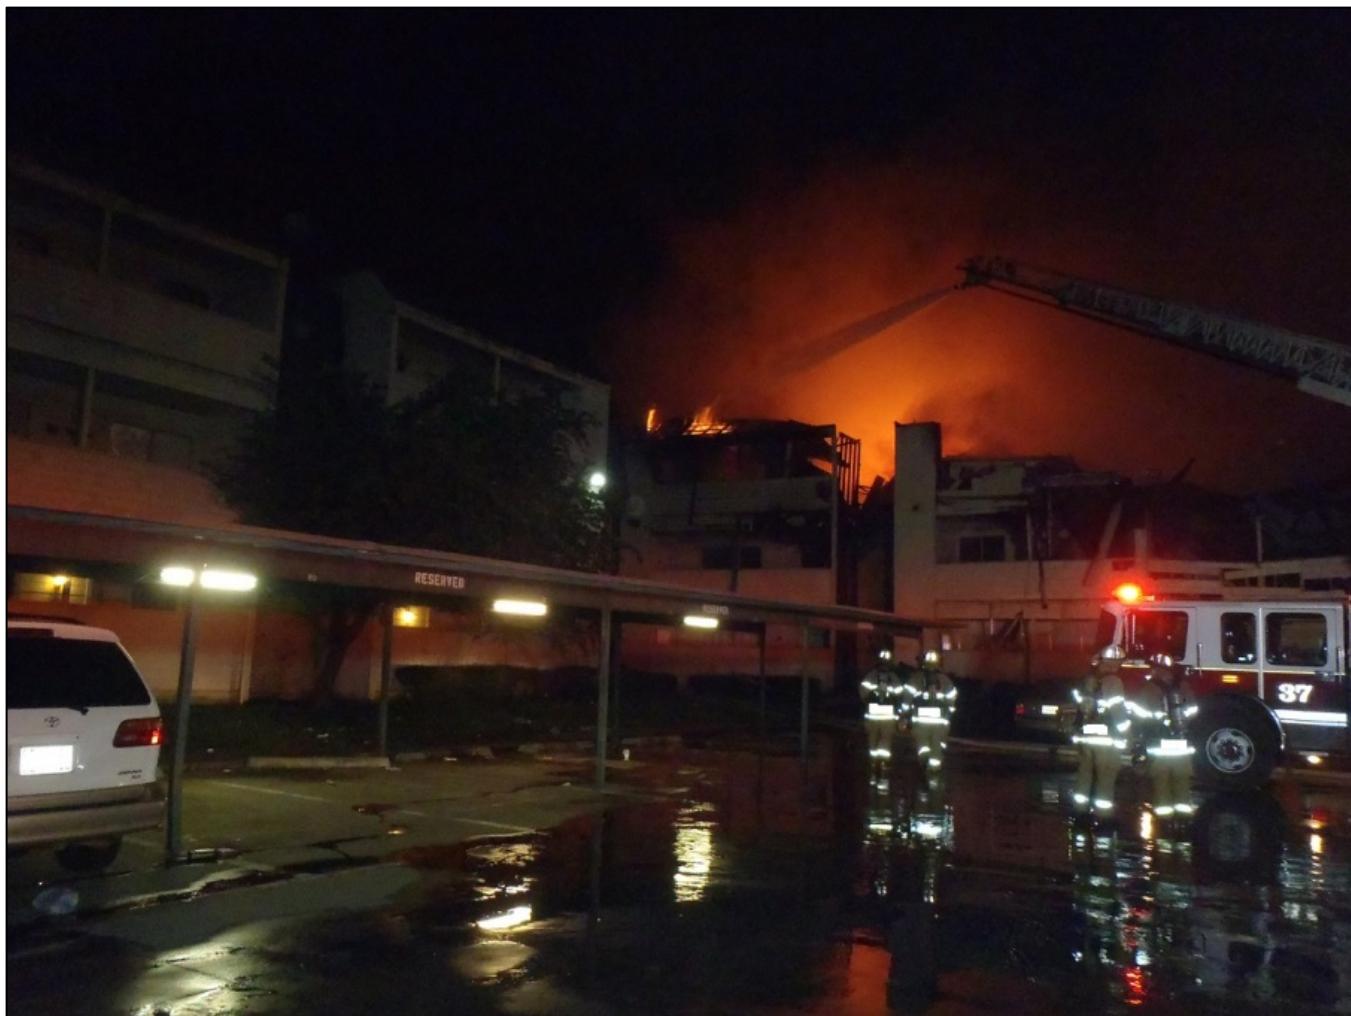
**Photo 9. T53 crew preparing to enter fire building from Side A for interior search at approximately 0444 hours, prior to the collapse.**  
*(Photo courtesy of fire department)*
