# Application of a microphone phased array to identify noise sources on a horizontal vibrating screen

David S. Yantek<sup>a</sup>  
Hugo E. Camargo<sup>b</sup>  
Rudy J. Matetic<sup>c</sup>  
NIOSH/PRL  
626 Cochrans Mill Road  
Pittsburgh, PA 15236

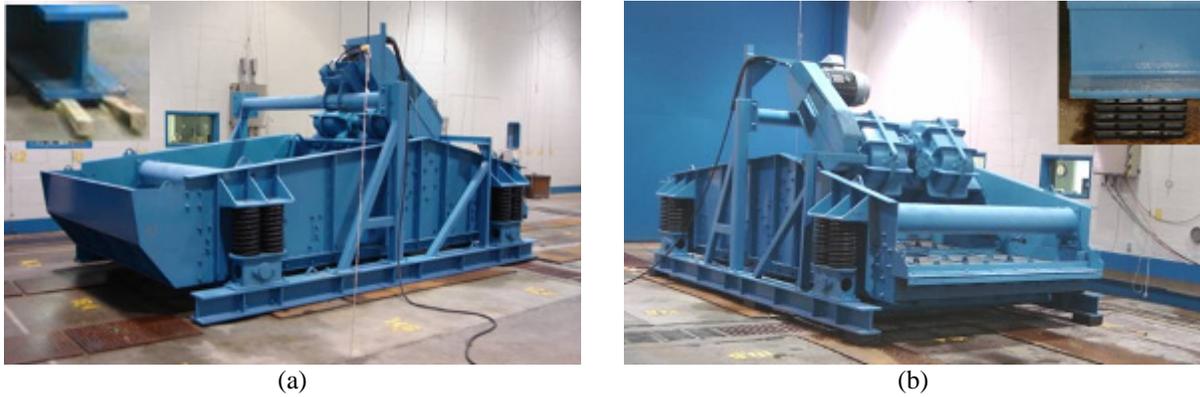
All testing was performed using a dual-vibration mechanism Conn-Weld G-master horizontal vibrating screen with a 2.44 m x 4.88 m screening deck. The A-weighted sound power level of the vibrating screen was measured in the NIOSH Pittsburgh Research Laboratory (PRL) reverberation chamber (see Figure 3) which is NVLAP accredited for sound power level measurements. The sound power levels were determined in one-third-octave bands with the screen placed directly on the reverberation chamber floor and with the screen supported on vibration-isolation pads<sup>9</sup> to prevent vibration-radiated noise from the reverberation chamber floor as recommended by ISO 37xx. For the data collected with the screen directly on the chamber floor, wooden wedges were driven under the frame rails to prevent the screen from rocking on the floor. A Bruel & Kjaer Pulse data acquisition system and 18 Bruel & Kjaer Type 4188 microphones were used to measure the sound pressures. First, the sound pressure levels were measured using a Bruel & Kjaer Type 4204 Reference Sound Source. Next, the sound pressure levels were measured with the vibrating screen turned on. A measurement time of 30 seconds was used for all tests. The operating speed of the eccentric mechanisms was checked

**Figure 3:** Horizontal screen in reverberation chamber for sound power level measurements with the screen (a) placed directly on the floor and (b) with the screen supported with vibration isolation pads.

Next, the screen was tested with the frame rails resting on a set of vibration isolation pads that were designed to isolate vibrations above 10 Hz. Ironically, placing the screen on vibration isolation pads increased the A-weighted sound power level to 108.3 dB. The most significant increases occurred at the higher frequencies. After observing the operation of the screen, it was noticed that the belt guard was rattling against the mechanism support. Further inspection revealed that the structure used to support the front belt guard appeared to be vibrating more. This may be due to the decrease in frame rail stiffness due to different boundary conditions with the frame rails supported along their length versus using a soft suspension.

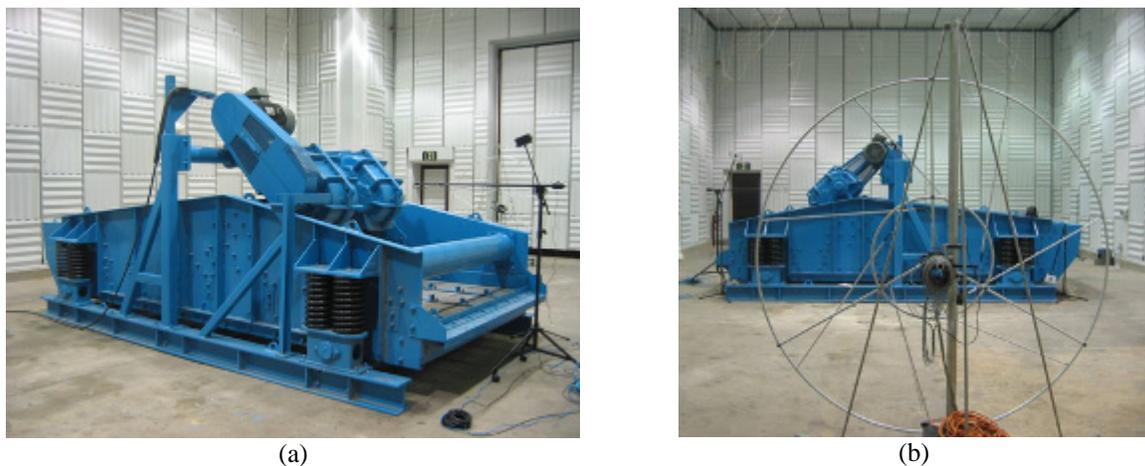
Noise source identification was performed using the beamforming technique.<sup>9</sup> The screen was positioned in the NIOSH PRL hemi-anechoic chamber with the screen directly on the chamber floor with wooden wedges driven under the frame rails to prevent rocking. To collect the beamforming data, a Pulse data acquisition system was used to simultaneously record the sound pressures from a 42-microphone wheel array (see Figure 4).

**Figure 4:** (a) Vibrating screen in hemi-anechoic chamber (b)View of vibrating screen from beamforming array.

Measurements were performed at a distance of 5.54 meters from the sides of the screen and 3.05 meters from the ends of the screen, so the entire screen would fit within the measurement area of the array. Measurements were also performed with the array a distance of 2.3 meters
