Ergonomics Interventions at Badger Mining Corporation

Janet Torma-Krajewski

Martin Lehman

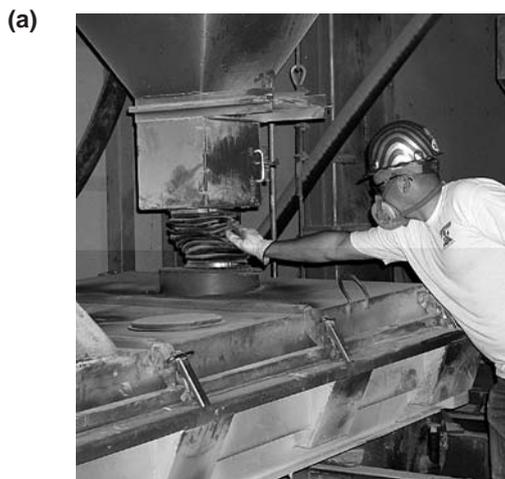
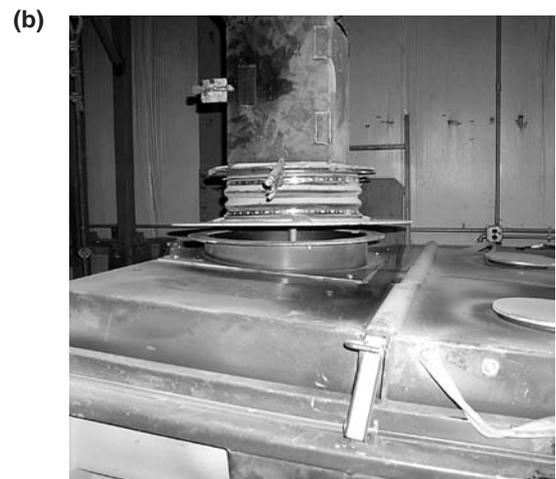
To maintain the actuator, internal orifice plates needed to be removed and replaced when they became clogged with wet sand (Figure 5a).

Completing this task once a shift resulted in exposure to awkward postures (excessive reaching and leaning forward) and climbing four flights of stairs.

Figure 5. (a) Manually reset actuator, (b) automatic actuator.

Installing an automatic actuator eliminated the need to manually maintain it, the awkward postures as well as climbing the stairs (Figure 5b). The automatic actuator was 500 USD plus labor.

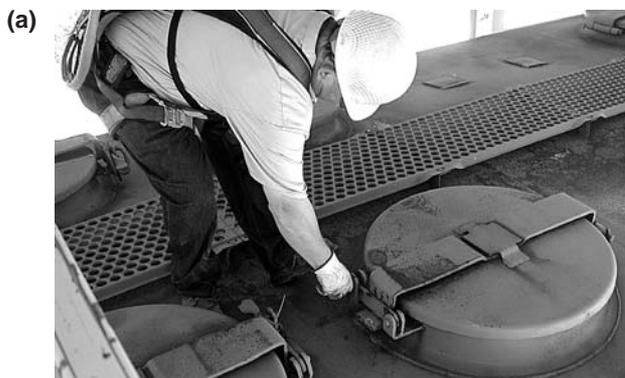
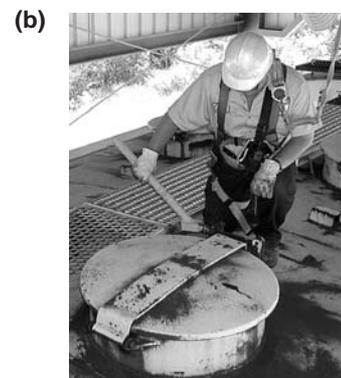
To open the rail car cover, the associate used his foot to release the latch while bending over to open the cover (Figure 6a). This task was

Figure 6. Rail cover latch released (a) manually and (b) with a hand tool.

done every day, 8 times per shift. Associates experienced hip and back discomfort.

Two hand tools were constructed by the maintenance team to unlatch different types of covers. The associate knelt on one knee as he placed the tool on the latch and then pushed down on the tool with his arm to release the latch. Once the latch was released, the cover was opened (Figure 6b). Although the associate was still exposed to an awkward posture, briefly kneeling on one knee probably resulted in less risk than the trunk flexion when the hand tool was not used. The material used to fabricate the two tools was available scrap material so the only cost associated with this intervention was for labor.
