# EVALUATION OF MINE SEALS USING GROUND PENETRATING RADAR

*NIOSH, Pittsburgh Research Laboratory*

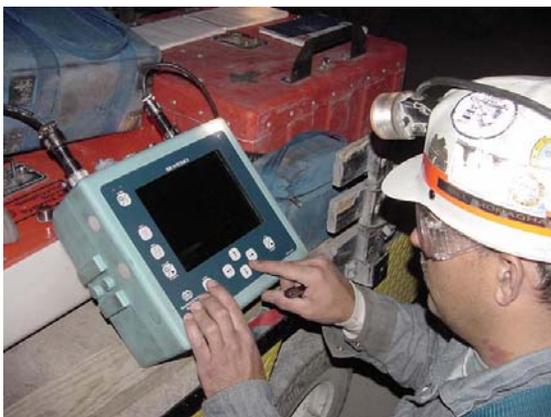
**Figure 1:** Engineer using the SIR-2 unit.

In this study, GPR was used as a non-invasive means of evaluating mine seal construction uniformity. The equipment used was a GSSI SIR<sup>®</sup> System 2 (SIR-2) Model No. DC-2 control unit built by Geophysical Survey Systems, Inc.<sup>2</sup> The SIR-2 is a lightweight, portable, general-purpose radar system and is available as an intrinsically safe unit for use in the underground coal mine environment (figure 1).

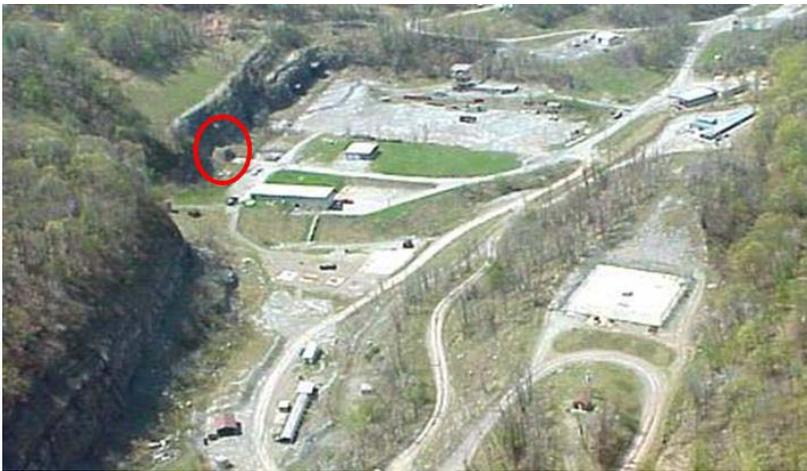
**Figure 2.:** Photo of the Lake Lynn Laboratory. Various test areas are shown (buildings and open areas). The red circle shows the main entrance to the underground mine.

The mine seals were constructed in the NIOSH Lake Lynn Experimental Mine (LLEM). The Lake Lynn Laboratory (LLL) is a unique research facility, located about 50 miles southeast of Pittsburgh, Pennsylvania, that is designed to provide a full-scale mining environment for the testing and evaluation of mine health and safety technologies. The LLL occupies more than 400 acres and is composed of surface test and training areas and an underground mine (figure 2).

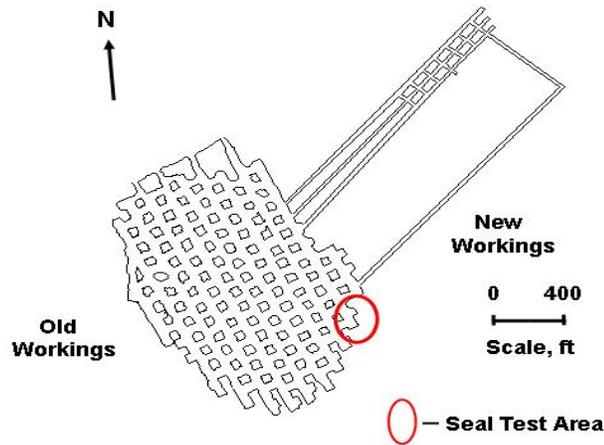
**Figure 3.:** Layout of the Lake Lynn Laboratory Mine.

The LLEM was built at an abandoned commercial limestone quarry where underground entries 49-ft wide by 33-ft high (old workings) were developed when surface mining ceased in the late 1960's. Later, under the auspices of the U.S. Bureau of Mines, 7,545 ft of new underground development was constructed using 19.7-ft wide by 6.6-ft high entries (new workings). The new workings can be configured to simulate modern-day coal mining scenarios; including room-and-pillar and longwall mining layouts (NIOSH 1999, Triebisch, 1990) (figure 3).

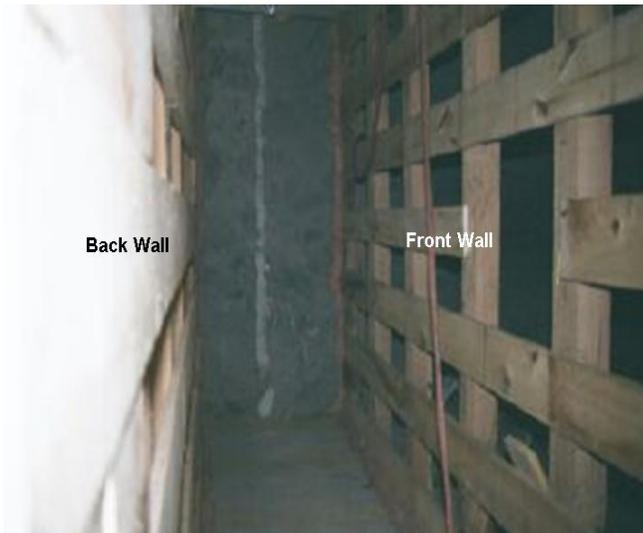
**Figure 4.:** Photo of inside of Mine Seal No. 1 showing the wooden form.

Next, 8-in wide by 1-in thick boards were placed in a horizontal position and were nailed to each post (figure 4). The boards were placed at the bottom of the form and an 8-in horizontal space was left between each row of boards. This procedure was followed on the front and back walls of the form. Fiberglass insulation was then packed into any void space on the mine roof, ribs, and floor areas to minimize slurry leakage around the form. A 48.5-in space was left by design between the front and back walls of the form for the mine seal. Mine brattice cloth was placed on the inside area of the form, was overlapped on the mine roof and rib areas, and was secured with straps to form a tight seal. Eye bolts were then attached to each post through the brattice cloth and were tied together with 1/8-in galvanized steel cable that was extended between the front and back of the form (figure 5).

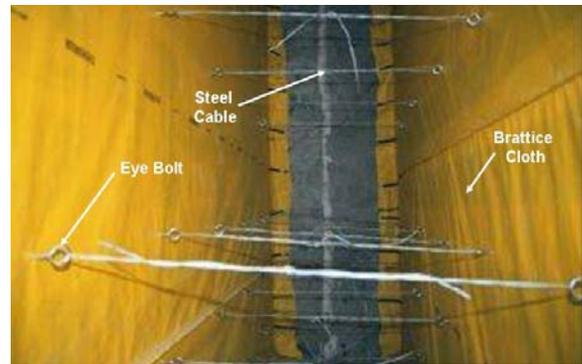
**Figure 5.:** Photo of inside of mine seal No. 1 before foamed cement was added.

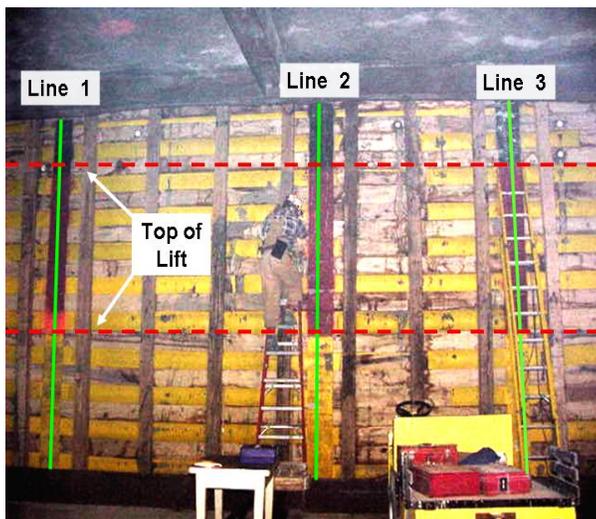
**Figure 6.:** Photo of mine seal No. 1 and location of GPR survey lines.

The seal material was cured for 33 days before the GPR evaluation was performed. In order to gain direct access to the face of the seal, three vertical sections were cut into the wooden form and brattice cloth. The three vertical sections were approximately 8-in wide and exposed the seal material from the mine floor to roof. Three vertical GPR survey lines were positioned along these sections shown in figure 6. The vertical sections were located at 4-ft from the left rib (line 1), about 12-ft from the right rib near the middle of the seal (line 2), and 4-ft from the right rib (line 3). Each vertical section was subdivided into one-foot segments for use as reference points during the GPR evaluation.

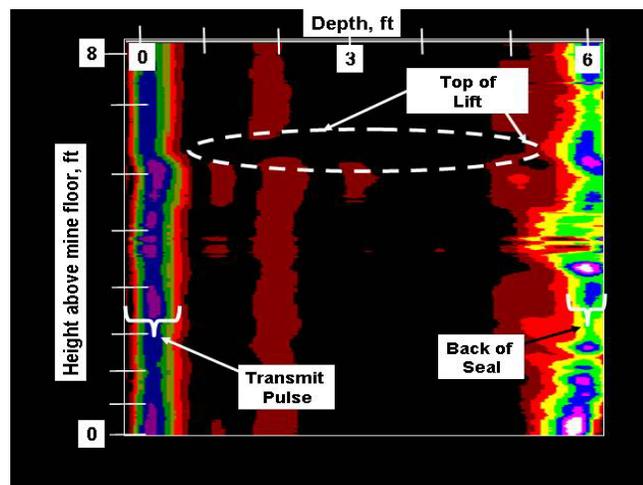
**Figure 7.:** Interpreted radar record (Line 2) for Mine Seal No. 1 using a 400-MHz antenna.

into the record corresponding to the 1-ft marks on the mine seal. In this manner, it was easy to associate any observed anomalies with the specific location on the mine seal. A representative post-processed radar record and the associated interpretations are shown in figure 7. The vertical scale in the figure represents the height above the mine floor and the horizontal scale represents depth into the seal. The reflected pulse energy is shown in terms of a color scale, with hot colors (yellow, white) being the higher level of reflected pulse energy and colder colors (brown, black) the lower levels. Areas in the record shown with similar colors should be interpreted as similar levels of reflected pulse energy. In the radar record, the top of the lift is visible along with the back of the seal. As discussed earlier, the top of a lift represents a boundary in the seal. Figure 8 shows the positions of all observed anomalies from the GPR surveys of the mine seal. As shown in figure 8, a total of 12 anomalies were observed in surveys where the 500-MHz antenna was used and four anomalies were observed in surveys where the 400-MHz antenna was used. Of the anomalies observed, 11 were located near the top of a lift and were either related to the hard surface that had formed at the top of the lift or areas where the seal components could have been mixed at different ratios. The five remaining anomalies could be related to the construction practice of the mine seal (use of eyebolts and galvanized wire).

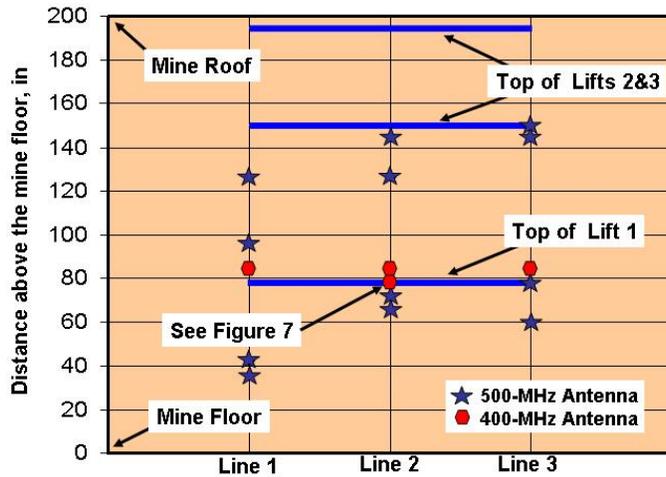
**Figure 8.:** Location of observed anomalies from radar scans of mine seal No. 1.

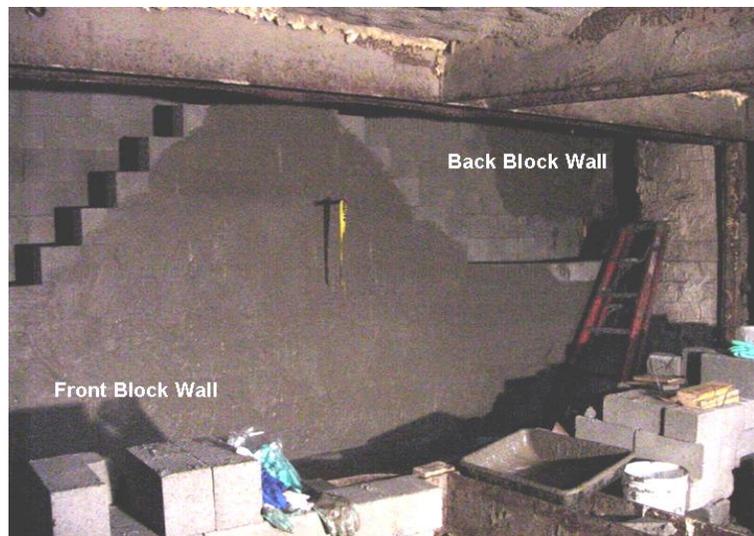
**Figure 9.:** Photo of solid block walls for Mine Seal No. 2.

Mine seal No. 2, a solid block, polyurethane foam, and gravel seal, was erected in the small chamber in the LLEM. The seal was constructed 8-ft high by 20-ft wide and about 2.5-ft thick. The seal was not hitched into the mine roof, rib or floor areas. The seal was built using two parallel walls of solid blocks with a 17.5-in open space between the walls. The walls were constructed with dry-stacked solid blocks (each measuring 6-in by 8-in by 16-in) and was capped by 2-in by 8-in by 16-in blocks and wedges at the mine roof (figure 9).

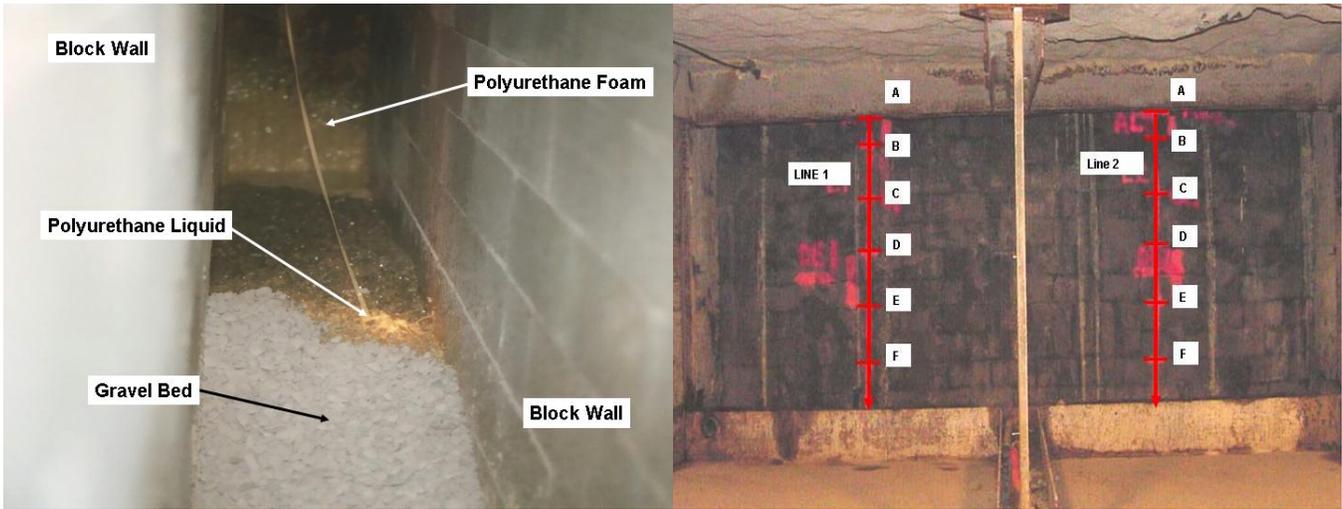
**Figure 10.:** Photo of inner core of Mine Seal No.2 during addition of polyurethane resin.

**Figure 11.:** Photo of Mine Seal No. 2 showing GPR survey lines.

GPR was used to determine if the gravel had been evenly dispersed throughout the mine seal. For the radar survey, two parallel vertical GPR survey lines were drawn on the mine seal face and were positioned about 6 ft from each mine rib (figure 11). Reference points (labeled A-F), spaced about 18-in apart, were then placed on the seal and were added to the radar records for comparative purposes. Each survey was made by placing the antenna against the seal face and then slowly moving downward at a constant velocity. The radar survey of the seal was made using 1,000-MHz antenna because this antenna

Figures 12 and 13 show two representative post-processed radar records and their associated interpretations. Reflected pulse energy is shown in terms of a grayscale, with near-white being the highest level of reflected pulse energy and near-black the lowest. Areas in the record shown with similar gray tones should be interpreted as similar levels of reflected pulse energy. The vertical scale shown in the figures corresponds to the reference points (labeled A-F) shown in figure 11.

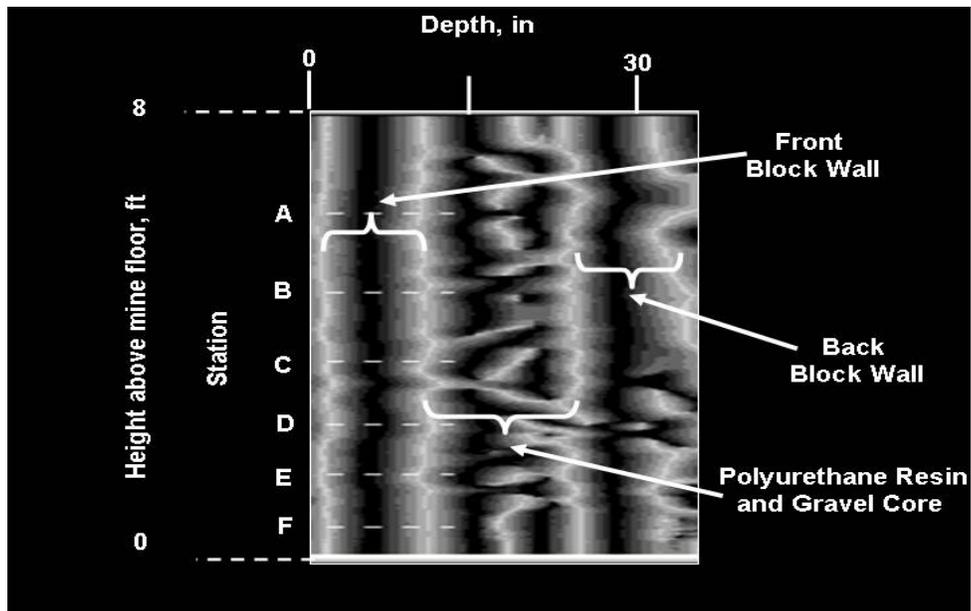
**Figure 12.:** Interpreted radar record for Mine Seal No. 2, Line 1.

In the radar records (figures 12 and 13), it is possible to see both the front and back block walls. It was hypothesized that the area between the block walls showed varying amounts of reflected pulse energy because of the concentration of gravel in the polyurethane foam was most likely not consistent

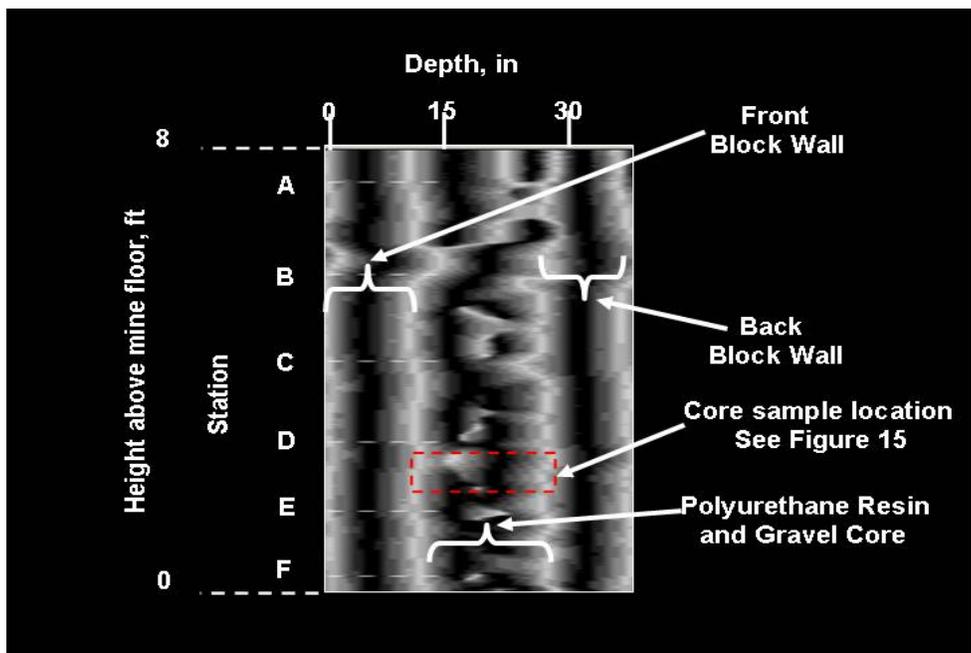
**Figure 13.:** Interpreted radar record for Mine Seal No. 2, Line 2.

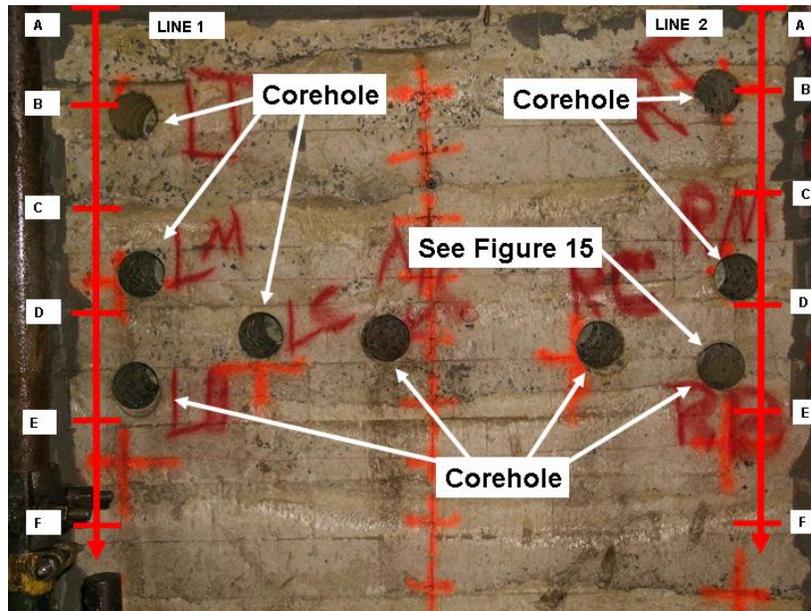
**Figure 14.:** Photo of Mine Seal No. 2 showing location of coreholes.

throughout the seal. To confirm this hypothesis, several large coreholes (6- by 18-in) were drilled into the seal after the GPR study was completed (figure 14). For this work, the block face of the seal was removed to facilitate core recovery. Figure 15 shows an example of a recovered core sample. This sample clearly shows a lift boundary and a detailed analysis of this core sample showed that the gravel was not evenly dispersed in the polyurethane foam. This confirms the hypothesis made from the radar records.

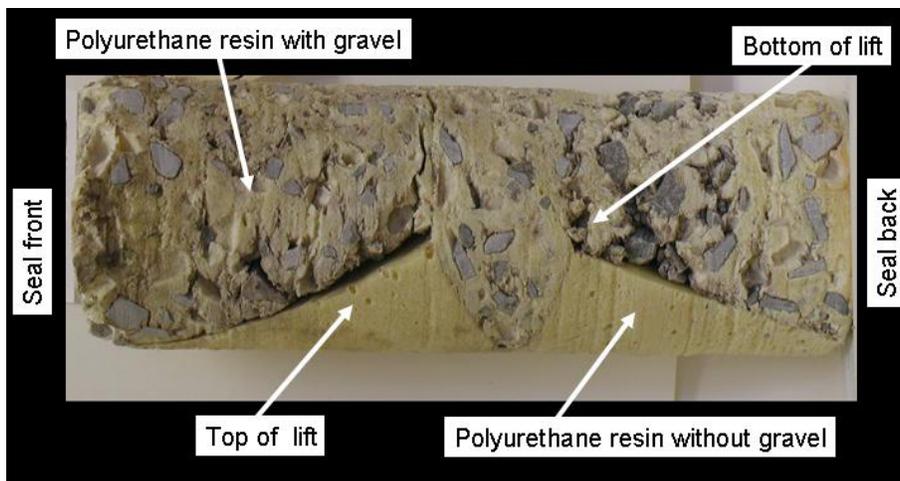
**Figure 15.:** Photo of recovered core sample from Mine Seal No. 2. Refer to figure Nos. 13 and 14.

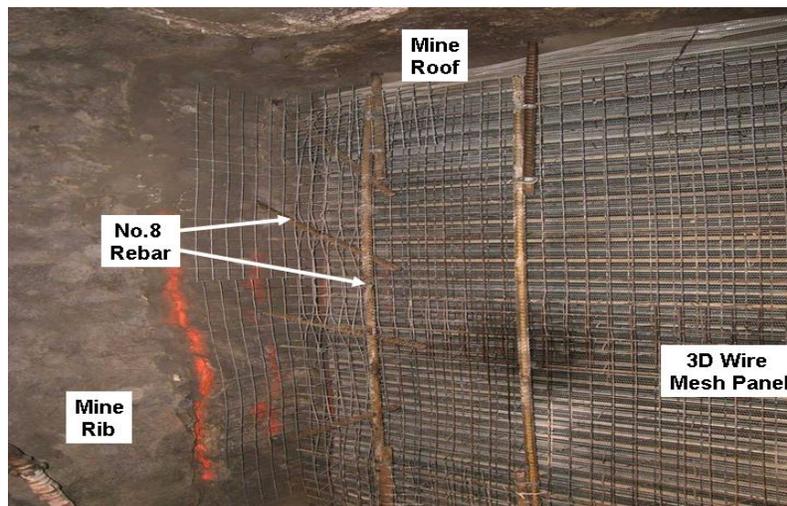
**Figure 16.:** Photo of Mine Seal No. 3 showing the mesh panels and reinforcing bars.

Mine Seal No. 3 was erected in the small chamber in the LLEM. The seal was constructed 8-ft high by 20-ft wide and 11-in thick and was built using Stayfoam<sup>2</sup> panel backing and Insteel 3D<sup>2</sup> wire mesh panels. The panels were anchored to the mine roof rib and floors with No. 8 reinforcing bar (rebar) that was drilled and set into the exposed strata. Across the front of the seal, the segments of rebar that were anchored into the roof and floor strata were affixed with steel strapping to vertical sections of rebar and the wire mesh panels (figure 16). The entire face of the seal was then sprayed with Riregrete<sup>2</sup> gunite to complete the construction.

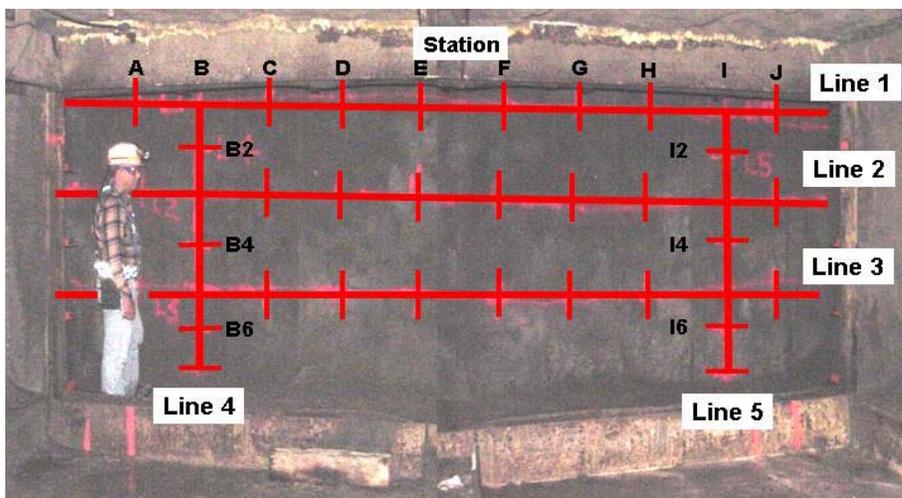
**Figure 17.:** Photo showing Mine Seal No. 3 with GPR survey lines.

GPR was used to determine if the metal construction components could be resolved. For the radar survey, three perpendicular horizontal lines (lines 1-3) were positioned on the seal with the first line located about 6-in below the mine roof interface and the remaining two lines spaced about 24-in apart. In addition, two vertical lines (lines 4-5) were positioned approximately 4-ft from each mine rib. Reference points, spaced 24-in apart, were added to each survey line and these points were also added to the radar records (figure 17). Each survey was made by placing the antenna against the seal face and then moving along the line at a constant velocity. The radar survey of the seal were made using 1,000-MHz antenna because this antenna could provide the necessary depth of penetration and the desired level of resolution. A total of 22 surveys were made of the mine seal and table 3 shows the setup parameters used for each survey.

reference points shown in figure 17. In the radar records, two layers of wire mesh can be seen. The Stayfoam<sup>2</sup> panel however cannot be discerned from the back of the second wire mesh panel most likely because it was attached to the panel. This also explains the higher energy reflections seen in the deeper portions of the radar records (shown as back mesh areas in the records) because the Stayfoam<sup>2</sup> panel had a closely spaced mesh and thus a larger reflective surface.

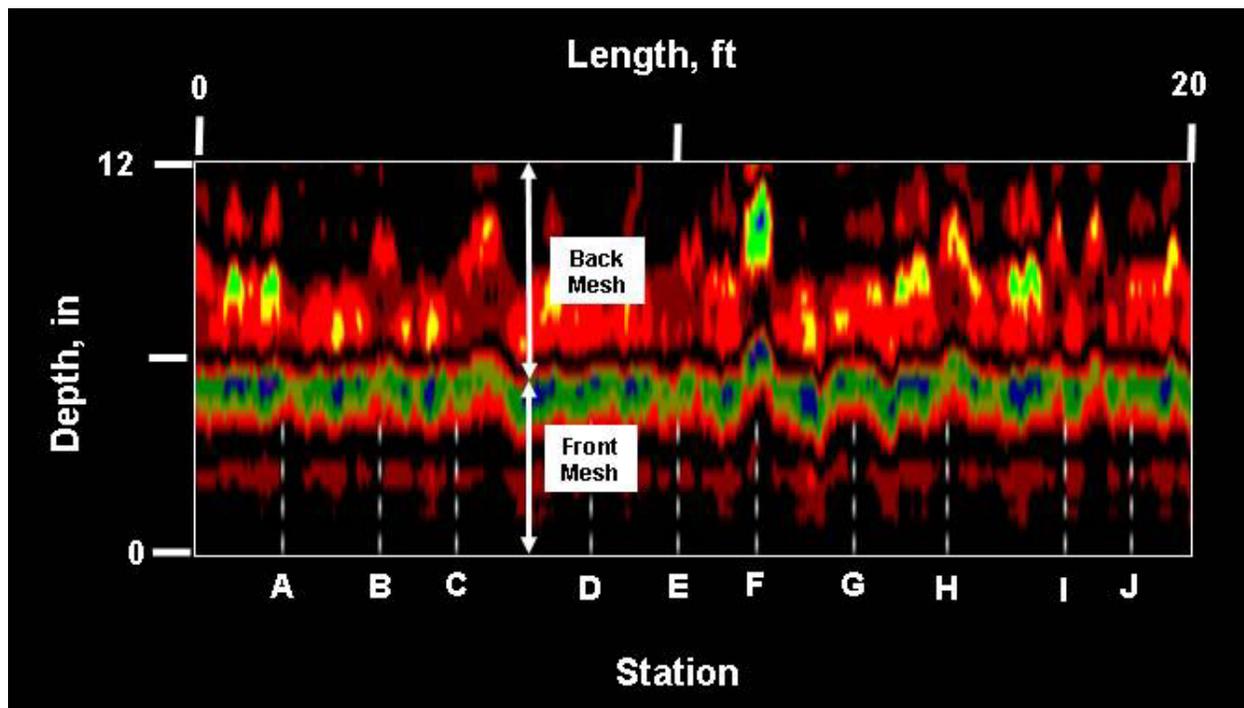
**Figure 18.:** Interpreted radar record for Mine Seal No. 3, Line 1.

Figures 18 and 19 show representative post-processed radar records of Mine Seal No. 3 and their associated interpretations. The reflected pulse energy is shown in terms of a color scale, with hot colors (yellow and bright green) being the higher level of reflected pulse energy and colder colors (brown and black) the lower levels. Areas in the record shown with similar colors should be interpreted as similar levels of reflected pulse energy. The vertical scale shown in the figure corresponds to the

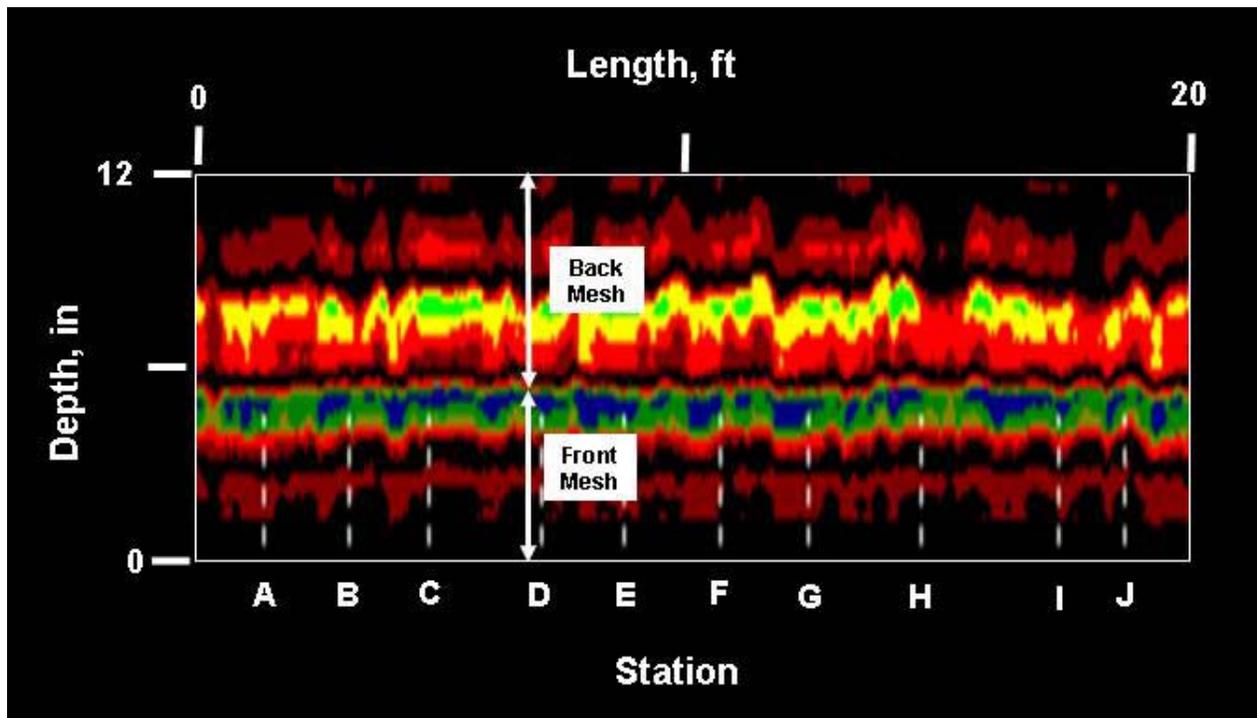
**Figure 19.:** Interpreted radar record for Mine Seal No. 3, Line 3.
