Improving the Capability for Real Time Assessment of Roof Conditions Through Intelligent Roof Bolt Drilling Operations

Robert Anderson, Design Engineer
J. H. Fletcher & Company
Huntington, WV

L. J. Prosser, Research Scientist
NIOSH-Pittsburgh Research Laboratory
Pittsburgh, PA

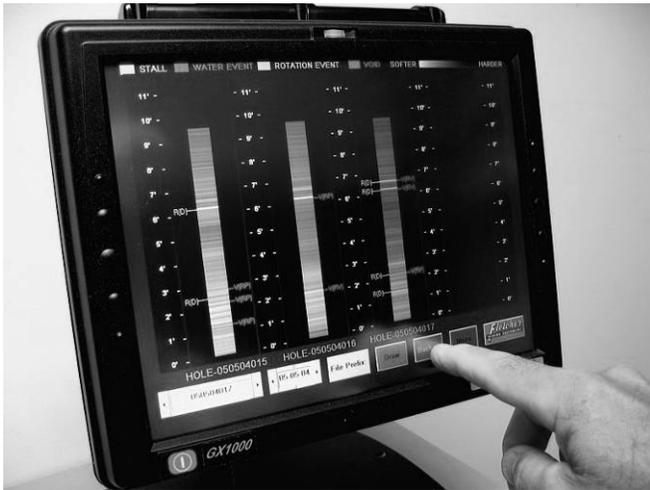
Figure 2. FLETCHER® Information Display

The software was tested in the laboratory and in the mine and was refined to improve its accuracy. In a recent project with West Virginia University (WVU), the software was modified to communicate in real time with the drill control unit and display the information as the holes were being drilled. With this new system, graphs illustrating information from four separate drill holes were displayed side-by-side so that trends could be easily seen. The display and analysis can be activated through a rugged touch screen panel installed on the bolting machine to facilitate use underground by the roof bolter or other mine officials (see figure 2).

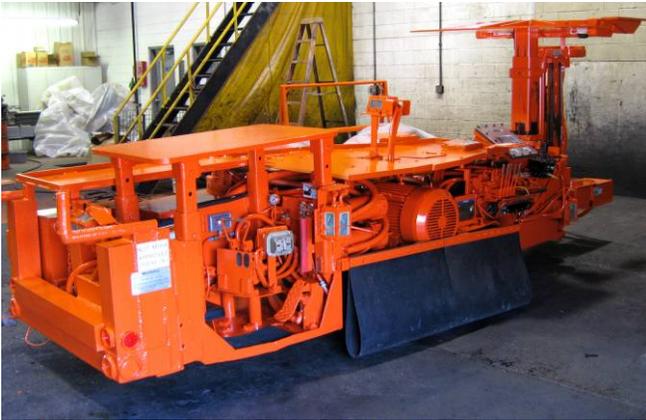
Figure 3. Roof bolter used for testing in underground coal mine.

In another joint project with WVU, a test machine was built for use in an underground coal mine. An older single-boom roof bolter was rebuilt with modern components including the latest generation of drill head and drill control unit. The FLETCHER® Information Display was installed in an explosion-proof housing on the machine. Figures 3 and 4 show the coal test machine and the information display.

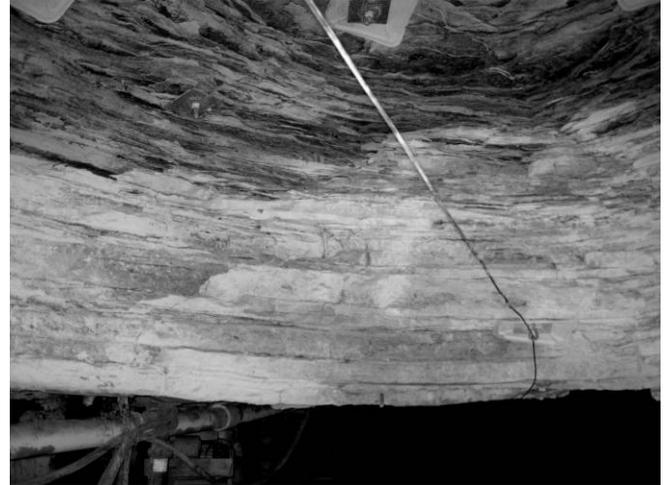
Figure 5. Section of roof adjacent to large roof fall.

The test machine was moved to another section of the mine where there had previously been roof problems including a large roof fall. Figure 5 shows this area and gives a cross section of the roof strata in this area.

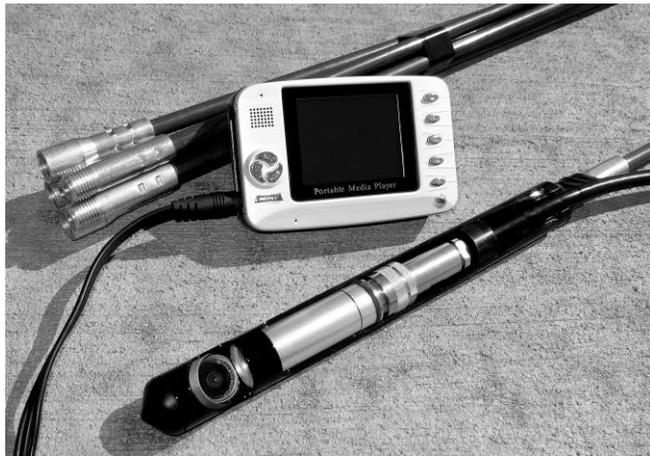
Figure 7. FLETCHER® Bore Scope.

Scoping holes were also analyzed using a small bore scope (less than 1 in diameter) as shown in figure 7. Video files were recorded for each hole. Initially, the bore-scope videos showed few discontinuities in the holes. Only two of the holes had obvious voids (see figure 8). The holes were flushed out with water, assuming that dust from the drilling might be obscuring the voids. The holes were bore-scoped a second time and again there were not clear voids at the locations indicated on the drill data files. A scratch tool was used to feel for soft bands or ledges in the holes.

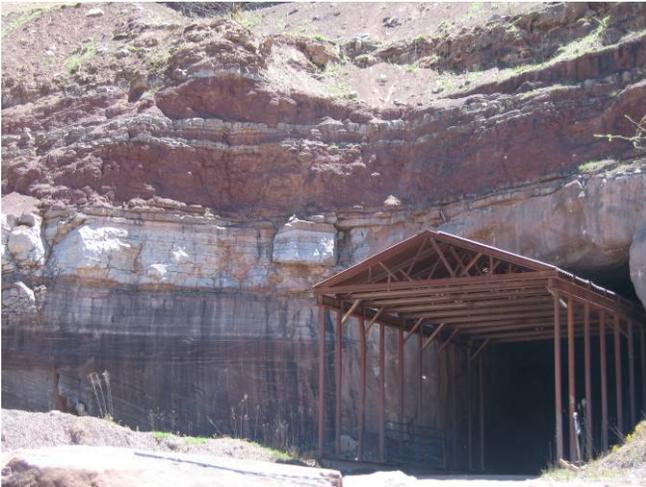
Figure 16. Red clay above limestone.

A photo from outside the mine opening shows the red clay above the limestone seam (see figure 16).
