Longwall Shield Recovery Using Mobile Roof Supports

Frank Chase, Research Engineer
NIOSH, Pittsburgh Research Laboratory, Pittsburgh, PA

Phyllip Worley, Senior Manager of Engineering
Peabody Energy, Wharton, WV

Allen McComas, President
Mobile Mining Support, Inc., Peach Creek, WV

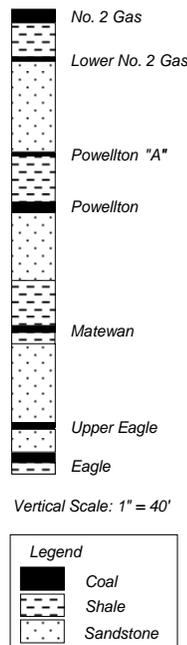
These rock unit thickness variations indicate ancient stream Figure 2. Immediate and main roof stratigraphy at Harris No. 1 Mine.

Harris is mining in the Eagle Coalbed. Figure 2 is a generalized stratigraphic column of the mine roof above the Eagle Coalbed up to the No. 2 Gas Coalbed, which has been extensively mined. It should also be noted that the major sandstone and shale units shown in figure 2 vary in thickness. For example, in a few of the core holes the upper two sandstone units merge into a 100-ft-thick unit. The same can be said for the lower two sandstone units.

channel activity. Usually, the interburden contains 6 distinct rock units; however, the actual number varies from 4 to 7. In general, the interburden is rather competent, with the percentage of sandstone, sandy shale, and limestone ranging from 59 to 80 percent. The shale unit, shown in figure 2, directly above the Eagle Coalbed varies in thickness from 0 to 10 ft. In areas of the Harris Mine, this shale unit can either be laminated, sandy, or nonexistent (replaced by a sandstone scour). These fluctuations explain the range in Coal Mine Roof Rating values from 44 to 71 (Molinda and Mark, 1994). These values indicate that the immediate roof rock is of moderate strength to strong.

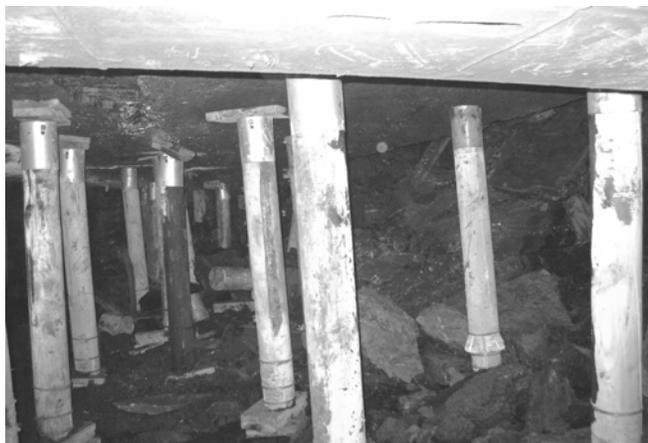
Figure 3. Engineered yieldable timber props equipped with active prestressing mechanical devices used as breaker line supports.

For the most part, there are three general methods that operators employ in order to prevent gob flushing into the working area. The first method relies solely on primary and supplementary intrinsic and standing supports. Traditionally, the standing supports were two or three 4-point cribs installed for each face shield removed. One needs to keep in mind that a shield is being lowered and adequate support needs to be installed to maintain the immediate roof. Many operators have opted to use hydraulic or engineered timber props (figure 3) to reduce the amount of time required to install compared to a wood crib. This reduces miner exposure to the unpredictable gob edge and shortens the move time.

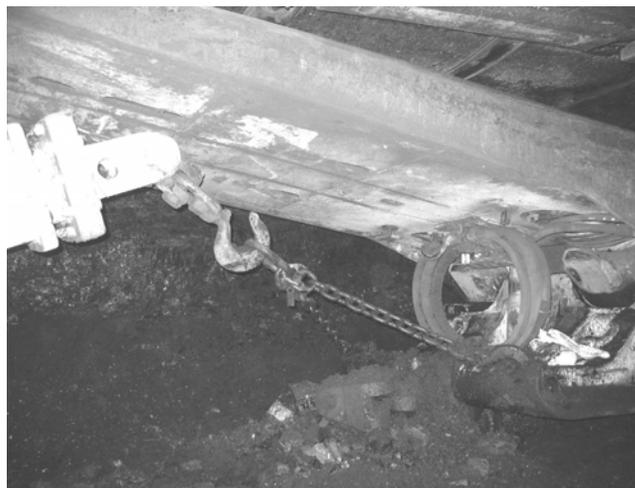
Figure 4. Shield retriever advancing walking shield.

Another method which operators utilize to prevent gob flushing are walking or trailing shields. The majority of the mining community is accustomed to using the terms “walker” or “walking shields.” Therefore, this paper will comply and will use this terminology. If one shield is used, a chain or 1-in-diameter steel wire rope is hooked to the shield’s frame (legs or pontoons). The shield is moved out of the face area with a shield retriever. As shown in figure 4, some retrievers have a long boom with a hook on the end. The hook is manually placed in a large clevis that is attached to the chain or wire rope. The boom is raised and the shield is dragged out of the face so that the long axis of its canopy is situated parallel to the face (unmined block of coal) and perpendicular to the other face shields. This shield now functions as a walking shield, and is pressurized a few inches slightly in front of the shield tip and canopy corner to retrieve the next shield. After the next shield is removed, the walking shield is dragged forward

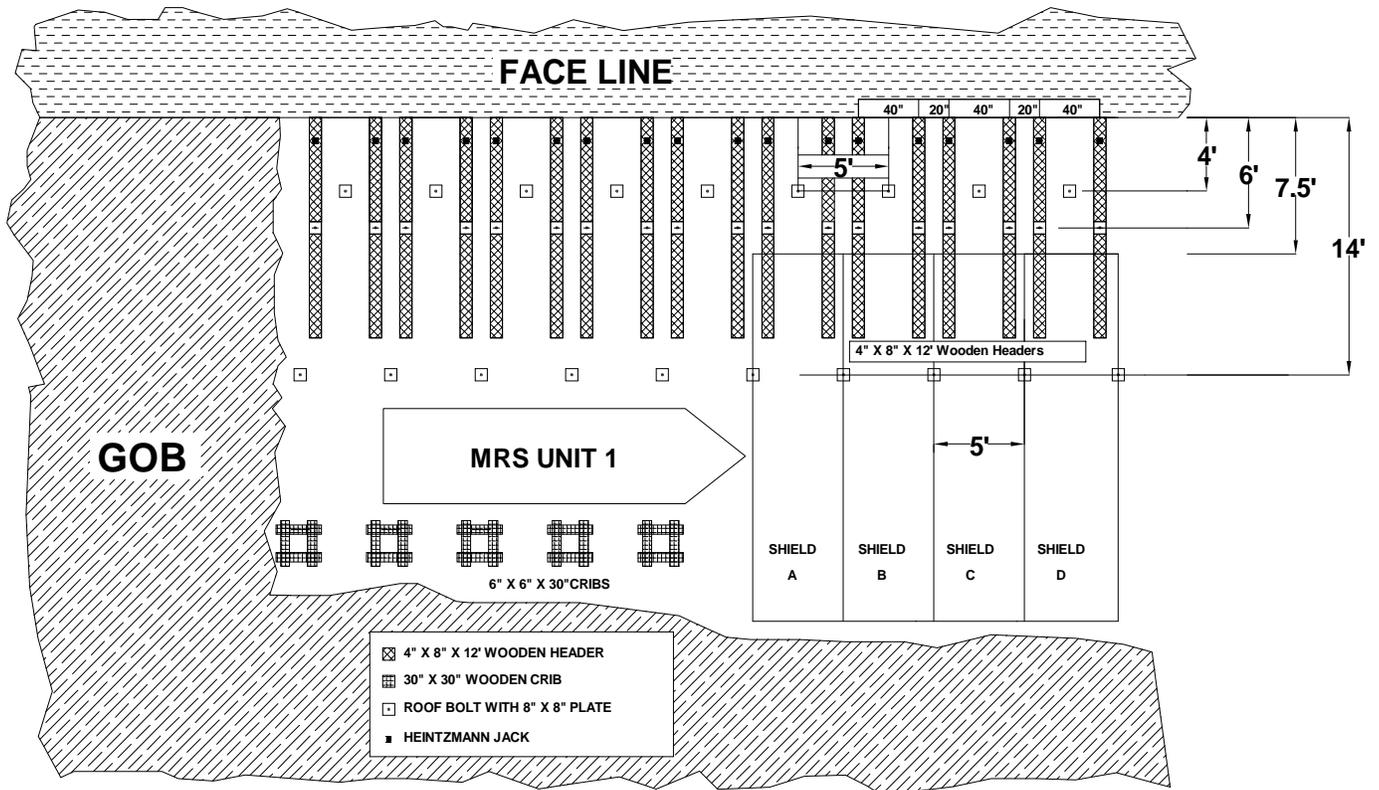
Figure 5. Harris No. 1 Mine shield recovery plan.

Figure 5 depicts the current support plan and MRS positioning for shield recovery operations at Harris. If ground conditions permit, Harris pulls shields from mid-face to both the headgate and tailgate, or bidirectional. As figure 5 suggests, after shield “A” is retrieved and begins being dragged to the tail (or to the right in figure 5), a crib is built in its place, in line with the previous ones shown. Then the MRS is lowered, trammed forward and reset. As the operator trams the MRS forward to recover the next shield, they align the canopy edge of the MRS with the leg socket connection to the shield’s canopy as shown in figure 5. The process then repeats itself. As previously indicated, walkers are pressurized only a few inches in front of the shield canopy of the next shield to be recovered. Based on the manufacturer, the cable reel and/or plow necessitates the MRS’s canopy to be pressurized approximately 3-4 ft away from the shield toward the gob side as illustrated in figure 5. This has not constituted a problem at Harris; however, under weak immediate roof rock conditions it should be considered. MRS’s used on previous models at Harris had 4-ft extensions welded on the canopy’s duck bill enabling them to be situated a few inches from the shield corner, similar to walkers.

compared to figure 5, significantly less support is required when using two MRS’s. Harris has opted to use a single MRS due to the restricted width of the recovery room. The MRS canopy width for the model used at Harris is greater than that of a standard shield. This places the side of a second MRS in close proximity to the roof caving area, and gob flushing causes frequent machine fouling.

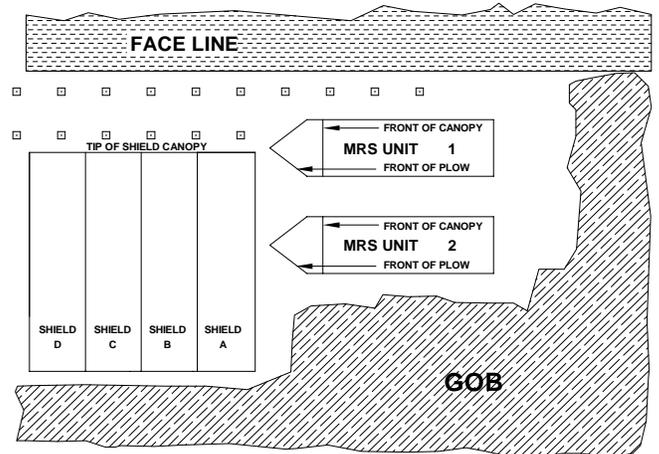
Figure 6. Shield recovery plan using two MRS’s.

Figure 6 illustrates a MSHA-approved plan employing two MRS’s that was submitted by another mining company. As

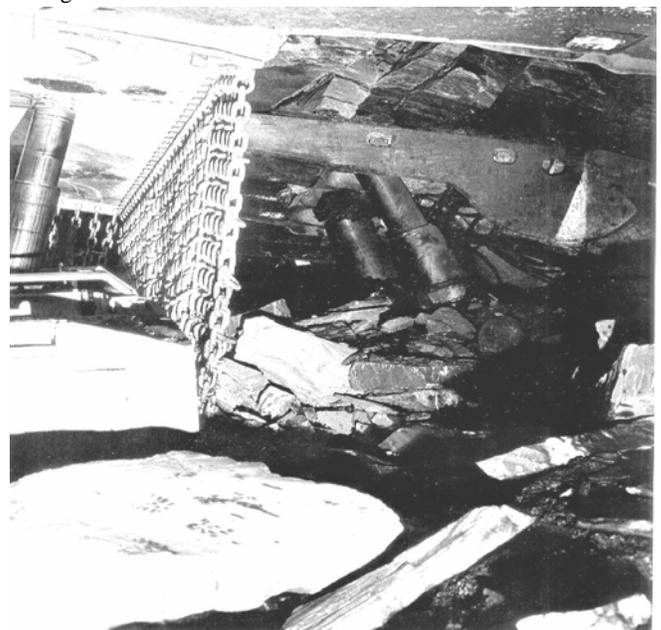
Figure 7. Shield recovery under adverse conditions.

The advantages of MRS's are most evident in adverse conditions. Figure 7 exemplifies some less than desirable conditions in which MRS's have performed well at Harris. This recovery room's roof was highly fractured due to multiple seam stress load transfer and horizontal stress damage. The shield behind the MRS was abandoned because the conditions were extremely difficult at this location and because the shield was nearing the end of its useful life. The decision was made not to

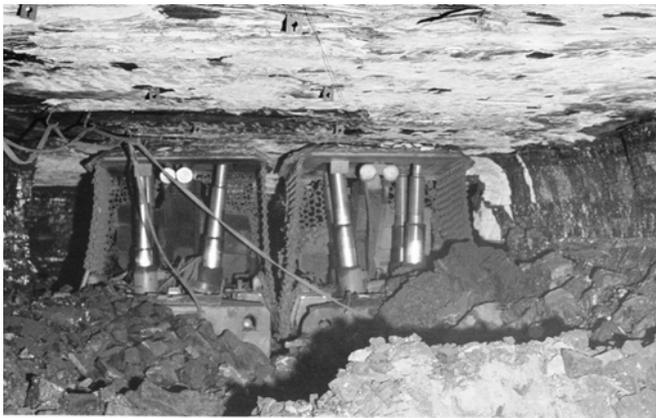
Figure 8. MRS's plowing floor debris.

take the risk or spend the time recovering the shield under such adverse conditions. MRS's also have the ability to bulldoze their way through excessive floor debris (figure 8). With walking shields, it is more likely that some of the debris may have to be removed to facilitate their advance.

Another positive feature of MRS's is that they have two pressure gauges mounted on the front of each support (figure 8). These gauges can be visually monitored by operating personnel to determine loads and rates of loading on the units. In addition, MRS's are equipped with a lighting array which can also be used to examine loading conditions. This array can be seen from farther distances compared to the pressure gages. Green, yellow, and red pulsating lights indicate different total load levels or incremental changes in loading. If a fall seems imminent based on either or both of these systems, the mobile can be quickly trammed out of harm's way. Walkers on the other hand have been trapped, gone iron-bound, and lost because they leapfrog much more slowly. In the event of a high roof cavity or fall, walkers cannot advance if the canopy doesn't pressurize against the roof. If this occurs, the walkers must be dragged with the retriever. Sometimes, the miners will place cribbing on top of the shield so that when the canopy is raised the cribbing will contact the roof allowing the walkers to advance. Obviously, this significantly increases miner exposure to hazardous conditions. MRS's are also better designed for use in mines with floor abnormalities or excessively muddy roadway conditions.

Gob flushing and face spalling pose another problem for walkers. If a sufficient amount of debris enters into the shield's cavity where the hydraulic controls and hoses are located, miners must leave their safe location under the face shields and using a sledge hammer and slate bar, break and pry out the material. MRS's have a steel chain curtain draped from the canopy and down the sides of the units to protect the interior compartment from gob flushing (figures 8 and 9).

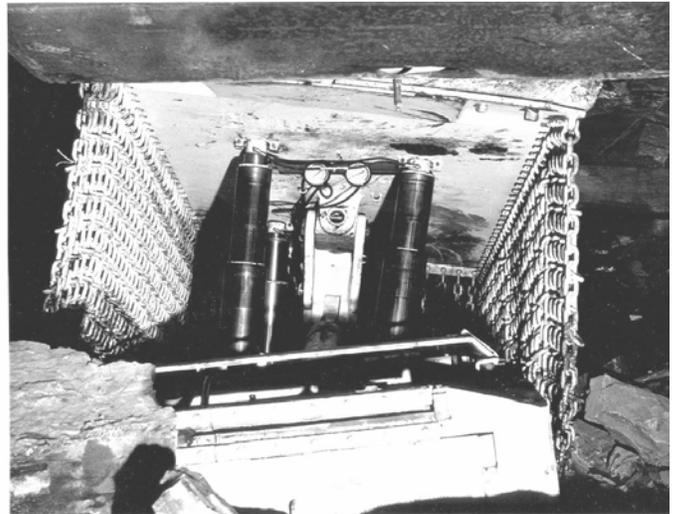
Figure 9. Articulated MRS frame and canopy.

Shields are designed to be loaded vertically and also laterally along the long axis of the shield from the tip to the back. When shields are used as walkers, they are subjected to side loading, a type of loading which they were not designed for. Side loading occurs because the roof tends to deflect or rotate downwards as it cantilevers back towards the gob. The canopy on MRS's is designed to tilt side-to-side in relation to the base structure. This better accommodates side loading conditions and allows the canopy to conform to most types of roof and floor orientations (Barczak and Gearhart, 1997). These concepts are exemplified in figure 9, which shows the canopy canted to the right or gob side of the

photograph. The right side of the MRS is riding up on floor debris and the frame is articulated in relation to the canopy.

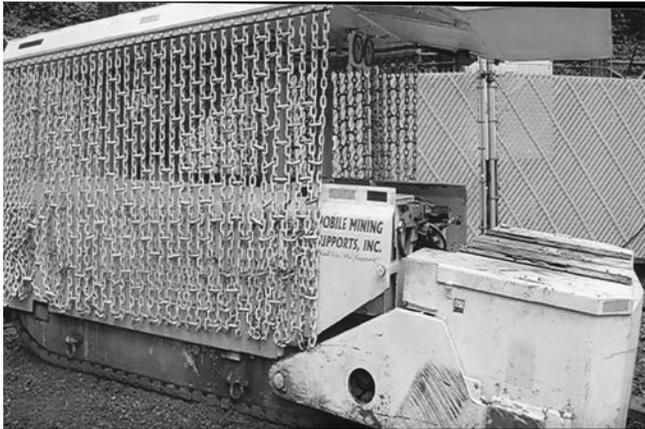
Figure 10. Battery powered MRS.

In light of the above, a West Virginia-based, MRS leasing concern designed and fabricated the first battery powered MRS's (figure 10). These units are powered by a single 1,000-amp-hour battery housed in a one-inch-thick steel compartment. The total weight of the battery and compartment is six tons for a total machine weight of 31 tons. The battery compartment is located at the front of the unit (figure 10) and is mounted onto the frame with a large hinge pin. The compartment can be moved up or down for

clearance or to plow floor debris. A specially-designed, double bank charger is normally located at the charging station. A fully charged battery will power the unit for 5 to 6, 8-hour shifts. Twelve hours prior to being discharged, a battery indicator light will come on. This allows the battery to be switched-out at the most convenient time, for example, during a shift change. Usually, a scoop will bring a fresh battery to the MRS and battery switch-out time is approximately 5 minutes. The spent battery is then recharged for 8 hours, allowed to cool for 8 hours, and then is ready for reuse.
