21st International Conference

AN EXAMINATION OF THE LOYALHANNA LIMESTONE'S STRUCTURAL FEATURES AND THEIR IMPACT ON MINING AND GROUND CONTROL PRACTICES

Anthony T. Iannacchione, *Senior Scientist*
Paul R. Coyle, *Geologist*
National Institute for Occupational Safety and Health
Pittsburgh Research Laboratory
Pittsburgh, Pennsylvania USA

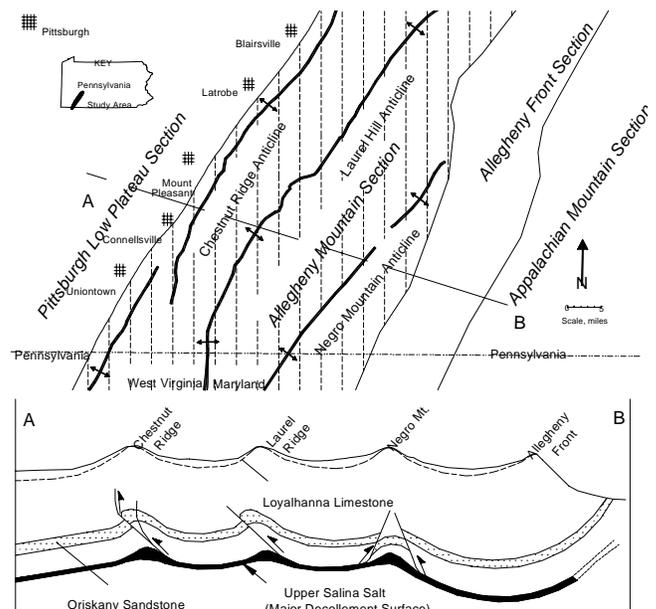
Figure 1. Location of major anticlinal structures and a generalized cross-section through the Allegheny Mountain Section of the Appalachian Plateaus Province.

(figure 1). These outcrops have historically been the sites for commercial aggregate mining, especially those closest to the population centers in and around Pittsburgh, Pennsylvania. Currently nine quarries mine the Loyalhanna through underground and surface operations in Monongalia Co., West Virginia, and Fayette and Westmoreland Counties, Pennsylvania, (table 1) along the linear trace of Chestnut Ridge.

Apparently the Loyalhanna and surrounding strata in the Allegheny Mountain Section have moved some distance along the Salina detachment horizon (figure 1). In addition, the overlying Middle Devonian rocks are intensely faulted. The faults originate within the Salina and quickly rise into a series of branching splay thrust faults under the limbs of the anticline. The complicated nature of the stiffer rock units between the Salina and the Tully Limestone is shown in figure 5 where these units are either stacked in an imbricate fashion by ramping thrust faults (5) or flexurally bent by an overturned fold with imbricate faulting (11). Gwinn explained the stacking at depth as caused by shortening of the detached strata above the Salina Salt. This produced a depressed zone along the anticlinal crest which has helped to create Chestnut Ridge's broad fold at the surface. Shumaker indicates that the highly deformed Salina has thickened into a salt core under some parts of Chestnut Ridge. The overlying Middle Devonian rocks are overturned in relatively tight folds with large splay faults emanating from the base of the overturned limb.

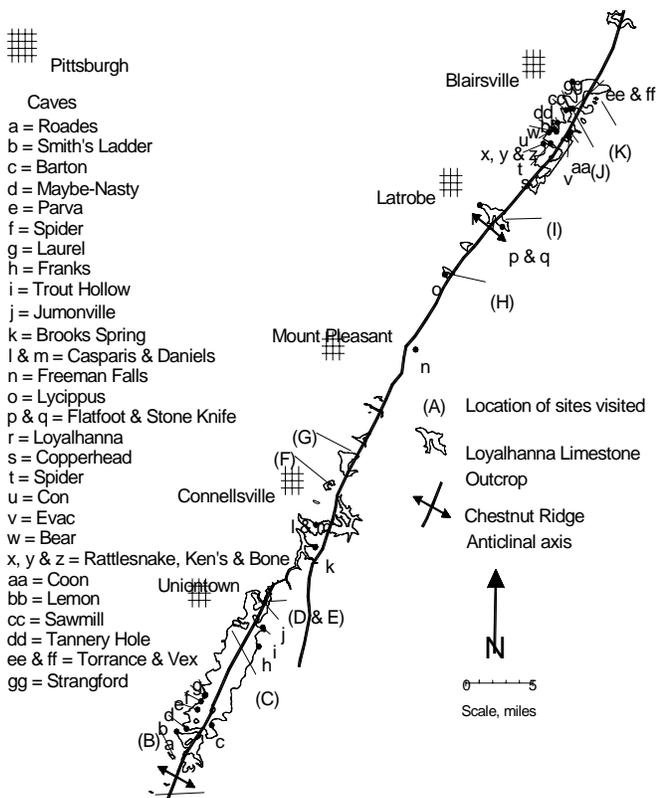
Figure 2. Location of Loyalhanna Limestone outcrop, caves, and sites visited during this study. Capital letters A, B, D, E, F, G, H, I, and J are quarries; C is a highway outcrop; and K is an abandoned coal strip mine.

1. The first fault is exposed along Rt. 40 (Site C, figure 2) where it climbs the western flank of Chestnut Ridge at an altitude of about

The Summit and Griffin Domes have extensive caves developed in the limestone. Caves occur when existing joints open as the confining stresses are relieved by erosion, uncovering the limestone. These unconfined joints are then widened as flowing water dissolves the limestone over extended periods of time. The residual fine-grained material that is left in place can be easily carried away by the small streams of flowing water. Under these conditions, whatever locked-in stresses that once existed are released. Quarries that clearly have low stress conditions (Site D and J, figure 2) are located within the Summit and Griffin Domes.

Despite the low stresses discussed above at two quarries, the level of horizontal stress is, in general, considered to be excessive. Mines with excessive levels of horizontal stresses (Sites F and I, figure 2) are located in saddle structures and are close to either an inferred cross-strike slip fault or a projected lineament that may form the boundary of a large ramp structure. At both of these mines a significant number of joints with low dip angles were observed. Additional research is required to fully understand the important structural factors that either diminish or concentrate stresses in this area.

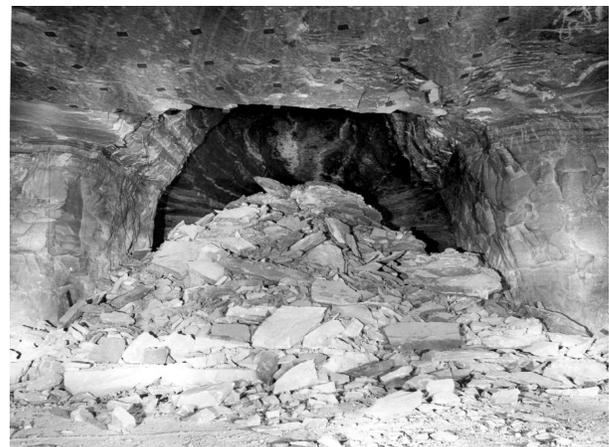
Figure 3. Massive roof fall measuring 45 ft wide by 20 to 30 ft high and extending for approximately 200 hundred feet.

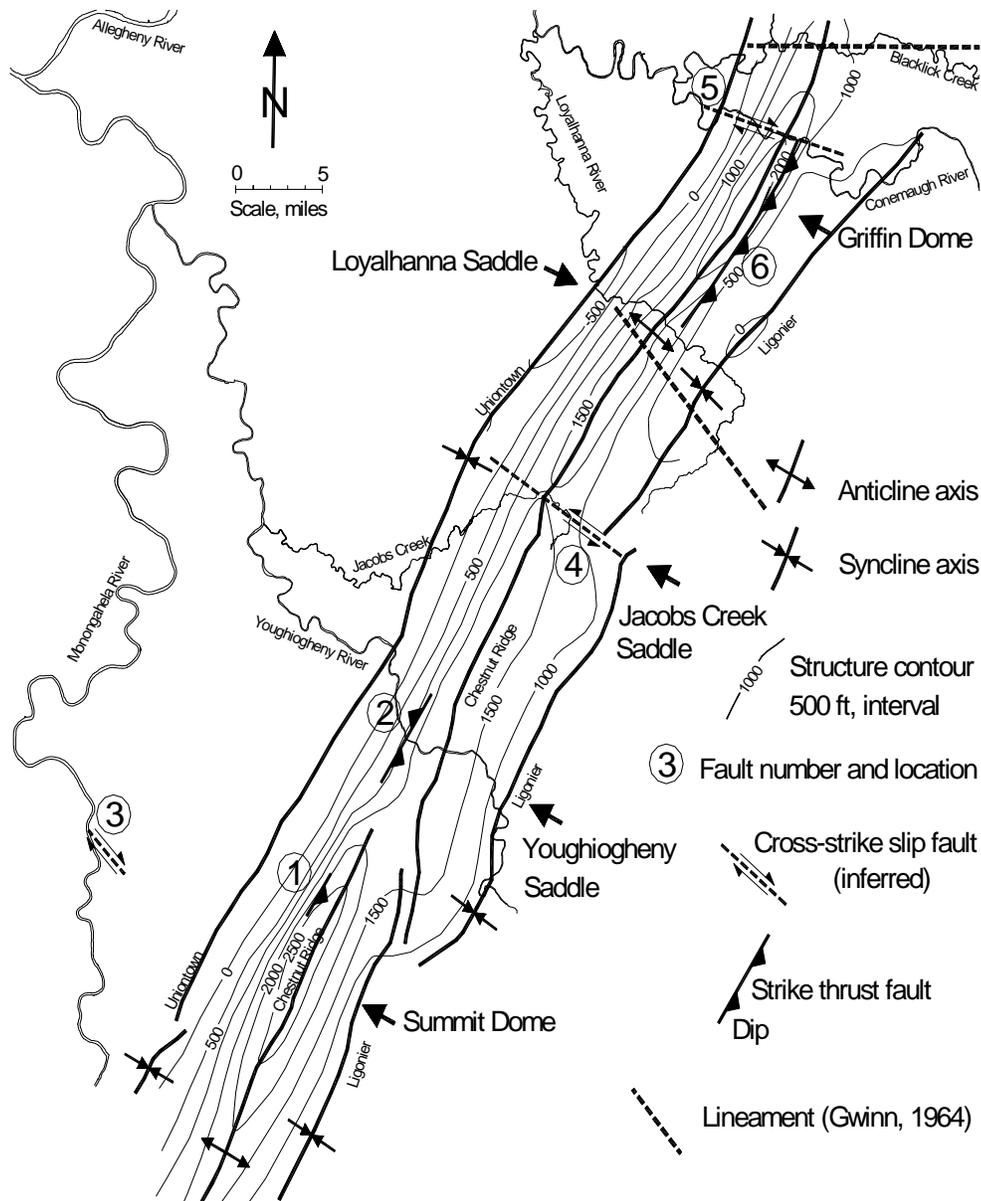
Figure 4. Structure contour map on the top of the Loyalhanna with major fold structures, surface faults, lineaments, and rivers and streams.

areas form enclosed contour elevations called domes. The Summit Dome (figure 4) lies midway between the Cheat River Gorge to the southwest and the Youghiogheny River Gorge to the northeast. The Griffin Dome (figure 4) lies further to the northeast between the Loyalhanna and Blacklick Creeks.

Six major faults have been previously recognized within the study area as shown in figure 4. Three of the faults were reported by Hickok and Moyer (7) and three were reported by Shaffner (8, 9). Two were observed on the western flank of Chestnut Ridge (Fault No. 1 and No. 2), a third along the Monongahela River (Fault No. 3), a fourth and fifth inferred slip faults transecting Chestnut Ridge (Fault No. 4 and No. 5), and a sixth was observed along the eastern flank of Chestnut Ridge (Fault No. 6). These faults can be classified as either strike thrust faults or cross-strike slip faults. The strike thrust faults, in general, have bearings along the strike of the anticlinal structure and dip at a relatively low angle. The cross-strike slip faults (Faults No. 4 and No. 5) were never actually seen by Shaffner although he speculated that they must exist in order to explain the topographic and structural anomalies in this area. The inferred strike of these faults is perpendicular to the anticlinal structure with dips of approximately 90°. These trends are consistent with those expected in response to the formation of the Appalachian Mountain System. A summary of the characteristics of each fault shown on figure 4 follows:

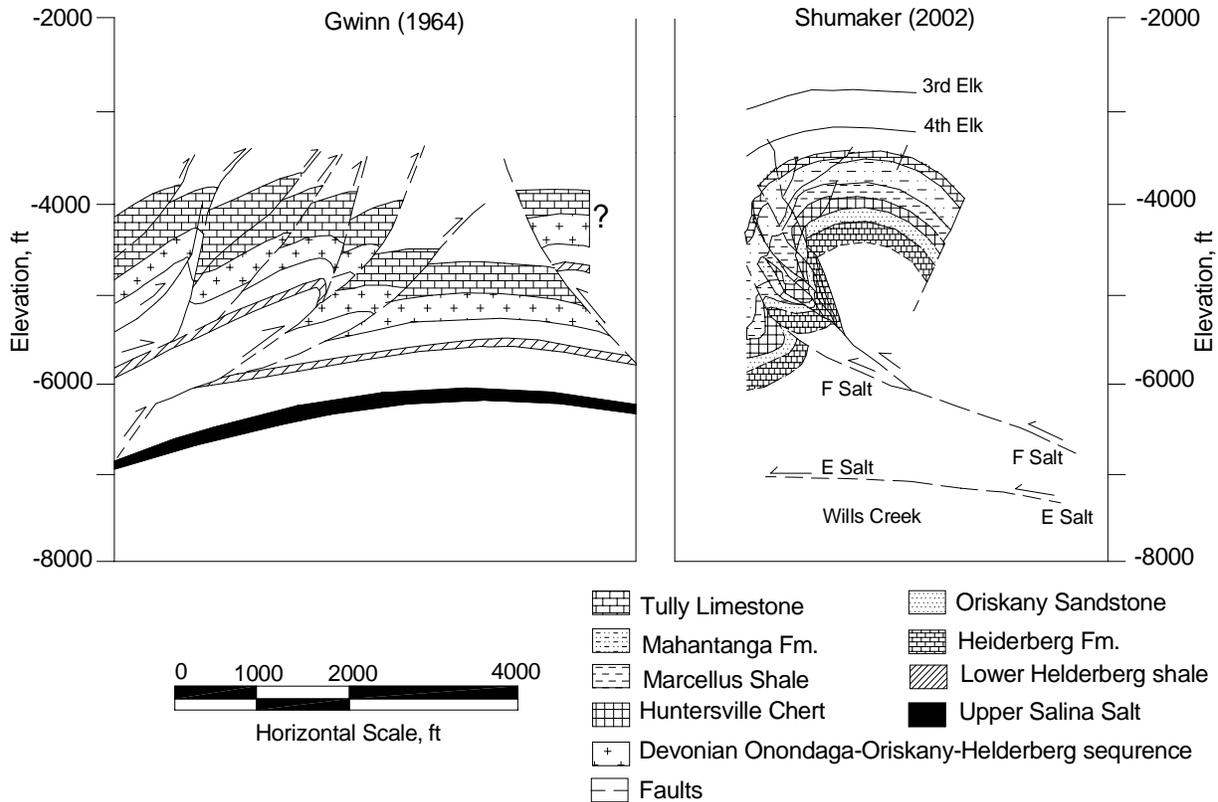
Figure 5. Complex structure under Chestnut Ridge at depths of -2,000 to -8,000 ft below sea level (5, 11).

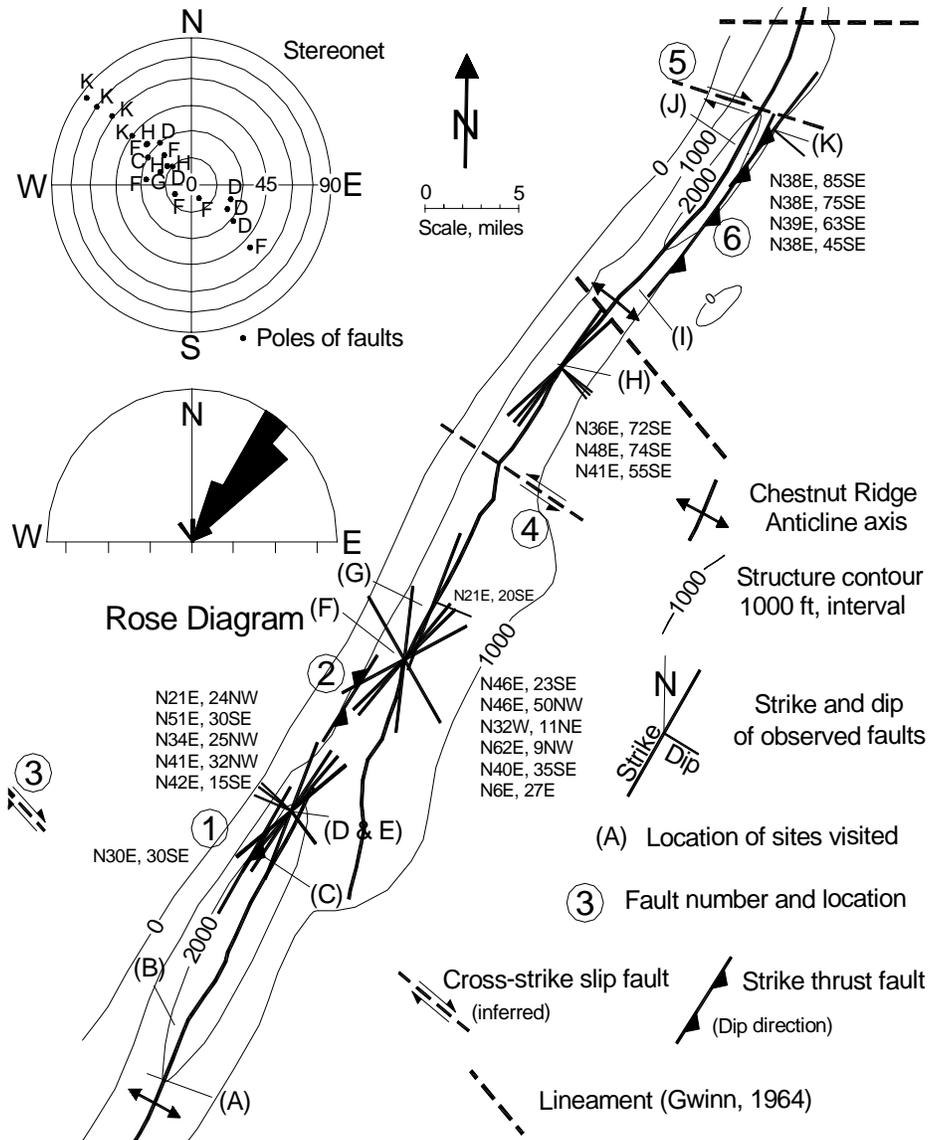
Figure 6. Location and strike and dip of faults observed during this study.

In addition to these known and inferred faults, numerous other faults were observed during visits to several quarries. Figure 6 shows the location, bearing, and dip of these faults in various formats. First, the location, strike, and dip of each fault are displayed in conjunction with the structure contour map on the Loyalhanna. Second, a stereonet projection is provided which locates the poles of the fault planes. Two important facts are revealed in the stereonet: (1) the faults align along a consistent orientation of N 40° E, and (2) the dips of these faults vary widely from approximately 60° to the northwest through 80° to the southeast. The consistent strike is further illustrated with the associated rose diagram. The strike of N 40° E, observed at all quarries with the exception of Site F (figure 6), aligns closely with the general bearing of Chestnut Ridge. While the dips vary widely, some consistencies can be observed. For example, all the faults from sites G, H, and K dip to the southeast, whereas the majority of the faults from site D dip to the northwest. Site F shows both northwest and southeast dipping faults.

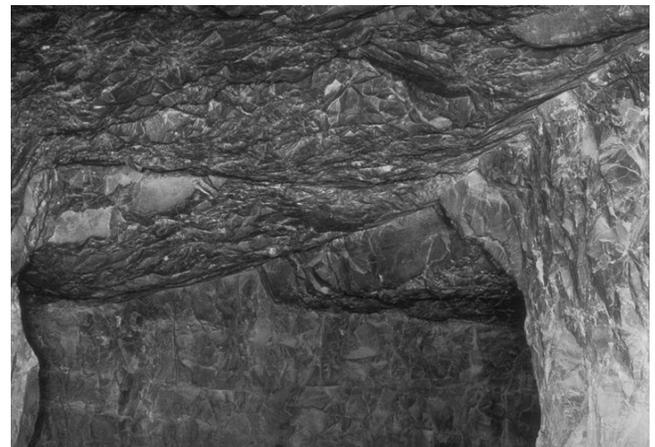
Figure 7. Unstable roof associated with typical low-angle thrust faults.

Most mines should expect to encounter strike faults with dips ranging from 10 to 60° either to the northwest or southeast. These strike faults are more likely to occur on the southeastern side of the Chestnut Ridge Anticline from the Loyalhanna Creek northward and on the northwestern side south of Loyalhanna Creek. It is also likely that Loyalhanna dips will increase significantly on the flank side of these faults. The immediate roof associated with typical low-angle thrust faults can be very unstable and in many locations has failed entirely (figure 7).

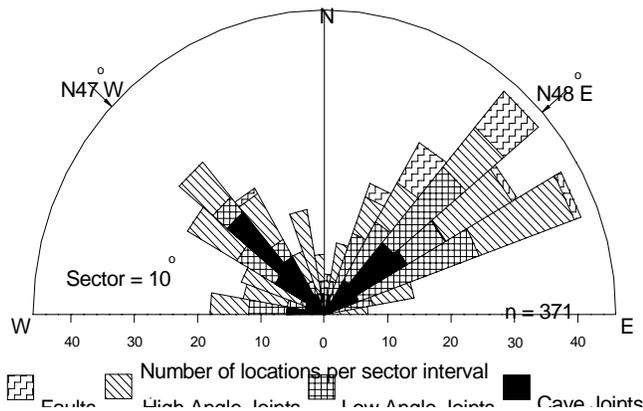
Figure 8. Rose diagram of fault and joint data from study area. 371 measurements were grouped into two clusters. Northwest quadrant data had a mean resultant direction of N 47° W (left arrow). Northeast quadrant data had a mean resultant direction of N 48° E (right arrow).

Jointing was observed throughout the study area and was found to have two distinct trends. A total of 371 joint bearings and dips were measured and plotted on a rose diagram shown in figure 8. These measurements were grouped into two clusters: 1) northwest quadrant data with a mean resultant direction of N 47°W of mostly vertical joints; and 2) northeast quadrant data with a mean resultant direction of N 48° E with varying dips. The N 47° W joint trend strikes across Chestnut Ridge and the N 48° E trend roughly parallel the strike of Chestnut Ridge. These trends are coincident with the orientation of local folding and faulting and are thought to be caused by the same processes.

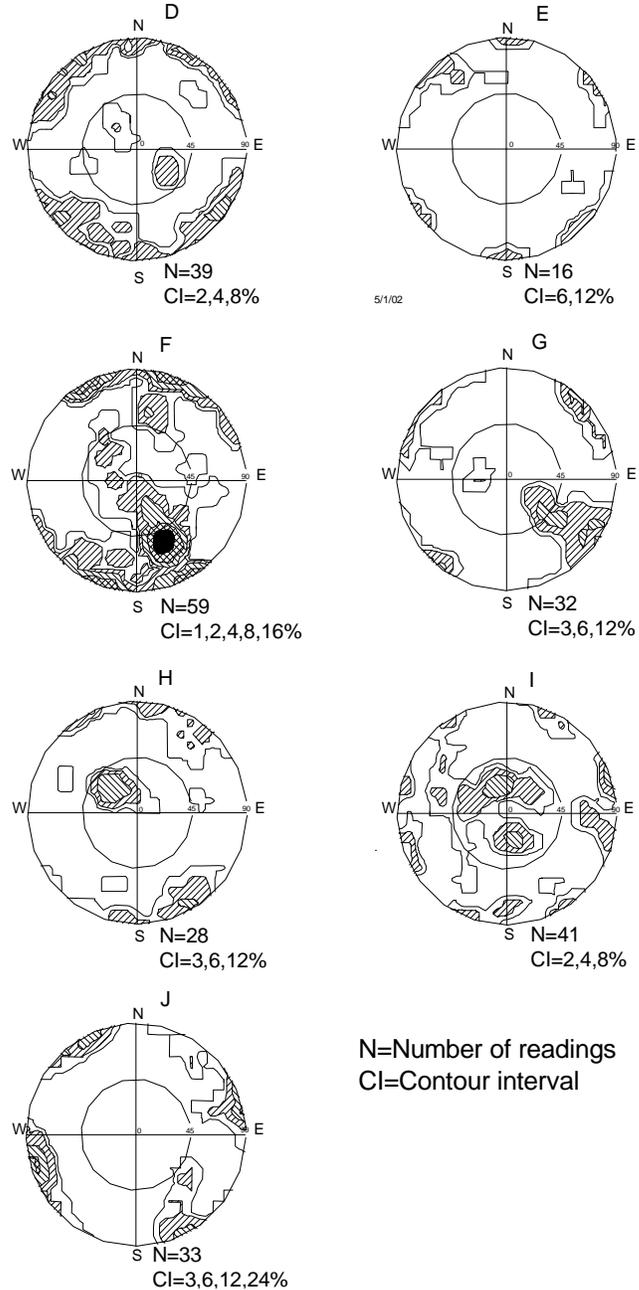
Figure 9. Stereonet projections for seven of the sites visited during this study.

The joint bearings and dips become more significant when the measurements from individual sites within the study area are analyzed (figure 9). For example, at site D (figure 2) most of the joints are vertical with a modest concentration of joints dipping from 10 to 45° to the northwest and lesser concentration of joints dipping from 0 to 45° to the southwest. Site E and J are composed almost exclusively of vertical joints. Sites F and G are dominated by joints dipping from 0 to 90° to the northwest. Site H has a strong concentration of joints

dipping from 0 to 45° to the southeast. Sites F and H have a significant number of joints dipping from 0 to 45° oriented over a wide range of bearings. The spacing of most joint sets ranges from a few feet to tens-of-feet. Displacements along vertical joints were not observed, however, lateral displacements along joints dipping from 0 to 45° were observed at Sites F and I.

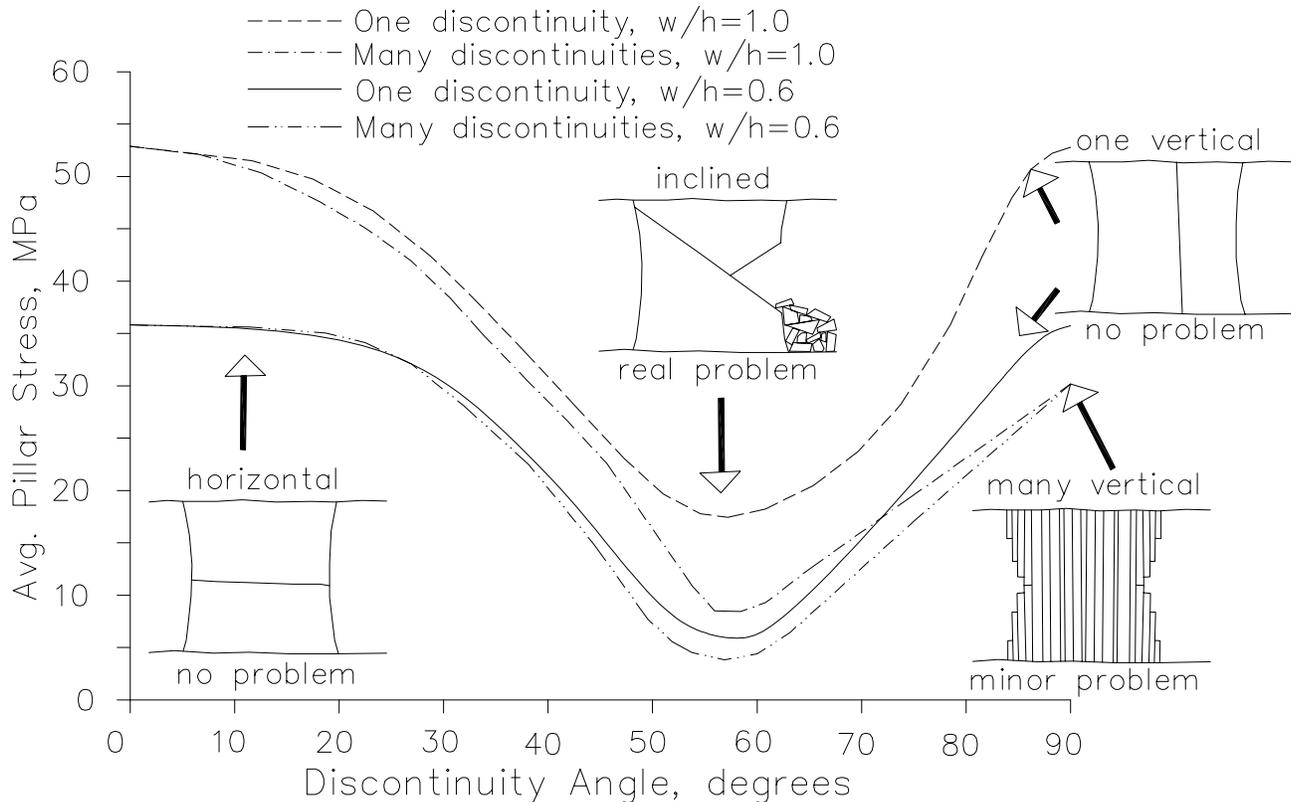
Figure 10. Changes in average vertical peak stress as the dips of discontinuities are varied from 0 to 90° for two different width-to-height ratio pillars.

To illustrate some of these concepts, a model with very closely spaced joints, relatively low joint strength, and variable joint dip was presented by Iannacchione (18). The highest pillar strength occurred with a discontinuity dip of 0° and gradually decreased as discontinuity dip angle increased (figure 10). As the discontinuity dip angle increased above 60°, pillar strength began to increase again, although the original starting strength was never achieved. This result could be expected when near vertical joints are closely spaced, allowing buckling at the edges of the pillar and producing a strain-softening material behavior. Conversely, a near vertical through-going discontinuities with a dip approaching 90° could allow a pillar to regain almost of its strength (figure 10).

pillars took on the appearance of the “real problem” pillars shown in figure 10. Because of the significant percentage of joints within the critical dip range of 30 to 75°, pillar stability is expected to be an important safety issue, especially when pillar width-to-height ratios fall below 1.0 (18, 19). Width-to-height ratios above one are more desirable because there is less chance for the discontinuity to pass entirely through the pillar.
