**ORAU TEAM
Dose Reconstruction
Project for NIOSH**

Document Title: Pinellas Plant – Site Description	Document Number: ORAUT-TKBS-0029-2 Revision: 01 Effective Date: 10/04/2006 Type of Document: TBD Supersedes: Revision 00
---	--

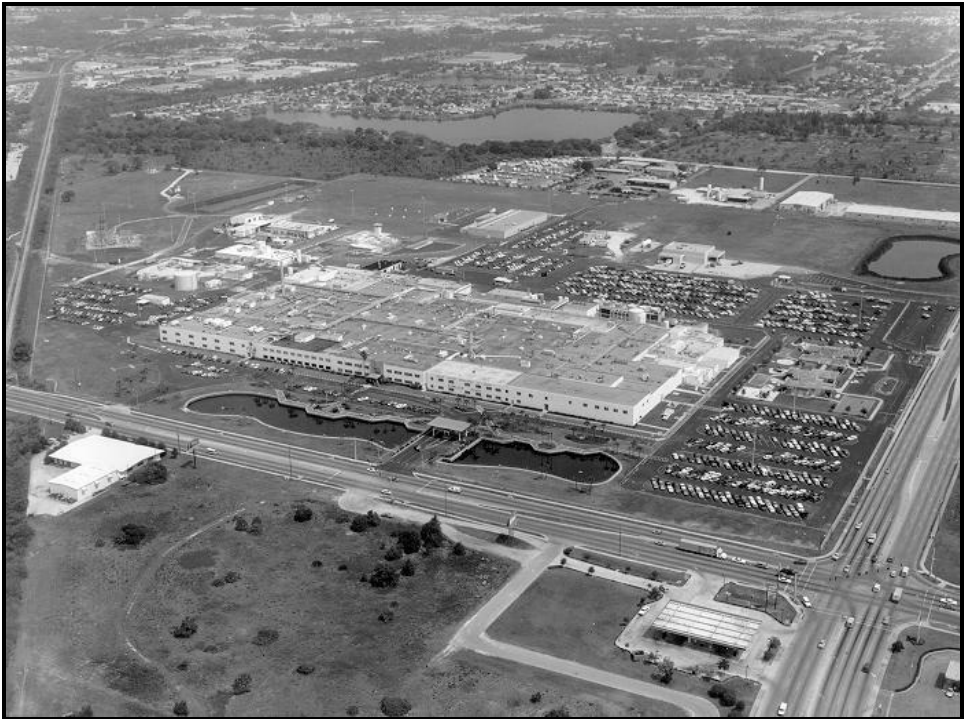
Figure 2-2. Aerial photograph of Pinellas Plant (FAS 2004).

The area around the Pinellas Plant is characterized as urban land consisting of high-density residential developments, commercial buildings, streets, highways, parking lots, and other types of development (USDA 2004, p. 8). Figure 2-2 is an aerial photograph from 1992 that shows the proximity of residential and commercial development around the Pinellas Site.

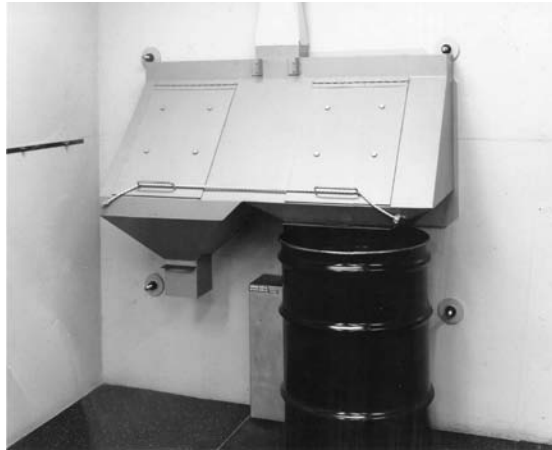
Figure 2-5. Boom box and collection container (ORAUT-2006-0163).

For the "Boom Boxes", a special treated plywood barrier was installed inside of the chamber doors to deflect some of the detonation. They were rotated 90 degrees after each generator test, allowing for four tests. Particles of the generator would imbed into these boards.

The radioactive waste would have been comprised of the generator remains, Styrofoam pieces and particulates, plywood, cables and connectors. This would be collected in the container as shown in Figure 2-5. (ORAUT-2005-0272)
