One Career Fire Fighter Dies and a Captain Is Hospitalized After Floor Collapses in Residential Fire - North Carolina

Fatality Assessment and Control Evaluation Investigative Report #F2002-11

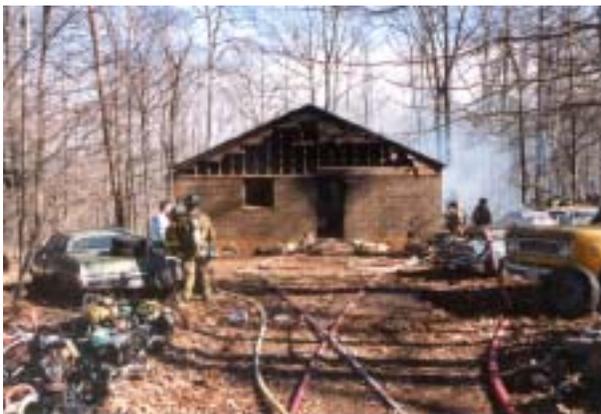
Site of the incident

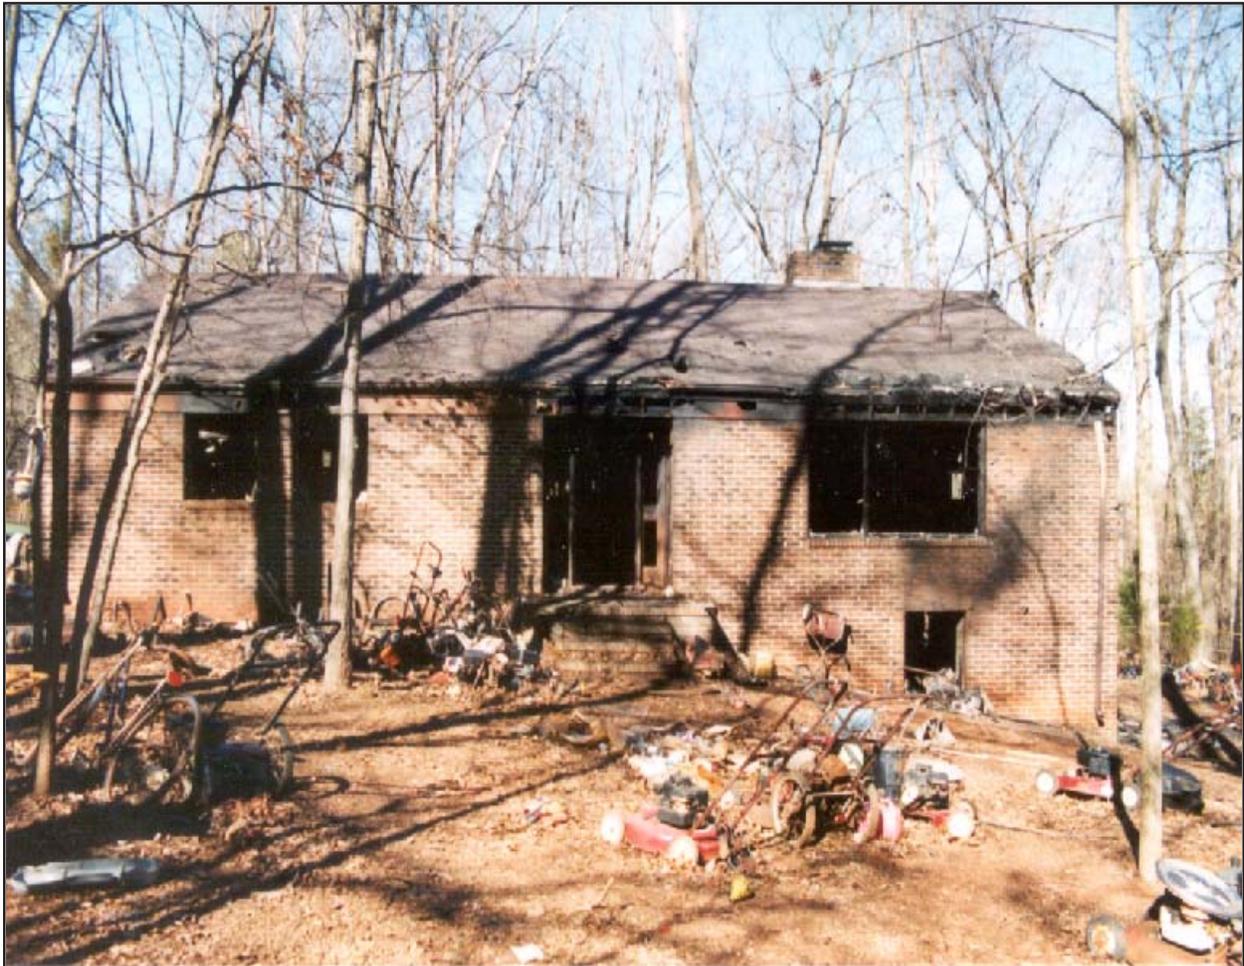
Photo. Front of Structure Involved in Incident (D-Side)

At approximately 1231 hours, Engine 2 arrived on scene with a Chief. The Chief from Engine 2 approached the IC standing near the roadway on Side A, and told him he would assume the role of IC. The new IC told the Chief from Engine N1 to pull a second 1 3/4 hoseline and stretch it to the front door (D-Side) (Photo). The new IC walked up to the side door (A-Side); several fire fighters came out of the doorway and advised him of the conditions inside. At approximately 1233 hours the new IC told the two Captains from Engine 1551, the victim, and several fire fighters to bring the hoseline around to the front door (D-Side). Officers and fire fighters reported to NIOSH investigators that they saw smoke and fire through the basement window (D-Side). As reported by the County Fire Marshal, getting the hoselines around to D-Side was a difficult task due to the amount of debris in the yard and on the porch.

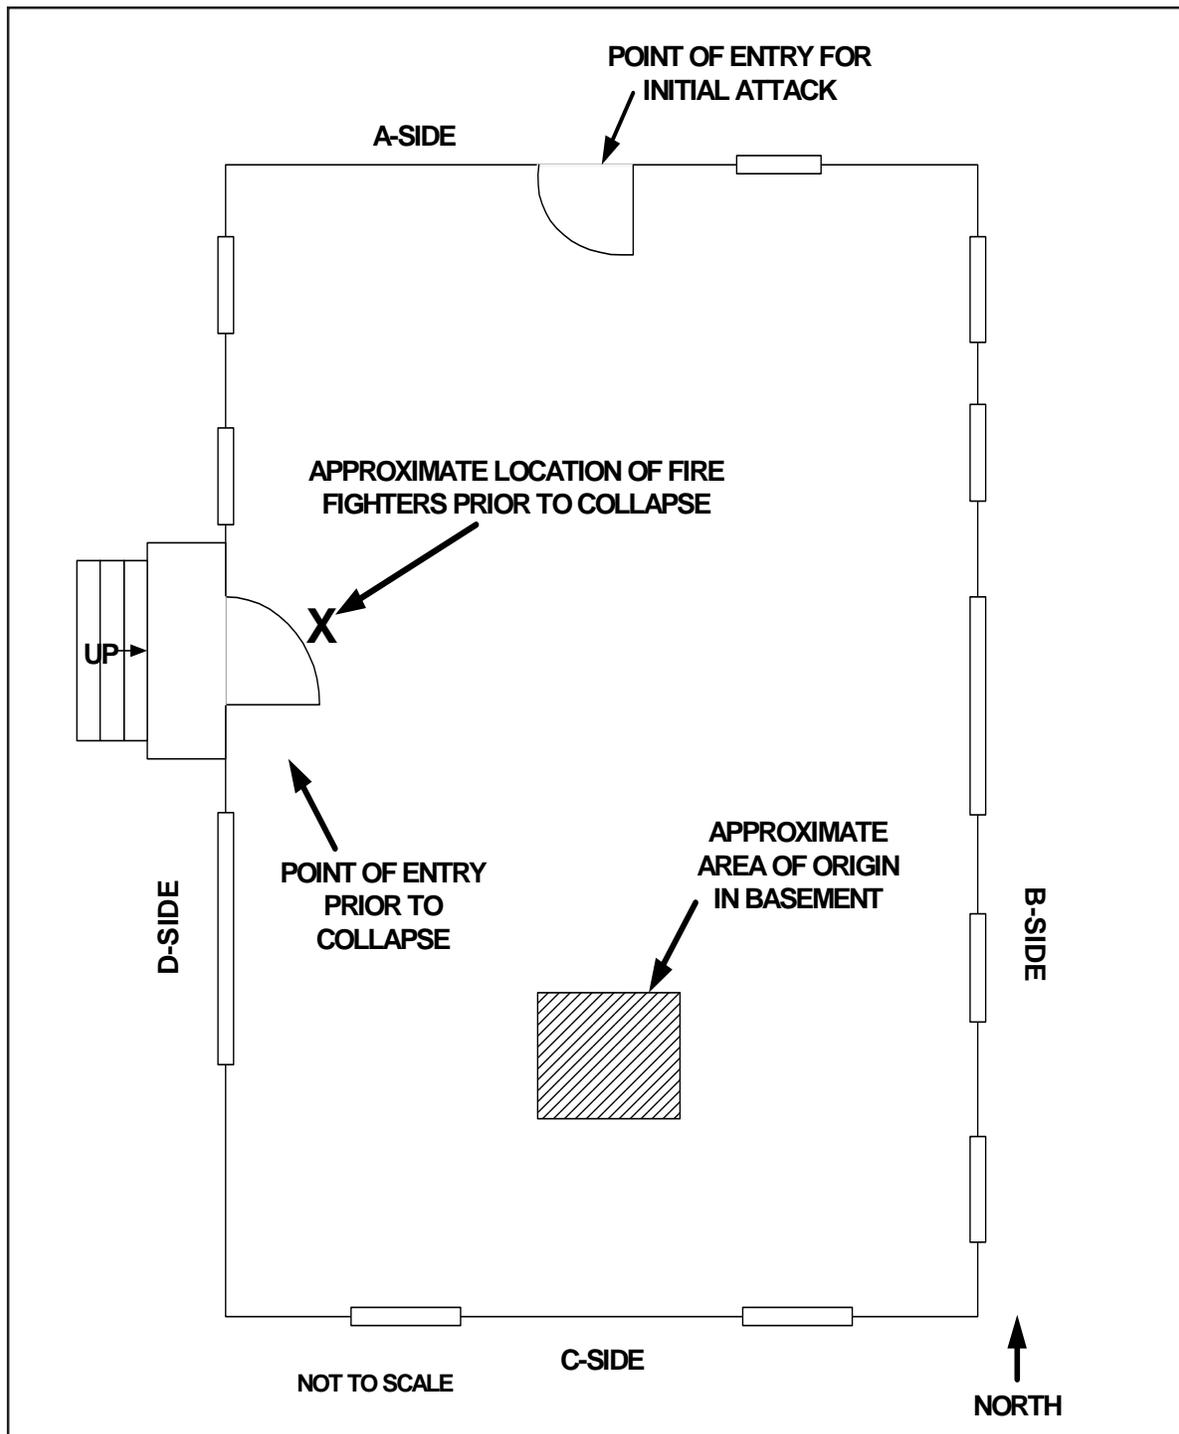
Diagram. View of Main Floor Where Collapse Occurred

At this point, a basement window beside the front porch broke and fire began to blow outward (D-Side). A Deputy Chief with the victim's department, who was standing at the bottom of the stairs to the porch, yelled to the crew inside to exit. The Captain at the door told the Captain in front of him on the hoseline that there was fire below. At approximately the same time, the officer and the fire fighter began making cuts on the D-Side of the roof felt the roof shake, and they quickly made their way off. *Note: They were unable to perform complete ventilation; only a few cuts were made.* At approximately 1236 hours, the Captain behind the victim on the hoseline felt the floor bounce and reached for the victim as the floor collapsed. *Note: According to the County Fire Marshal's office, the entire first floor of the structure and the contents collapsed into the basement. The origin and cause of the fire were determined to be a woodstove located approximately in the middle of the basement. Most of the structural studs of the first-floor walls were suspended in mid-air, and the floor joists had either collapsed or were burned away.*
