INTERIM SURVEY REPORT:

RECOMMENDATIONS FOR ERGONOMICS INTERVENTIONS

FOR SHIP RECYCLING AND REPAIR PROCESSES

PUGET SOUND NAVAL SHIPYARD, BREMERTON, WASHINGTON

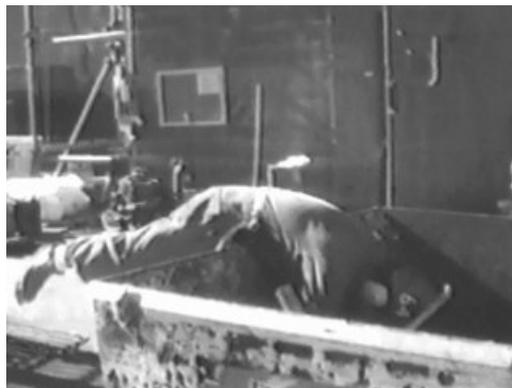
Figure 1. Emptying Scrap Bin at Drydock Sorting Pad

As the surface vessels and submarines are being dismantled as part of the Inactivation, Reactor Compartment Disposal, and Recycling activity, hundreds of bins of scrap metal are generated. Each bin measures approximately 5 feet by 3 feet by 3 feet. The bins hold a variety of material: stainless steel, painted steel, unpainted steel, aluminum, and other metal components. Each bin is filled during the “cut and carry” dismantling process for the vessel or vessels within the drydock. At the time of the site visit, four submarines were being dismantled within the same drydock. The scrap bins are moved from the vessels to the sorting pad area by forklifts. The sorting pad is surrounded by large shipping containers (approximately 5 feet x 20 feet), each for a specific type of metal.

The sorting pad worker removes the individual pieces of metal from the scrap bin by hand. The worker makes a determination of the type of metal in hand and then carries the item to the appropriate shipping container. The worker then places or throws the item into the shipping container and returns to the scrap bin for the next item. Each bin takes approximately 20 minutes to empty and sort. Individual items can weigh anywhere from a few ounces for metal strapping to in excess of fifty pounds for triple valve assemblies.

Changes in how the scrap bins are presented to the worker may help in eliminating the extreme back flexion required to reach to the bottom of the bins to remove items. The current layout of the sorting bin in the drydock is illustrated in Figure 11.

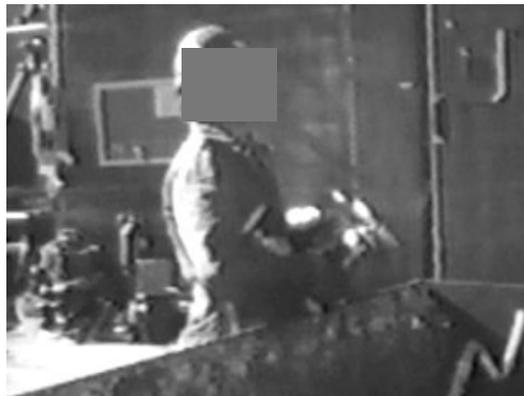
Figure 2. Worker Carrying Triple Valve Assembly to Shipping Container

The sorting pad worker often must reach far in front or deep into the bin while grasping objects of unknown weight. Awkward postures of the back and neck, such as extreme lumbar flexion and neck extension, are fairly common. Strain of the shoulder, neck, and back are possible due to the manual lifting tasks. Some items are relatively heavy resulting in increased physiological strain on the worker.

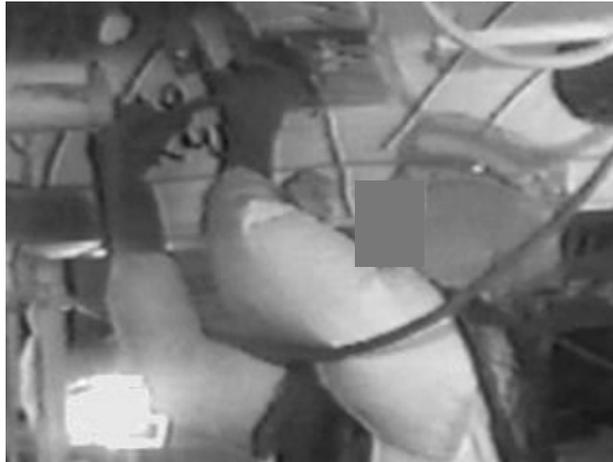
Figure 3. Worker Removing Insulation Tie Cap with Short Pry Bar

Insulation from the bulkheads and ceilings of vessels being dismantled is removed by insulators. The workers first cordon off the immediate work area to discourage entry by unauthorized personnel. This action is done by hanging warning tape and placards (e.g., “WARNING Man-Made Vitreous Fibers”) around the work area. The insulators don totally encapsulating chemical protective suits and supplied-air hoods under positive pressure. The initial task of the worker is to remove the insulation tie caps. These small, round disks secure the insulation onto the metal insulation studs. These disks are removed using pry bars or wrecking bars of various sizes while standing on ladders to reach the overhead insulation. Once all the insulation tie caps have been removed, the worker uses a hawksbill knife (i.e., a knife with a short, downward-curved blade) to cut the insulation into manageable widths of approximately 18 inches. While cutting into the insulation, a co-worker sprays the surrounding air with a water mist to entrap any loose fibers that may otherwise be respirable.

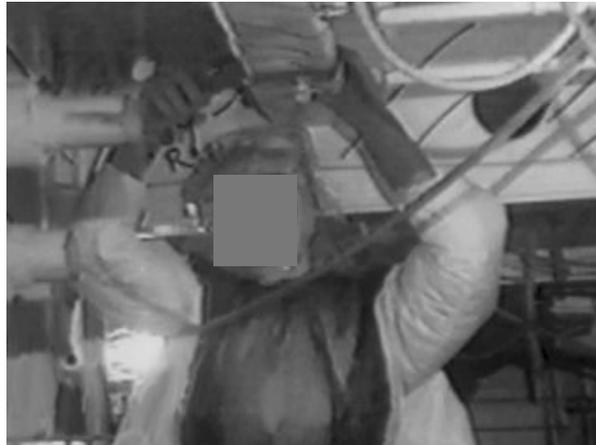
Figure 4. Insulation Worker Cutting into Insulation with Hawkbill Knife

The vast majority of work for the insulation removal workers is performed with arms overhead or out in front and away from the body, either using pry bars or knives, straining the arms, shoulders, and neck. Often the worker is on a ladder and is leaning backward (back extension) to get to the work as opposed to repositioning the ladder. Back extension such as this can be stressful to the worker. Pulling the insulation off the bulkheads or overhead areas requires the use of force to separate the insulation from the surface areas. This task is stressful to the arms, shoulders, neck and back. All of these tasks are performed while the worker is wearing an encapsulating chemical-protective suit with a supplied air respirator causing an increased physiological strain on the worker.

One possible intervention is the use of powered shears to reduce the upper extremity force required and deviated wrist posture required to cut the insulation with the hawkbill cutters. Pneumatic models that can be used on a variety of materials (industrial fabrics- -i.e. vinyl, textiles, wire, metal, and fiberglass) are commercially available. Approximate technical and cost specifications of a particular shear model are provided below in Table 4.

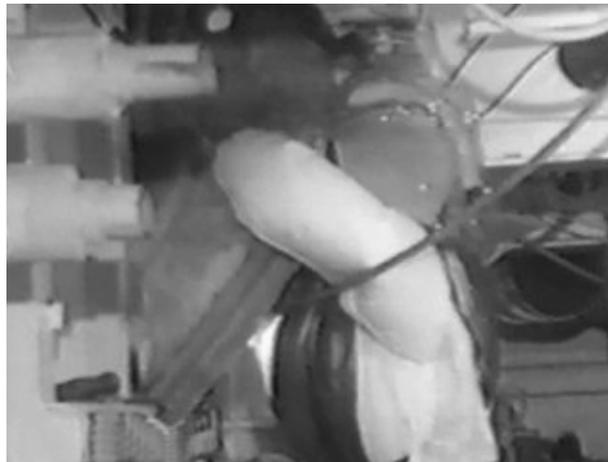
The worker then pulls on the insulation to break it free from the bulkhead or overhead area. The insulation is bagged and disposed of properly.

Figure 5. Pulling Section of Insulation Off Bulkhead by Hand

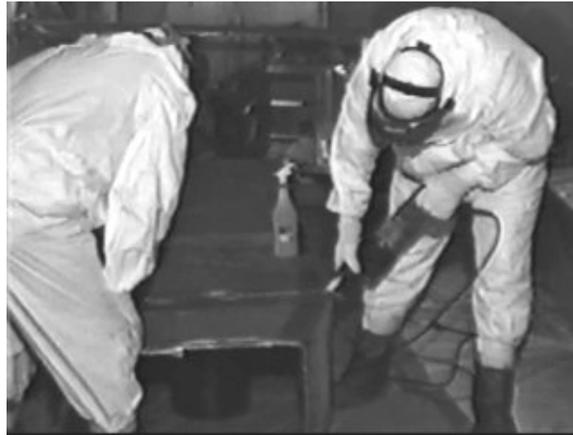
Figure 6. Two-Person Cutting Operation for Ductwork with Possible Hazardous Material

Ship dismantling, or Inactivation, Reactor Compartment Disposal, and Recycling as the process is known by at PSNS, requires the separation of components, bulkheads, and hull sections from adjoining locations. This separation is accomplished either by torch cutting or by using a reciprocating saw to cut through the steel, aluminum or other material. Torch cutting requires a fire-watch crew to stand by and a certain level of expertise by the user. Cutting with a reciprocating saw does not require the fire-watch crew and can be accomplished by nearly every worker making it the preferred method among supervisors. Also, areas containing suspected hazardous materials must be mechanically cut to minimize worker exposure to the substance. Chemical protective clothing is worn when there is the possibility of exposure to known hazards. Mechanical cutting can take place overhead to remove wire hangers, between shoulder and floor height to remove bulkheads, or below floor level to remove decking and supports. Some components are lowered to the deck to be cut to reduce the amount of overhead work.

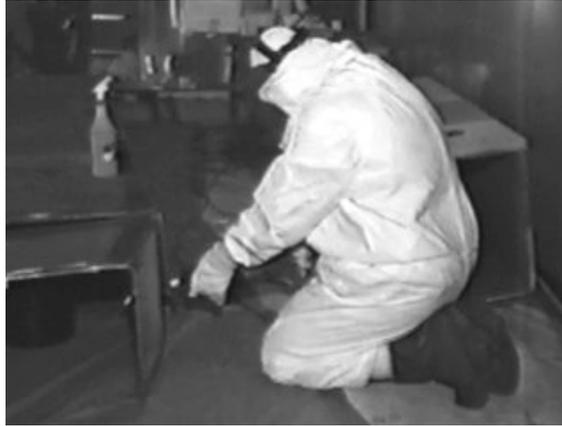
Figure 7. Worker Using Reciprocating Saw While Kneeling

Workers assume a variety of postures to cut the pieces of metal including kneeling, sitting, lying down, bending over, standing on ladders, etc. Workers typically cut for 2-3 hours and then carry cut material to a disposal area for another 2 hours. Workers often work in pairs, switching between cutting the material with the eight pound reciprocating saw and supporting the item being cut. Heavier items are removed using tandem lifts.

The ergonomic risk factors for reciprocating saw operators include: awkward postures of the spine and wrist, static kneeling postures, forceful exertion of the upper extremity to hold the reciprocating saw, and high noise exposure. Particularly significant is the exposure to hand-arm or segmental vibration from using the powered reciprocating saw. (Vibration damping gloves are required personal protective equipment while using the saw). Normal operation of the saw results in vibration that has been reduced by an anti-vibration mechanism incorporated into the design of the saw. However, when initiating a cut (plunge cutting) or when the blade binds in the material, an extreme amount of vibration is transferred to the arm of the user. The manual material handling of the cut pieces may result in back, neck or shoulder strain of the workers.

The most basic and effective method to reduce the number of musculoskeletal injuries due to the reciprocating saw use is to encourage the use of torch cutting whenever the material is non-hazardous and burnable. Although the reciprocating saw is the preferred method because it requires less training, set-up, and does not require a fire watch, these are not sufficient reasons to preclude torch cutting where appropriate. Since most reciprocating saw operators currently work in teams, each person can alternately serve as firewatcher while the other torchcuts. If one assumes that the torch cut operation would require an additional hour of set-up time per member of a five person IRR crew, the cost of this administrative intervention can be estimated as below.

If saws are utilized, the use of wheeled tripods or standing jigs as already developed at Puget Sound Naval Shipyard, will remove the worker from the vibration exposure. The addition of a stabilizing handle near the front of the tool that isolates some of the vibration from the worker is

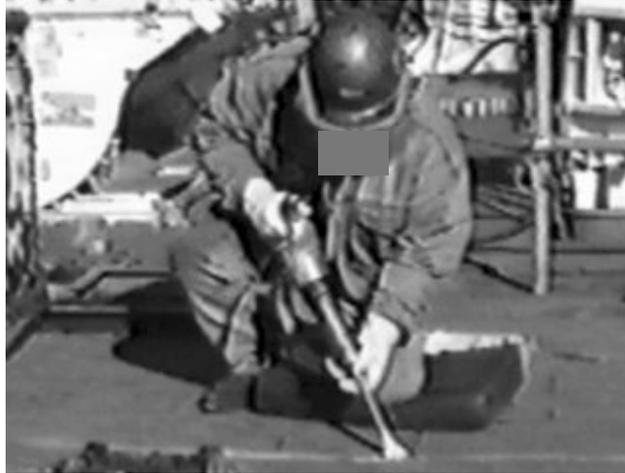
Figure 8. Worker Using Chipping Hammer to Remove Terrazzo Tile from Deck Surface

During the outfitting of vessels, some of the decking surfaces are covered in tile. This is particularly true of mess hall and lavatory facilities. Before the deck plate can be cut by either torch or reciprocating saw, a path must be cleared of tile. The tile is removed by using a chipping hammer to break the tile and flake the tile off the deck surface. This task requires the worker to kneel, sit or bend over the deck surface to operate the chipping hammer.

Chipping tile from deck surfaces puts the worker in awkward postures, having to kneel or sit on the deck. The back and neck are flexed. Exposure to hand-arm or segmental vibration is bad, having to hold the chipping blade in place with one hand while holding the tool weight and operating the trigger with the other hand. Few improvements to these tools have been made since the turn of the century. Noise exposure is also very high with the use of chipping hammers.

Removing tile from deck surfaces requires the worker to kneel or sit on the deck. Providing knee pads or cushions minimizes some of the contact stresses. Low industrial seating wheeled stools are available for approximately \$150 each. Depending on the application, worker postures may benefit from using the stools.

If chipping hammers can not be replaced as the tool of choice for this task, it is recommended that the widest blade possible (at least 2 inches) be used to minimize exposure time and the most vibration-damped tool available be used. New chipping hammers range in price from \$400 to \$750. From 1997 through 1998, this particular shipyard experienced thirteen musculoskeletal injuries related directly to chipping and removal of tile or other material. These injuries, including six identified as carpal tunnel syndrome and seven identified as strains, resulted in a total estimated medical and indemnity cost of \$69,390, or an annual direct cost of \$34,695.

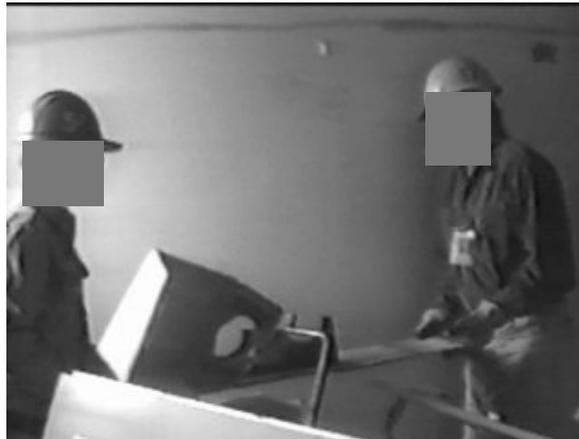
Figure 9. Workers Performing Tandem Lift of Scrap Material Inside Vessel

As part of the Inactivation, Reactor Compartment Disposal, and Recycling process at PSNS, material is cut apart and stored at temporary locations within the vessel being dismantled. This material is then manually moved from the internal storage areas to scrap bins for removal from the ship by crane. Depending on how the material was cut, it may require more than one individual to safely lift the object and carry it to the scrap bin. Somewhat confined spaces and the clutter of the stored material create tripping hazards in the narrow passageways.

There is the possibility that flexible conveyor systems or cable pulley systems can be used to either move material to the staging area or to move material into the scrap bins in the staging areas. Portable hoists may be useful in the staging areas as well to move heavy or bulky material.

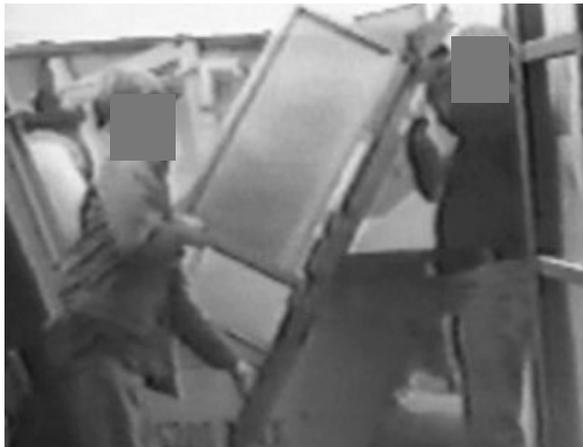
Figure 10. Workers Placing Scrap in Bin for Transport Off Ship

The manual material handling of scrap metal may result in strains of the lower back, neck, shoulder and upper extremities. Tripping hazards may be present. Sharp edges on the cut metal may cause lacerations to ungloved hands.
