Pillar and Roof Span Design Guidelines for Underground Stone Mines

Information Circular 9526

Gabriel S. Esterhuizen, Dennis R. Dolinar, John L. Ellenberger, and
Leonard J. Prosser

DHHS (NIOSH) Publication No. 2011-171

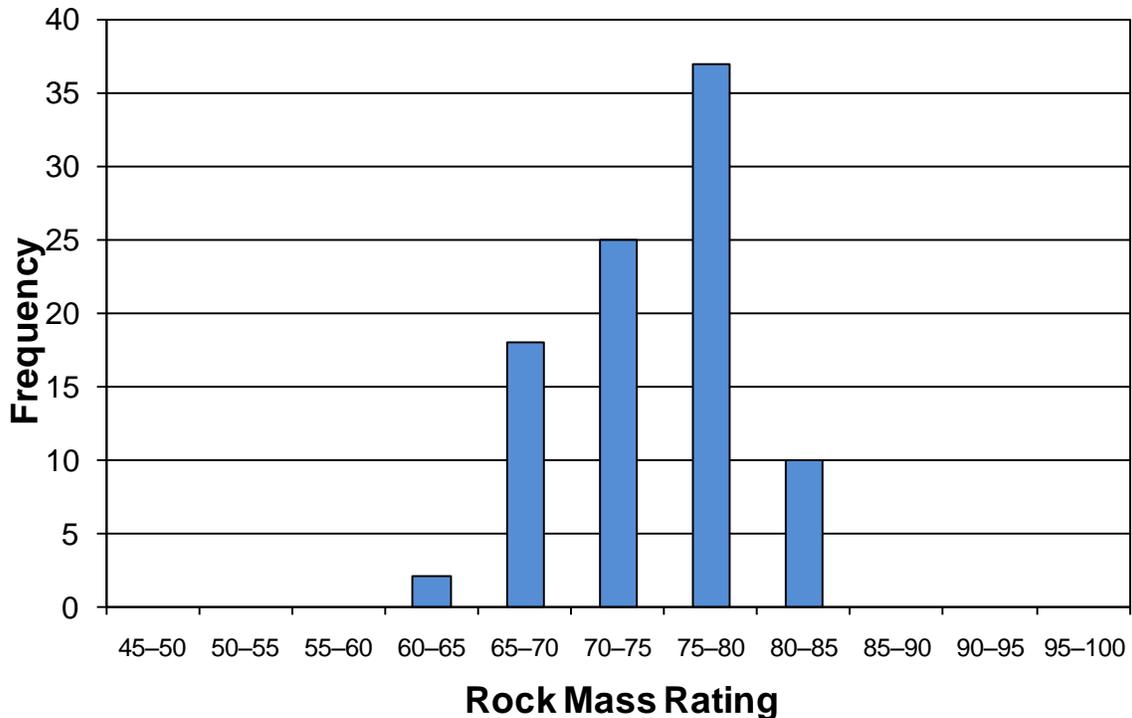
Figure 2. Distribution of rock mass rating (RMR) values in stone mines obtained by direct classification of rock exposure in underground stone mines and laboratory testing of rock cores.

In all cases the data collection for rock mass rating was conducted approximately 2 m (6 ft) from the floor of the mining horizon. The rating results, therefore, do not describe the detail of the rock layering in the immediate roof, but rather represent the typical rock mass conditions within the formation being mined. The rock mass ratings are presented in terms of the RMR-system [Bieniawski 1989] which classifies the rock mass on a scale of 0 to 100, with higher numbers indicating stronger rock masses. The RMR values fell within a narrow range, and the ratings for the immediate roof were not expected to be significantly different from the remainder of the formation. Figure 2 shows the distribution of RMR values obtained in this study. The values range from 60 to 85, which lay within the “good” to “very good” quality categories, according to the RMR classification tables [Bieniawski 1989].

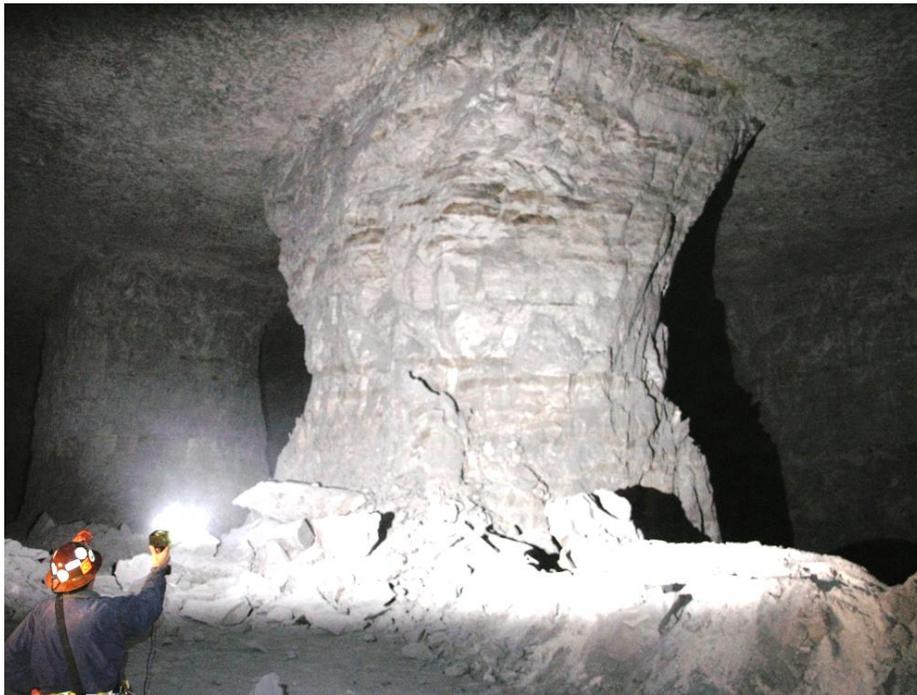
Figure 3. Partially benched pillar failing under elevated stresses at the edge of bench mining. Typical hourglass formation indicates overloaded pillar. The width-to-height ratio is 0.44 based on full benching height and the average pillar stress is about 12% of the UCS.

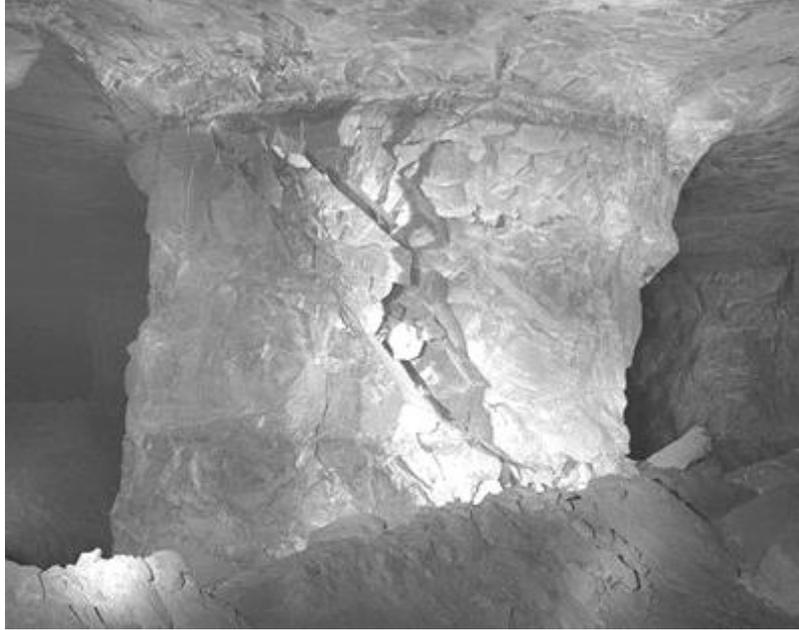
Figure 4. Partially benched pillar that failed along two angular discontinuities. Width-to-height ratio is 0.58 based on full benching height; average pillar stress is about 4% of the UCS.

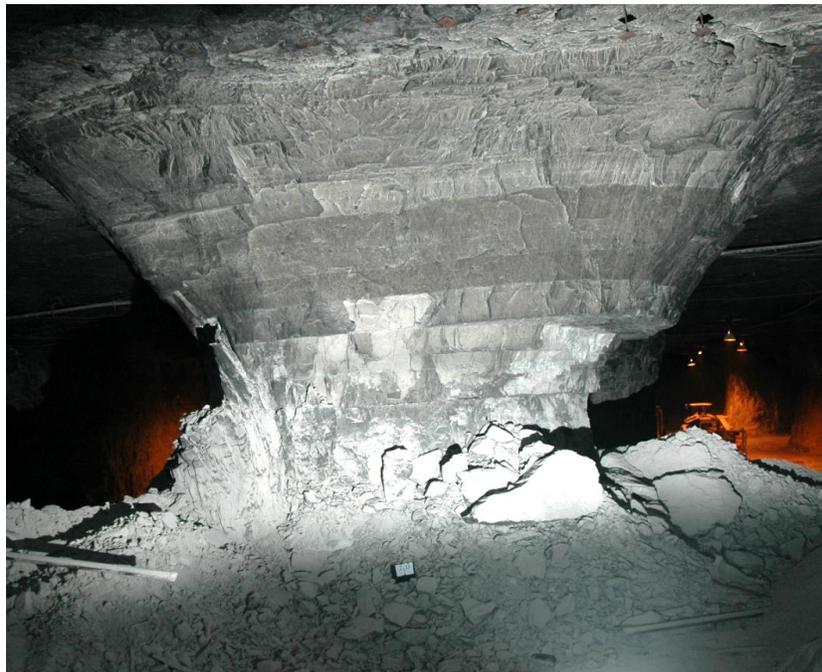
Figure 5. Pillar that had an original width-to-height ratio of 1.7, but failed by progressive spalling. Thin, weak beds are thought to have contributed to the failure. The average pillar stress was about 11% of the UCS prior to failure.

The pillars shown in Figures 5 and 6, listed as case 10 and 11 in Table 3, are examples of pillars that appear to have failed by this mechanism. In both cases the average pillar stress was only about 11% of the UCS of the limestone beds at this mine. Other pillars at the same mine seemed to be at an early stage of the same failure mechanism, where spalling is associated with the presence of weak, soft bands within the pillar. Figure 17 is an illustration of a partially failed pillar that appears to have failed by the same mechanism.

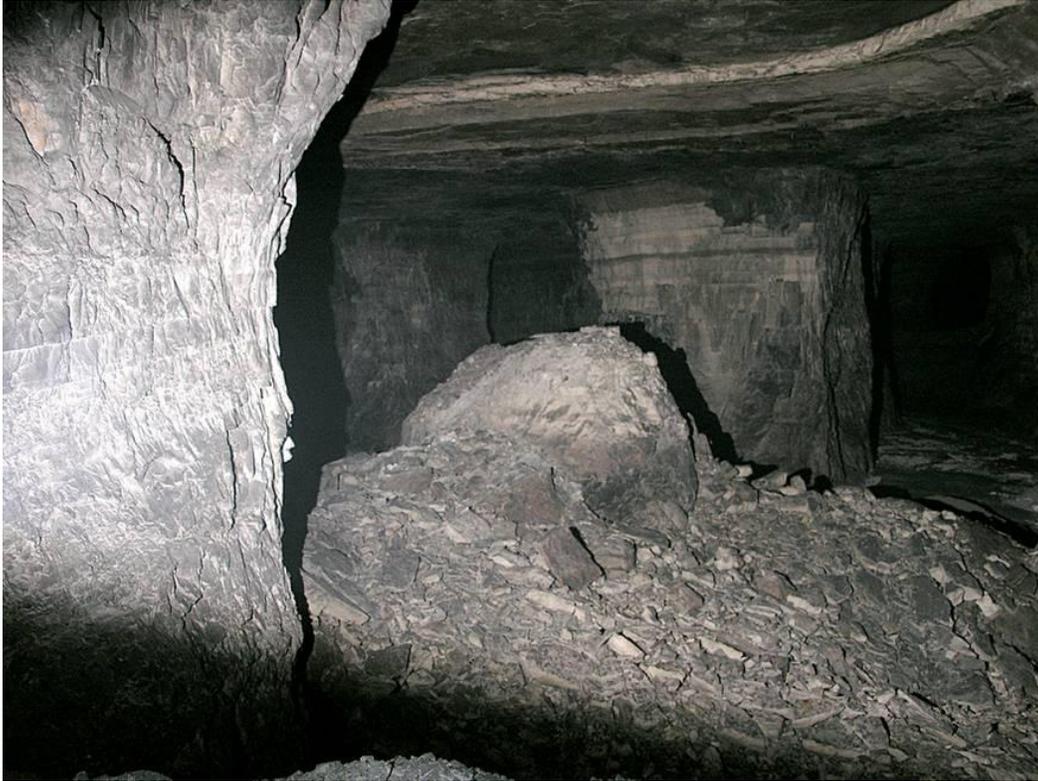
Figure 6. Remaining stump of a collapsed pillar in an abandoned area. Thin, weak beds in the pillar and moist conditions are thought to have contributed to the failure. The width-to-height ratio was 0.82 and average pillar stress about 11% of the UCS.

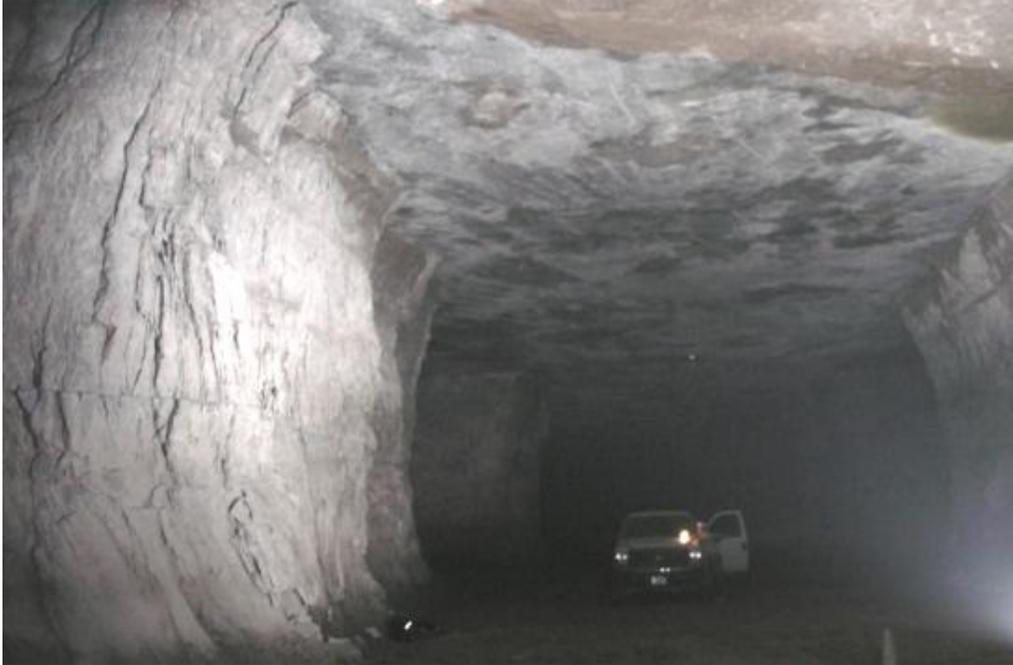
Figure 7. Example of rib spalling and resulting concave pillar ribs that can initiate when average pillar stress exceeds about 11% of the UCS.

Rib spalling is one of the early signs of elevated pillar stress. Figure 7 shows an example of rib spalling at approximately 270 m (900 ft) of cover. Spalling is characterized by fractures through the intact rock that are parallel to the direction of the maximum stress. Spalling normally initiates at the pillar corners and can spread to the pillar ribs, resulting in slightly concave ribs, shown in Figure 8. Rib spalling was observed to initiate when the average pillar stress exceeds about 11%–12% of the UCS. However, not all pillars that exceeded the 11%–12% stress ratio showed signs of rib spalling. It should, therefore, be interpreted as the lower limit for the onset of rib spalling. Rib instability can additionally be caused by unfavorable jointing in the rock mass or by poor blasting practices. The hazard associated with rib spalling can be mitigated by barring-down the loosened material, but this has the detrimental effect of reducing the pillar size. In some cases mine operators installed rib support, such as chain link mesh and bolts, to secure the rib walls, as shown in Figure 9.

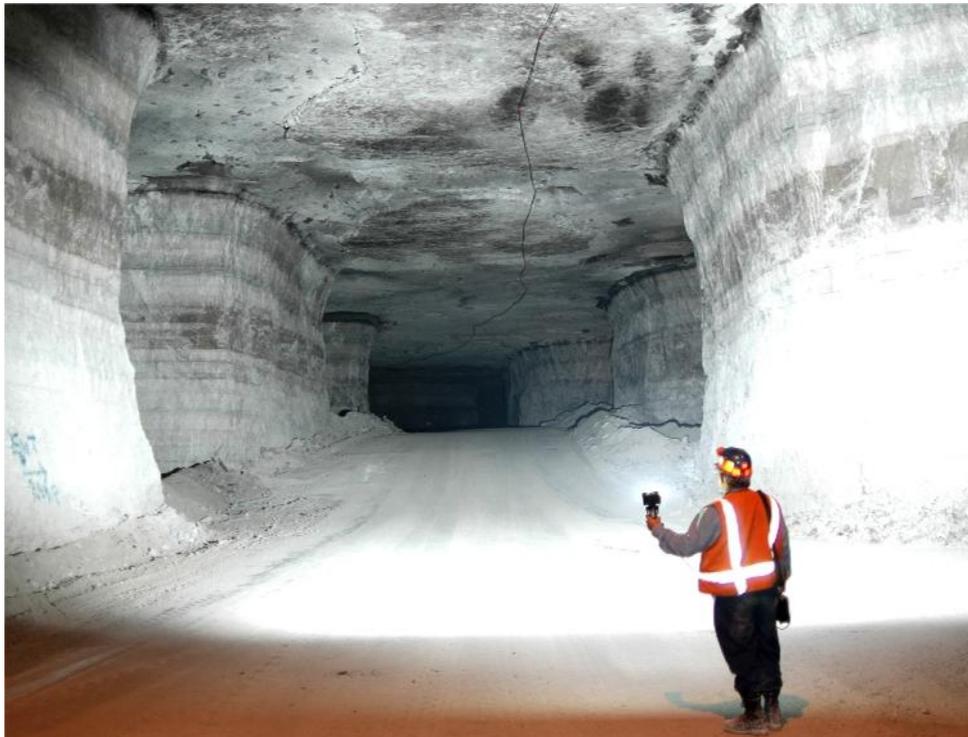
Figure 8. Stable pillars in a limestone mine at a depth of cover of 275 m (900 ft). Slightly concave pillar ribs formed as a result of minor spalling of the hard, brittle rock.

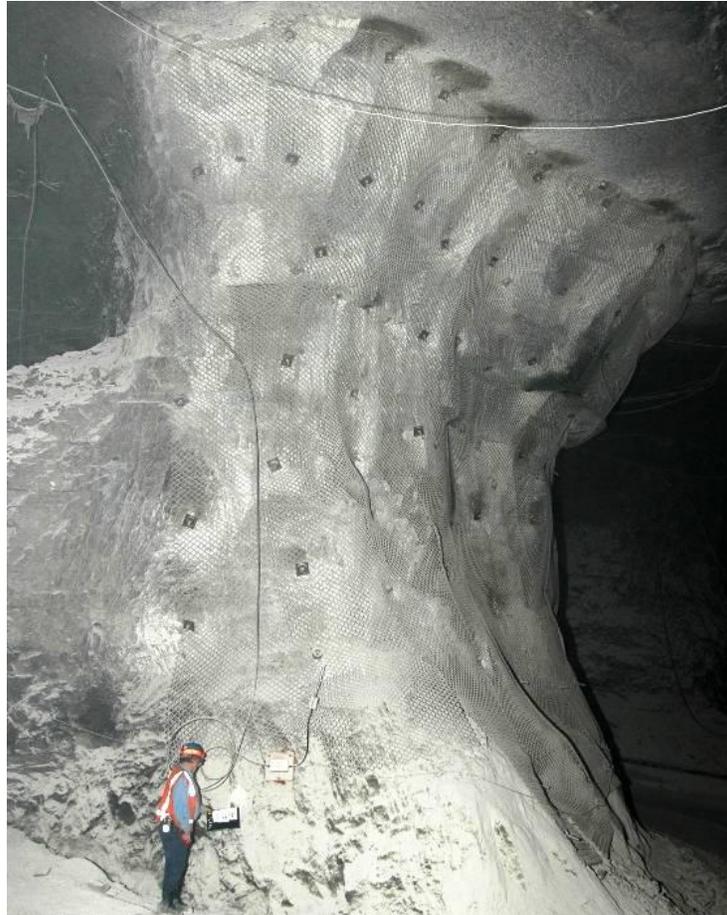
Figure 9. Pillar that has been clad with chain link mesh to prevent further deterioration of the ribs.

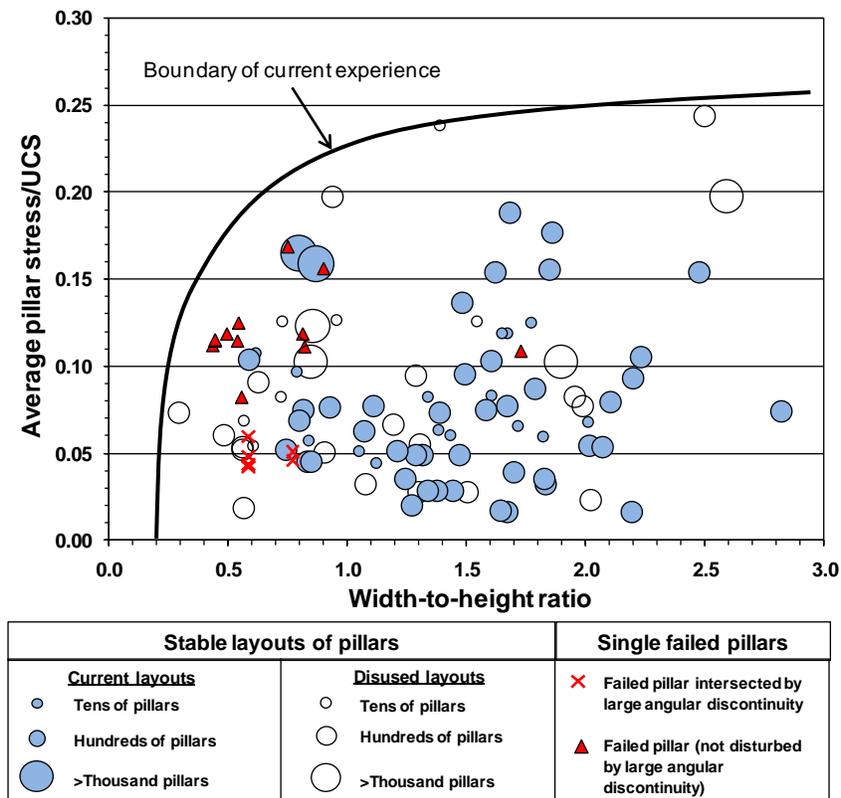
Figure 10. Chart showing pillar performance based on a survey of 34 underground stone mines.

The pillar layouts that were surveyed by NIOSH are presented in Figure 10 which shows the normalized pillar stress against the width-to-height ratio. The pillar stress is normalized by the average UCS of the intact rock (obtained from Table 1). Figure 10 also includes data points representing the 18 failed pillars (that are presented in Table 3), the failures associated with the presence of large, angular discontinuities, information on the approximate number of pillars in each layout and indicates whether a pillar layout is no longer in use. A bounding curve was drawn around the case histories, which represents the limit of current experience with stone mine pillar performance.

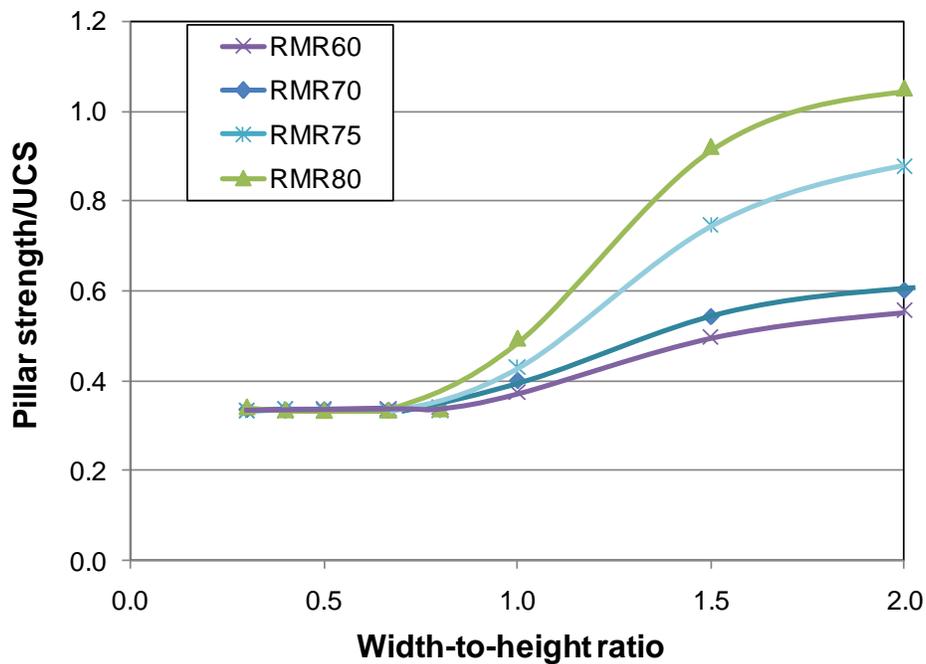
Figure 11. Effect of width-to-height ratio and rock mass rating (RMR) on pillar strength, based on numerical model results.

weaker than predicted by the models because of the increasing importance of local discontinuities on pillar stability. As the width-to-height ratio increases beyond 1.0, the pillar strength will increase rapidly as confinement is generated [Lunder 1994]. Figure 11 shows numerical model results [Esterhuizen 2006] in which both the spalling and shearing failure modes were modeled. The results show how the width-to-height ratio and the rock mass rating affect pillar strength. In these models it was assumed that spalling occurred when the maximum stress was one third of the UCS, which is higher than observed in limestone formations, and the confining stress is less than 10% of the maximum stress. It can be seen that the pillar strength only starts to respond to the increasing width of the pillar when the width-to-height ratio is greater than 0.7. The results also show that the rate of increase in strength is related to the rock mass rating.

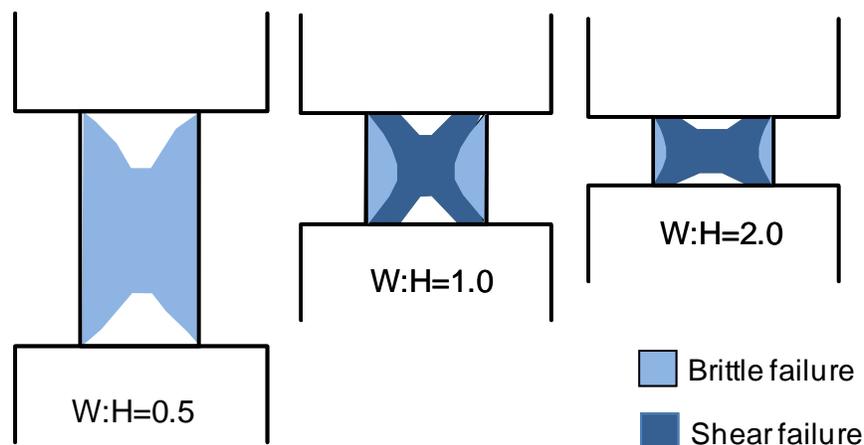
Figure 12. Sections through the center of pillars with different width-to-height ratios showing the extent of brittle and shear failure of the rock mass predicted by numerical modeling.

The stress-strain characteristics of the modeled pillars also showed that slender pillars start spalling when they are at or near their peak strength; conversely, wider pillars start spalling well before they reach their peak strength. This implies that if slender pillars show signs of spalling, they may be loaded at or near their ultimate strength, and failure may be imminent. The slender pillars also display a rapid drop in strength after reaching the peak strength, and the wider pillars lose their strength more gradually. A rapid drop in strength can result in violent pillar failure [Salamon 1970].

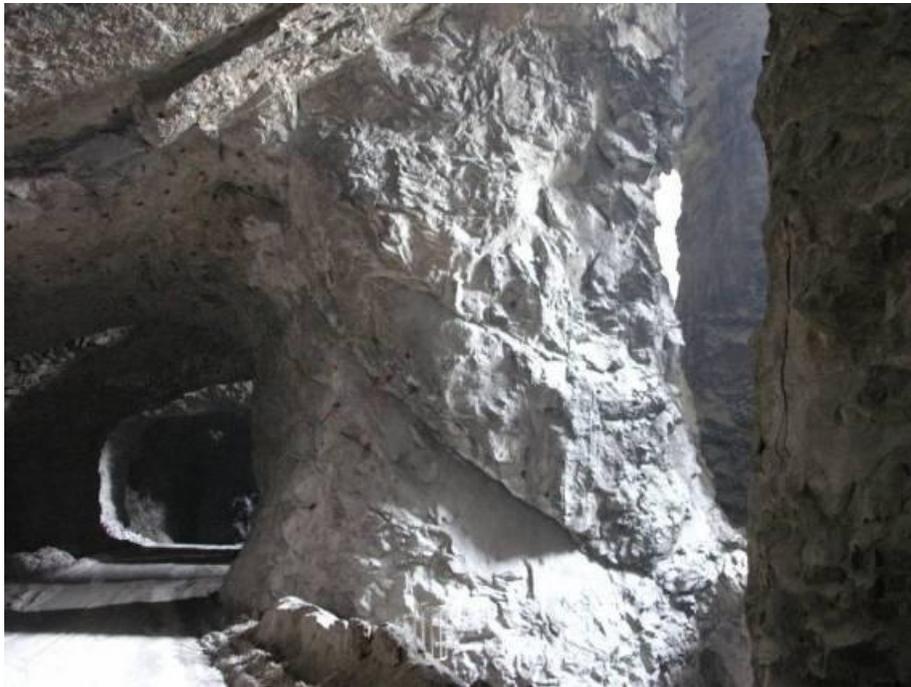
Figure 13. Example of a pillar that is bisected by a large, angular discontinuity.

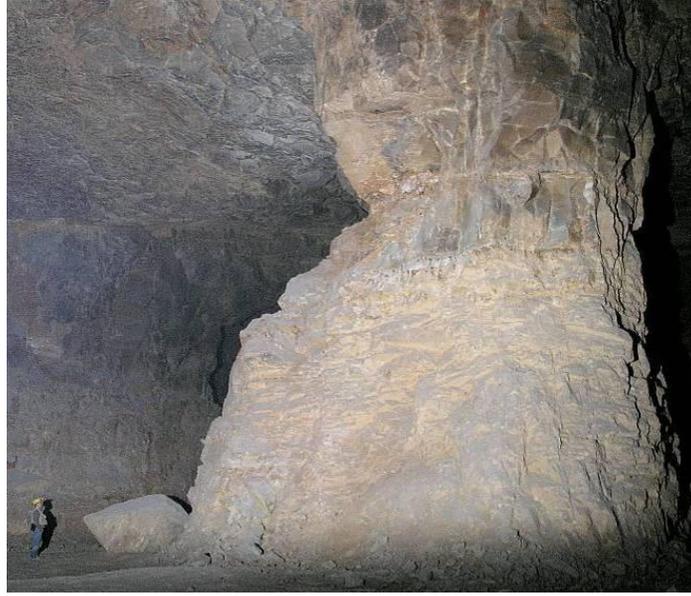
Figure 14. Rib failure related to large, angular discontinuities adjacent to a fault zone.

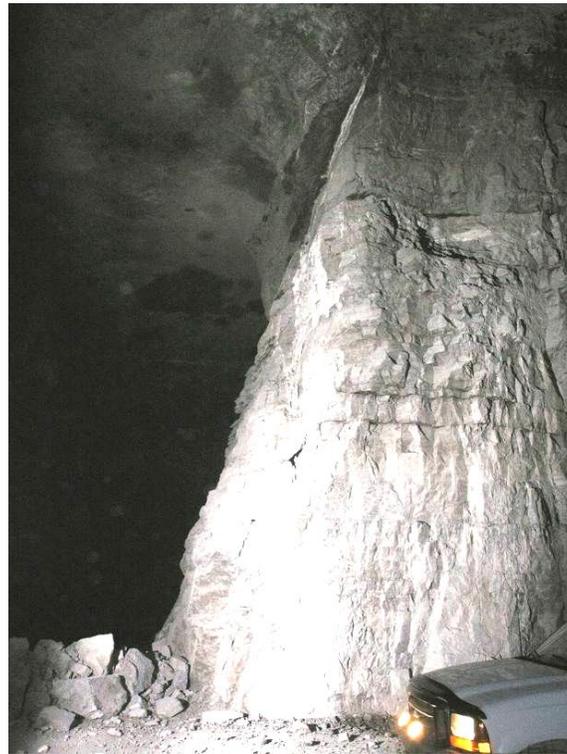
Figure 15. Loss of pillar rib at the location of a large roof-to-floor discontinuity in a limestone mine.

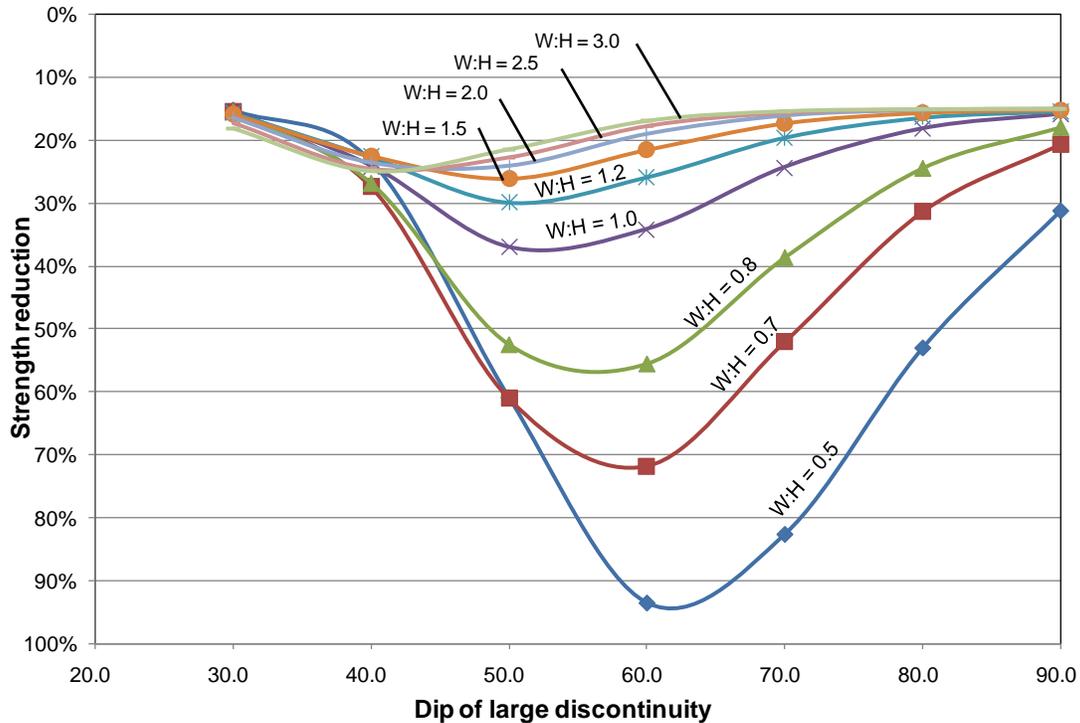
Figure 16. Chart showing the impact of large, angular discontinuities on the strength of pillars, based on the results of numerical models.

These findings are a further confirmation that excessively slender pillars should be avoided. The pillar strength calculation procedure, described in the Pillar Strength Equation for Stone Mines section, takes into account the weakening effect of large, angular discontinuities.

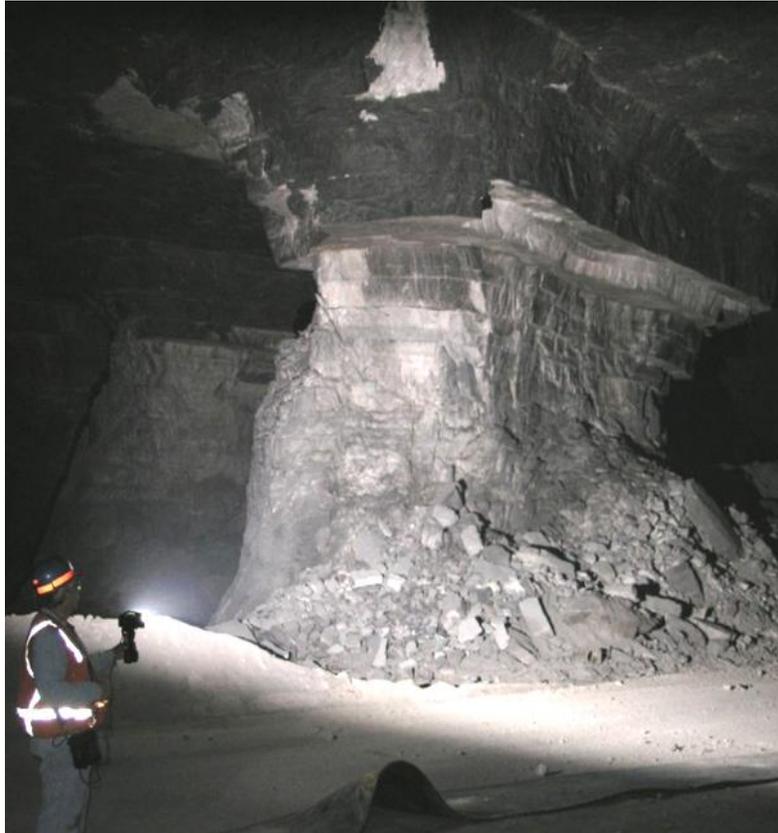
Figure 17. Pillar damage observed in rock containing thin, weak bands. Note spalling of the intact rock material between the weak bands.

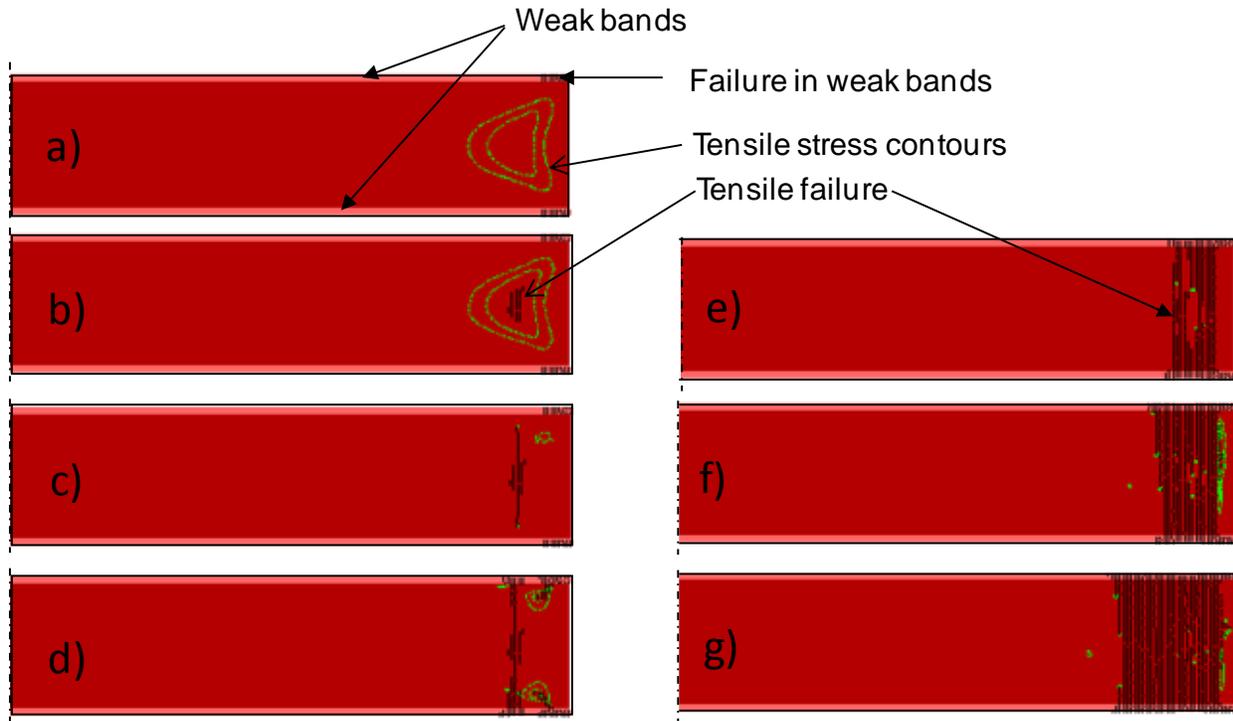
Figure 18. Stages of failure development in a beam of strong rock encased between two weak bands.

weak bed material. As the loading increases, the tensile stresses increase and tensile failure develops in the stronger slab (Figure 18b), which relieves the initial zone of tension (Figure 18c). As the vertical loading continues to increase, tensile stresses are induced on either side of the initial tensile failure zone and tensile failure continues to occur. The process repeats until the entire slab has failed or the extrusion mechanism is inhibited by frictional resistance between the weak bands and the rock slab. If the tensile failure process is inhibited, the remainder of the slab fails by shearing. The extrusion-tensile failure mechanism can explain the observed progressive spalling of intact rock at relatively low stress.

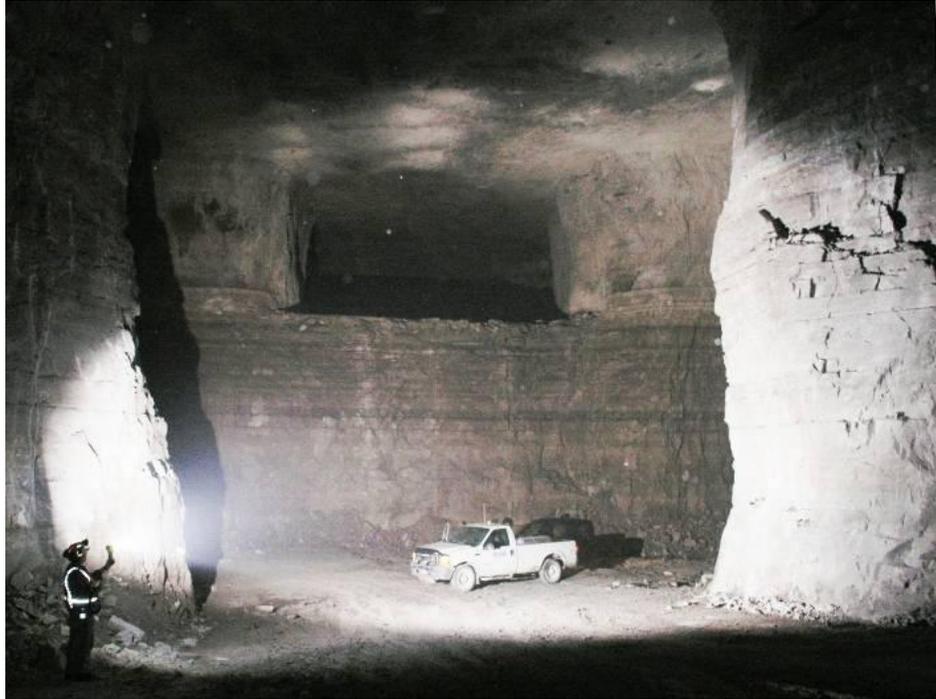
Figure 19. Example of bench mining of the floor between pillars in a limestone mine.

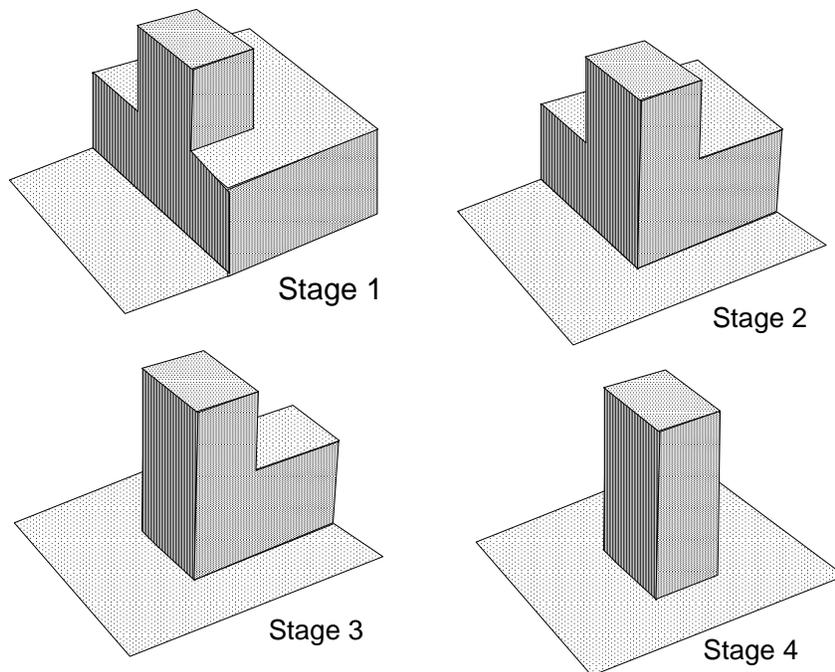
Figure 20. Stages of bench mining around a pillar used in the numerical models.

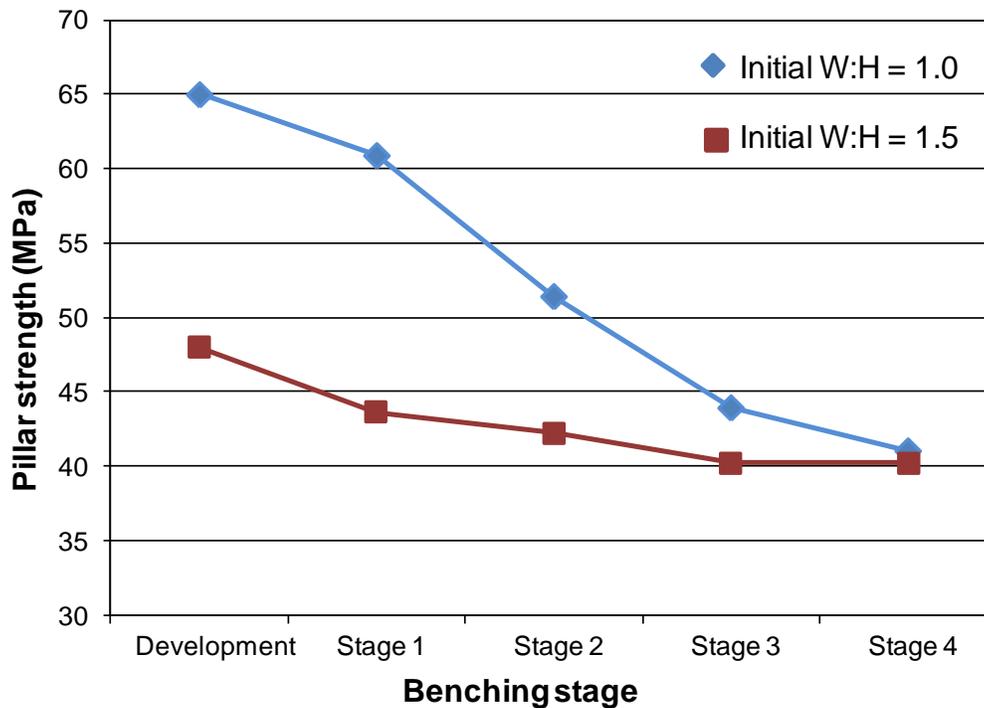
Figure 21. Results of numerical modeling showing strength reduction of pillars with initial width-to-height ratios of 1.0 and 1.5 from initial development through various stages of bench mining. Final width-to-height ratios at Stage 4 are 0.5 and 0.75.

Analyses were conducted for pillars with initial width-to-height ratios of 1.0 and 1.5. The models simulated benching that doubled the height of the pillars. The model results presented in Figure 21 shows that the strength of the pillar with a width-to-height of 1.0 is reduced by about 16% from its initial value of 48 MPa (6,900 psi) to a final value of 40 MPa (5,800 psi). The pillar with a width-to-height ratio of 1.5 experiences a reduction in strength of 37% from the development stage to the fully benched stage. One reason for the smaller strength reduction in the narrow pillar with a width-to-height ratio equal to 1.0 is that the strength is already near the minimum value on development, and increasing the height during benching only causes a small additional reduction in strength.

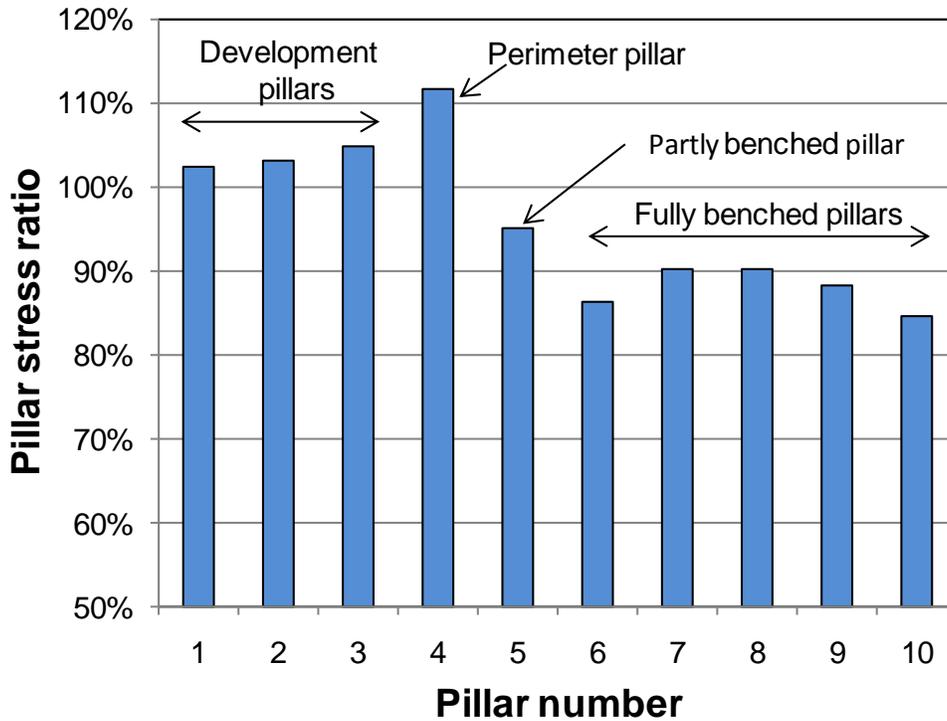
Figure 22. Results of numerical model showing the average pillar stress during bench mining as a ratio of the average pillar stress prior to bench mining.

From a pillar design point of view, it is important to also know how bench mining affects the pillar loads while the strength reduction is occurring. Figure 22 shows the average stress in the pillars near benching operations, as obtained from numerical models. The results show that the development pillars at the edge of the benched area are subject to an increase of about 12% in their average stress. The results further show that the stress in the partly benched pillar is lower than the stress in the adjacent pillar that has not been benched yet, indicated as “Perimeter pillar.” The lower stress in the partially benched pillar can be explained by the fact that its stiffness is reduced by the increase in height of one of the sides of the pillar, causing the load to be transferred to the stiffer development pillars. It can clearly be seen that the fully benched pillars are at a reduced stress level, owing to their relatively low stiffness. As benching continues, the stress in the fully benched pillars is expected to gradually increase back to the tributary stress.

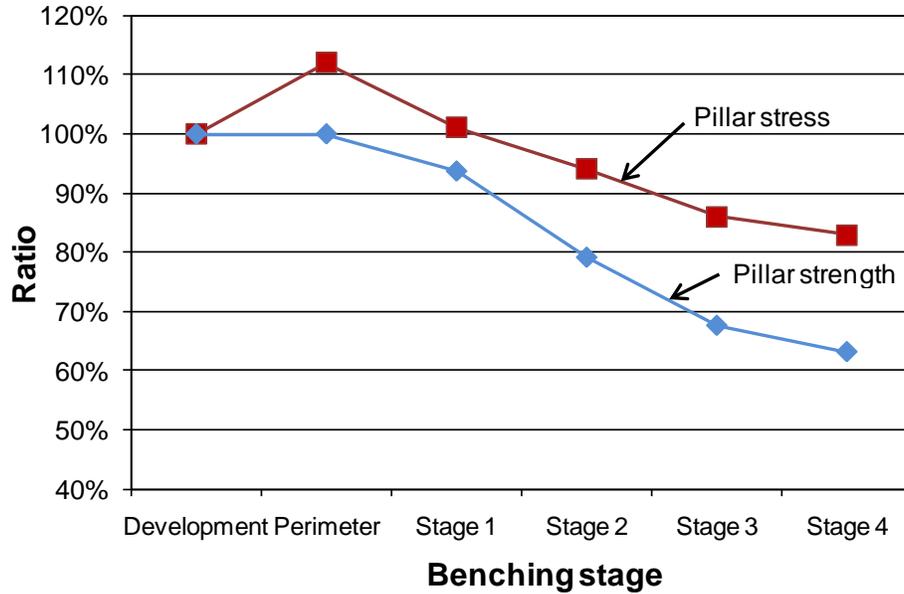
Figure 23. Change in the average vertical pillar stress and pillar strength relative to development during various stages of bench mining, for a pillar with a width-to-height ratio of 1.5 based on the results of numerical models.

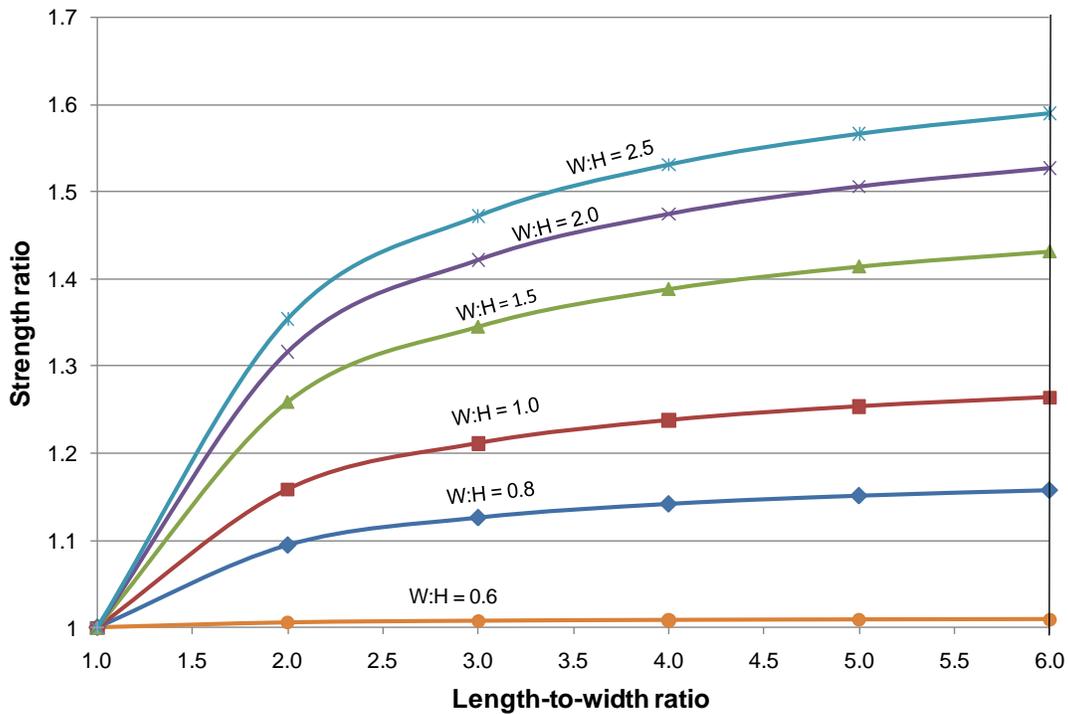
Figure 24. Strength increase caused by increasing pillar length for pillars with various width-to-height ratios. Results from calibrated numerical models assuming rock failure initiates as spalling followed by shearing.

Some of the accepted methods of estimating the effect of length on pillar strength do not account for the fact that the strength increase might be limited when pillars are slender. The methods would generally predict a similar strength increase for all pillars, regardless of the width-to-height ratio. Therefore, when designing slender pillars for brittle rock, it is necessary to consider the width-to-height ratio as well as the length-to-width ratio when calculating the strength of rectangular pillars.

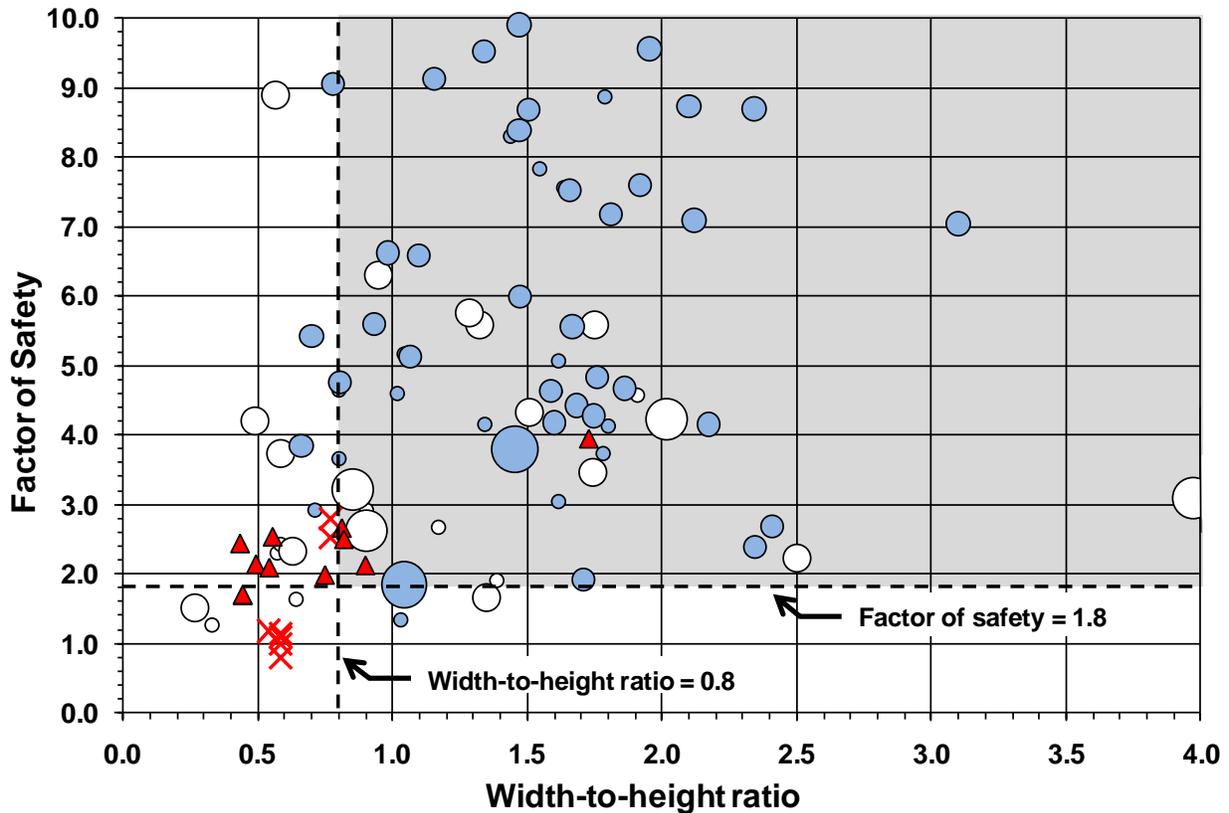
Stable layouts of pillars		Single failed pillars
<p>Current layouts</p> <ul style="list-style-type: none"> ● Tens of pillars ● Hundreds of pillars ● >Thousand pillars 	<p>Disused layouts</p> <ul style="list-style-type: none"> ○ Tens of pillars ○ Hundreds of pillars ○ >Thousand pillars 	<ul style="list-style-type: none"> × Failed pillar intersected by large angular discontinuity ▲ Failed pillar (not disturbed by large angular discontinuity)

Equation 7 was used to calculate the adjusted strength and FOS of all the pillars in the stone mine database. The results are presented in Figure 25, which displays the calculated FOS against the width-to-height ratio. Various symbols were used to indicate currently operating and disused layouts, failed pillars, and the approximate number of pillars in the various layouts. Disused layouts may have been abandoned because of stability concerns or changes in operating procedures. However, all the disused and current layouts are considered to be “successful” because they were all successfully supporting the overlying strata at the time of this study. The FOS axis shows values up to 10.0; this means that 13 cases with FOS values greater than 10.0 are not shown.

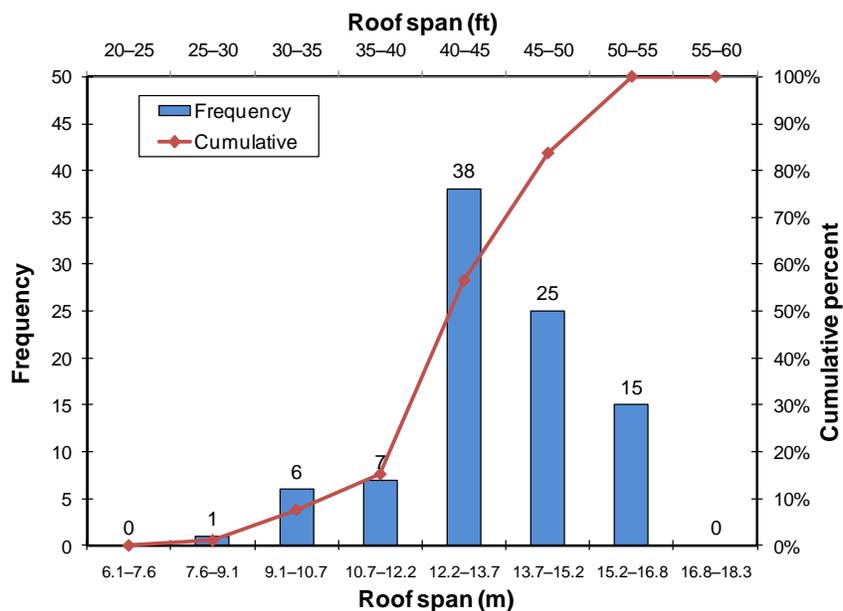
Figure 26. Distribution of roof span dimensions measured at 34 different underground stone mines.

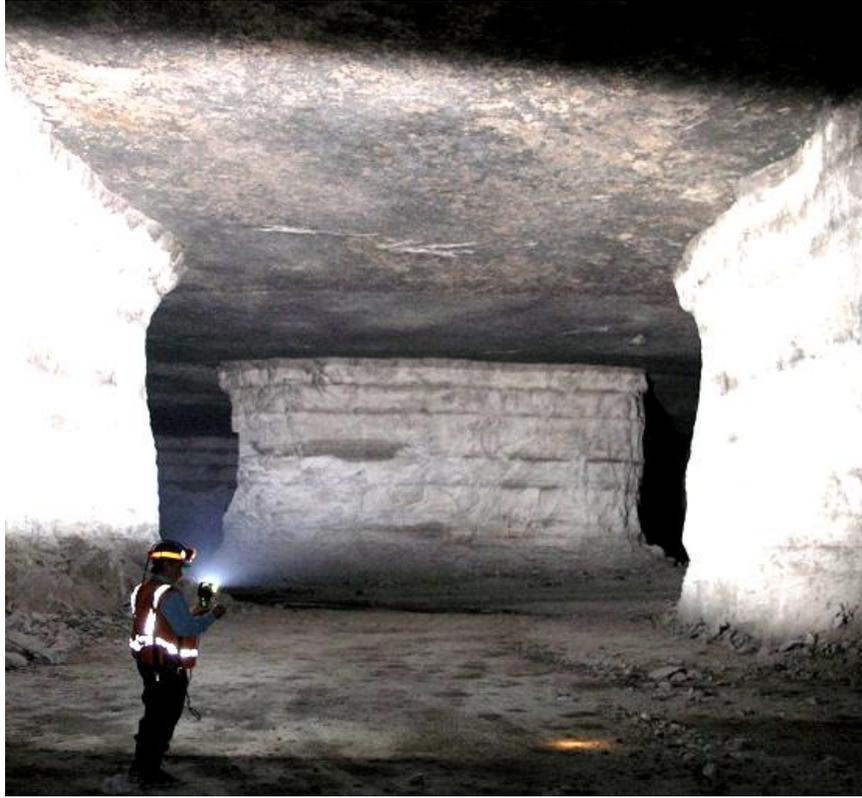
Figure 27. Naturally stable 13.4-m (44-ft) wide roof span in a stone mine.

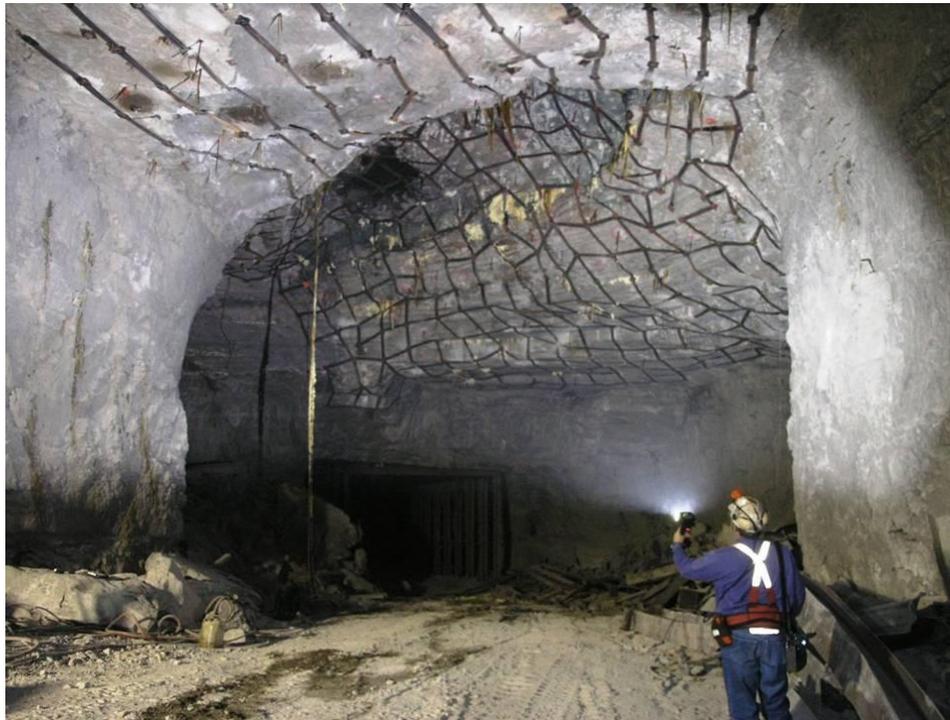
Figure 28. Bolts, straps, and injection grouting used to rehabilitate the roof at the site of a major roof fall.

Although the large roof falls only make up a small percentage of the total roof exposure, their potential impact on safety and mine operations can be very significant. Most cases of large roof falls required barricading off or abandonment of the affected entry. When large roof falls occur in critical excavation areas, the repair can be very costly. Figure 28 shows a case where extensive support was required to rehabilitate a large roof fall.

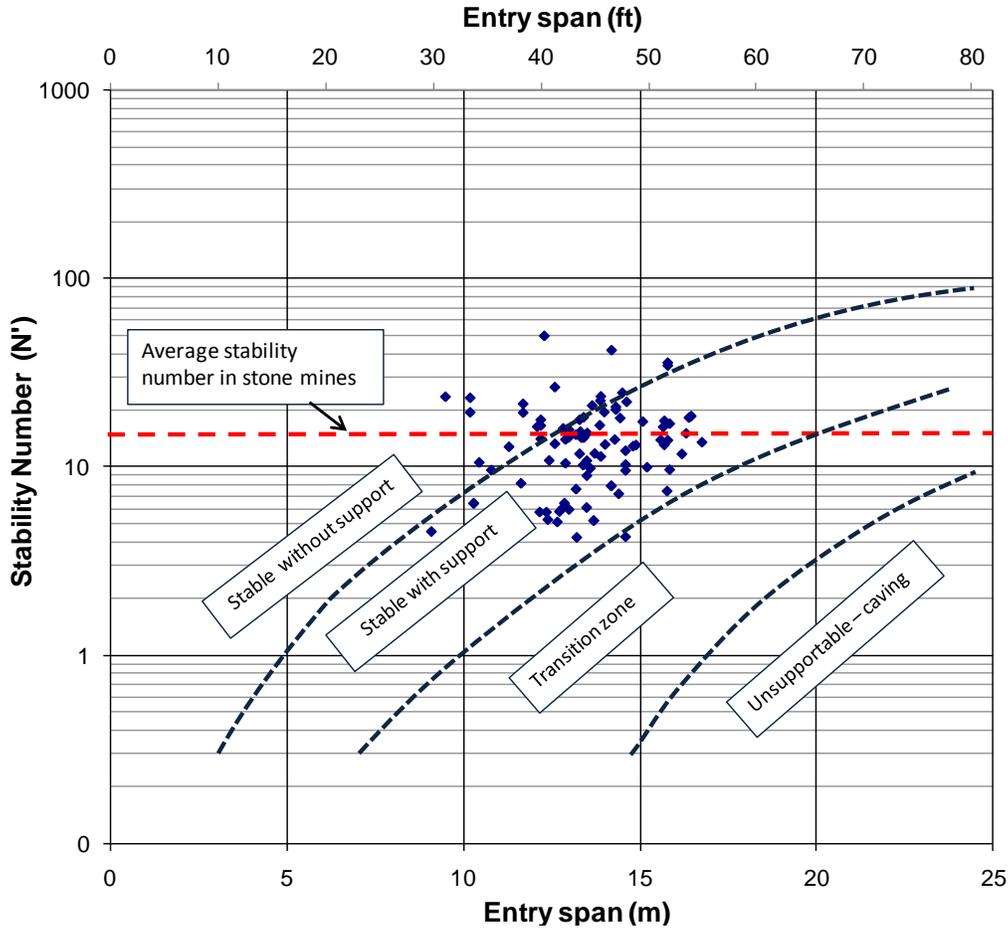
Figure 29. Stability chart showing stone mine case histories and stability zones, modified after Mathews et al. [1980], Potvin [1988], Nickson [1992], and Hutchinson and Diederichs [1996].

The stability number was calculated for each of the 92 stone mine sites and plotted on the Stability Chart shown in Figure 29. The chart also indicates the average stability number for stone mines as a horizontal dashed line.
