Pillar and Roof Span Design Guidelines for Underground Stone Mines

Information Circular 9526

Gabriel S. Esterhuizen, Dennis R. Dolinar, John L. Ellenberger, and
Leonard J. Prosser

DHHS (NIOSH) Publication No. 2011-171

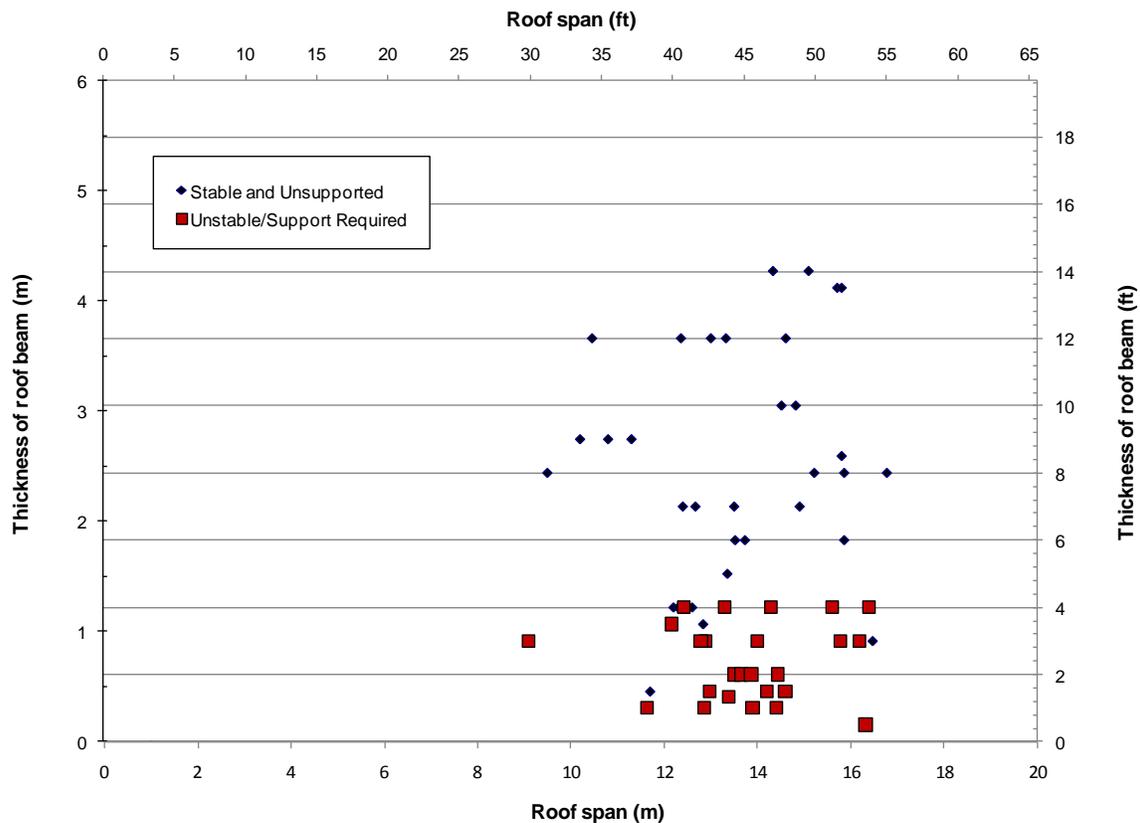
Figure 30. Chart showing the effect of the thickness of the roof beam on excavation stability in mines that did not experience horizontal stress related instability.

Several of the mines that used regular support did so to alleviate the effects of horizontal stress, which is not related to beam thickness. If these mines are removed from the data, the average roof beam thickness in mines that use regular support is 0.7 m (2.3 ft). Figure 30 shows the effect of the roof beam thickness on excavation stability in mines that did not experience horizontal stress related instability. It can be seen that when the beam is equal to or less than 1.2 m (4 ft), support is likely to be required to maintain stability, or the excavation may be unstable. Of the locations where the roof beam thickness was 1.2 m (4 ft) or less, 82% were unstable or required support to maintain stability. These results seem to indicate that mines with a relatively thin beam of rock in the immediate roof are more likely to encounter an unstable roof, and regular roof bolting becomes necessary. There was no correlation between roof beam thickness and roof span.

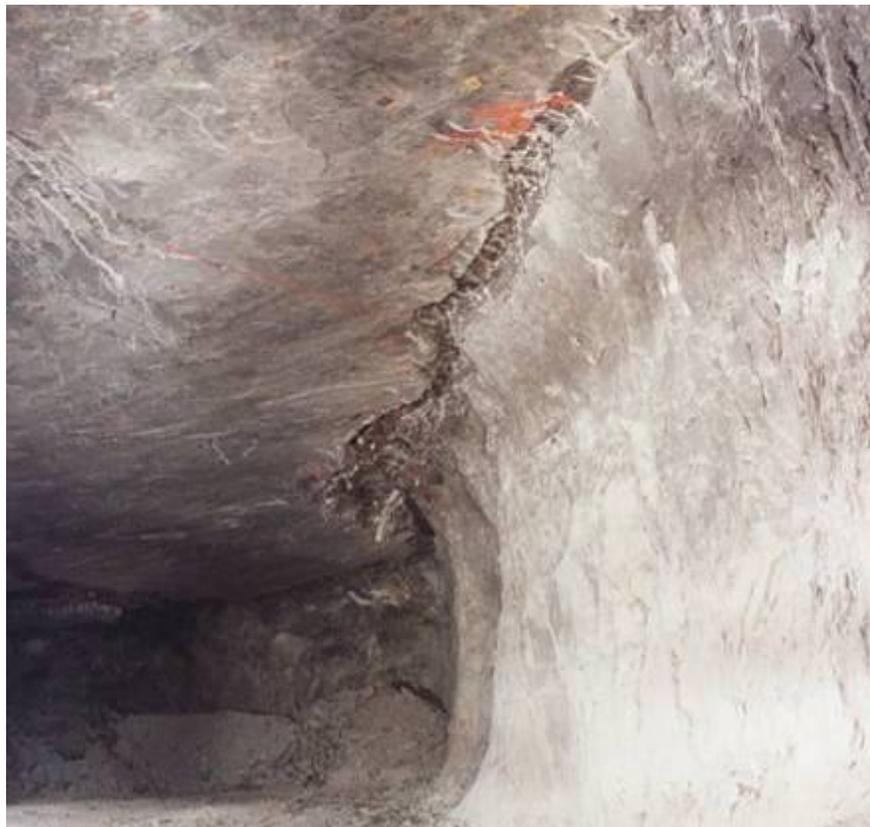
Figure 31. Roof guttering at the pillar-roof contact.

Horizontal stress can cause beams within the roof to buckle and fail in shear [Iannacchione et al. 2003]. Failure can initiate as guttering in one corner of an excavation, (i.e., called “cutter roof” in coal mines), as shown in Figure 31, and can propagate to a large-scale roof fall, as shown in Figure 32. Falls related to horizontal stress typically line up in the direction perpendicular to the regional maximum horizontal stress and are oval shaped when seen in plan view, as shown in Figure 33. The falls tend to propagate laterally in the direction perpendicular to the main horizontal stress, and can snake through the mine, as shown in Figure 34. Careful observation of the roof falls, their direction of propagation, and other signs of excessive stress can assist in identifying the orientation of the maximum horizontal stress [Mark and Mucho 1994].

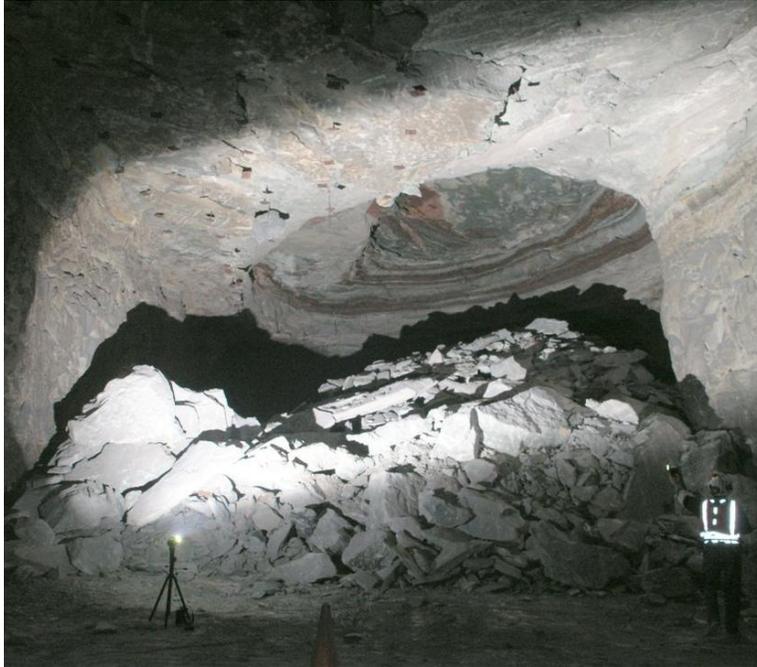
Figure 32. Large stress-related, oval-shaped fall that has propagated upwards into weaker, overlying strata in a limestone mine.

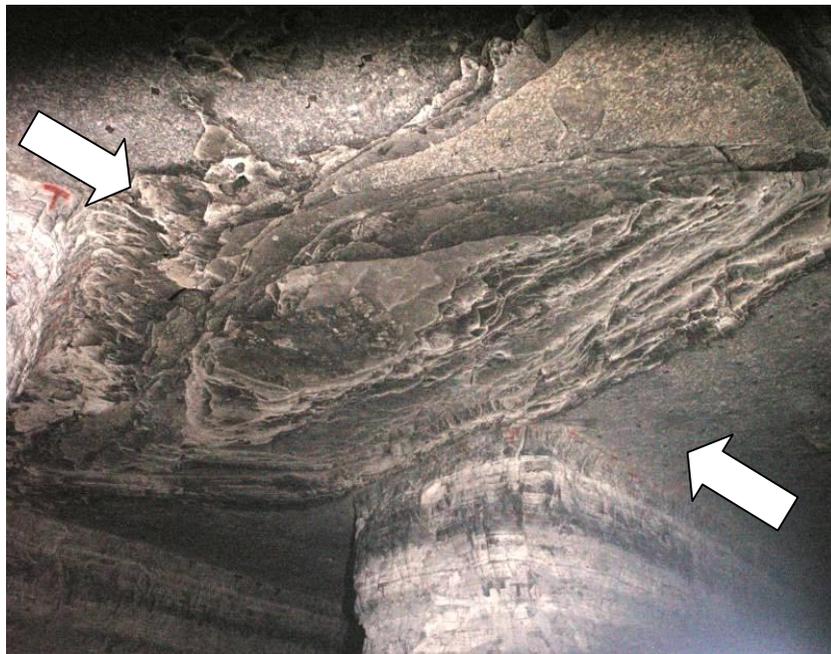
Figure 33. Horizontal, stress-induced roof failure that initiated between two pillars. Arrows show measured direction of maximum horizontal stress.

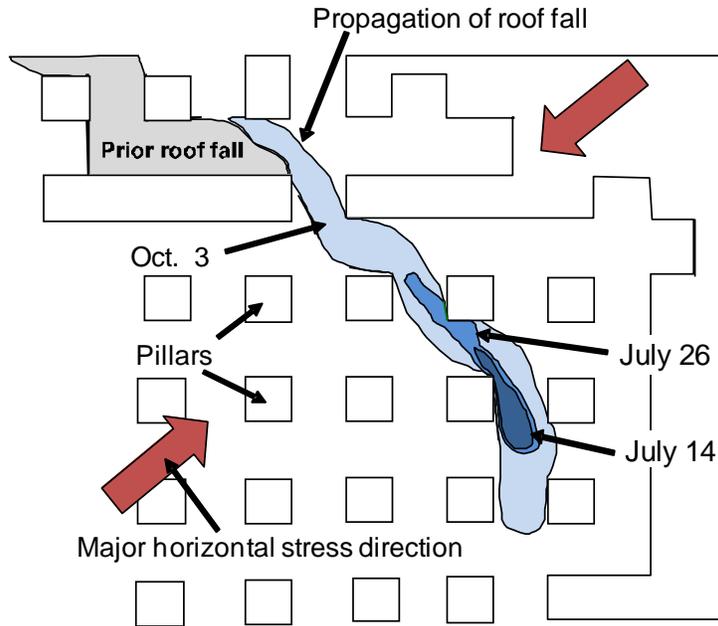
Figure 34. Plan view showing the development of a stress-related roof fall in the direction perpendicular to the direction of the major horizontal stress [Iannacchione et al. 2003].

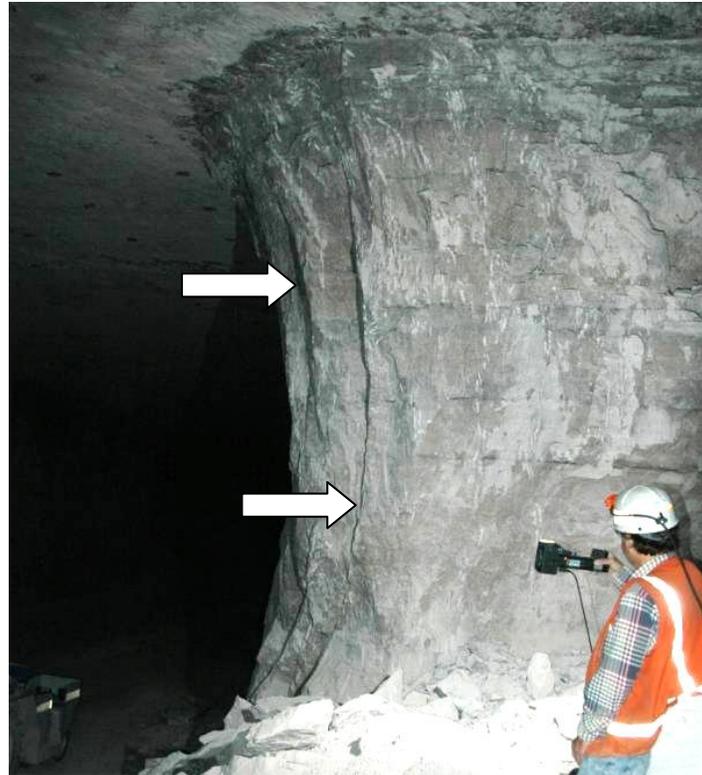
Figure 35. Extension fractures exposed in a pillar rib after the pillar was bisected by a new crosscut.

Numerical models were used to investigate how this type of failure might take place and how the presence of widely spaced bedding planes would affect the depth of the potential roof failure [Esterhuizen 2006]. The stability of the roof rocks was assessed by calculating a failure index, which is based on extension failure initiating when the maximum principal stress exceeds 10% of the rock strength. A failure index of less than 1.0 indicates potential rock failure, similar to the traditional factor of safety. The failure index results in Figure 36a show that, in the absence of bedding discontinuities, extension fracturing can extend over the room to form an arch which extends to about 3 m (10 ft) above the roofline. This arch is very similar to the extension fracture observed in the pillar rib, shown in Figure 35.

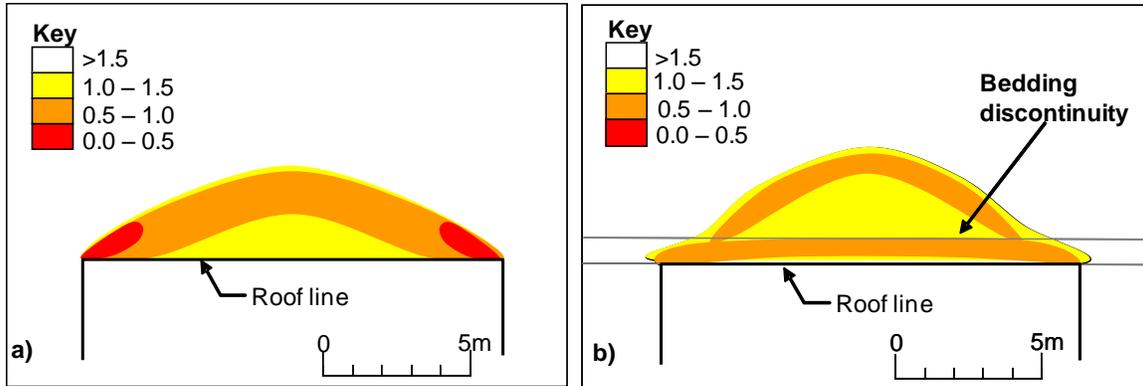
Figure 36. Vertical cross section through a heading showing rock failure index values (a) without bedding discontinuities and (b) with a bedding discontinuity 1 m (3.3 ft) above the roofline.

If a single bedding discontinuity is introduced 1 m (3.3 ft) above the roofline, see Figure 36b, the stresses are redistributed by the presence of the discontinuity. A reduction of the horizontal stress occurs in the 1-m (3.3-ft) thick roof beam as it deflects downwards, and some slip occurs along the bedding discontinuities. Separation of up to 2 mm (0.08 in) occurs across the bedding discontinuity near the center of the room. The deflection of the lower beam causes an increase in the stress within the overlying roof, which in turn causes the potential rock failure to extend to about 4 m (13 ft) above the roofline.

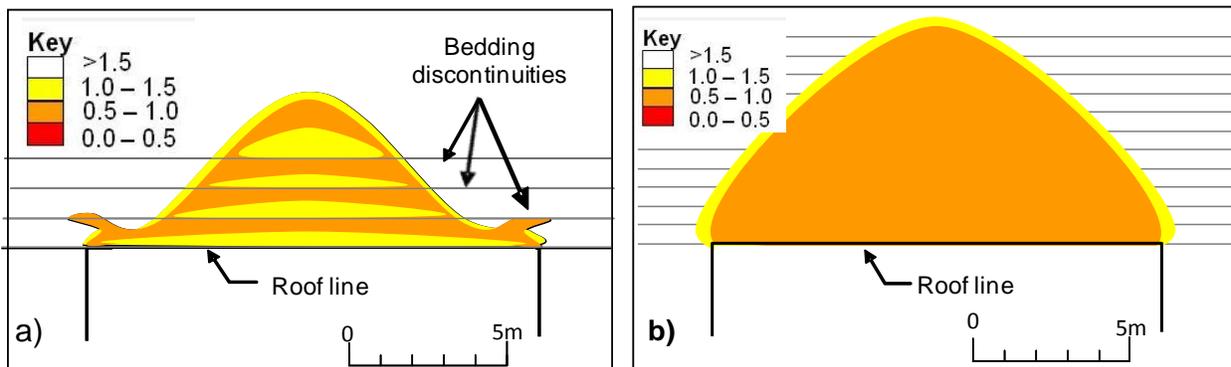
Figure 37. Vertical cross section through a heading showing rock failure index values (a) with three 1-m thick (3.3 ft) bedding discontinuities in the roof and (b) thinly laminated roof.

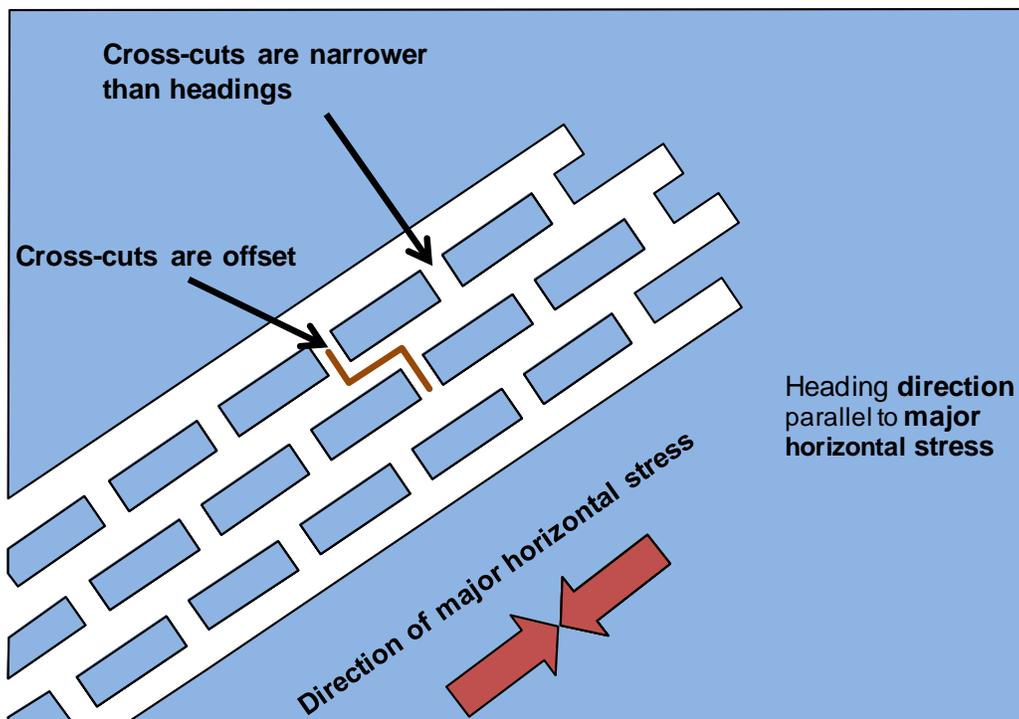
Figure 38. Diagram showing room-and-pillar layout modified to minimize the potential impact of horizontal, stress-related damage.
