Occupational Fatality Report

Tree Service Foreman Fatally Injured While Repairing a Skid-steer Loader – Massachusetts

Release Date: August 12, 2016
Investigation: # 15-MA-004-01

Massachusetts Department of Public Health
Occupational Health Surveillance Program

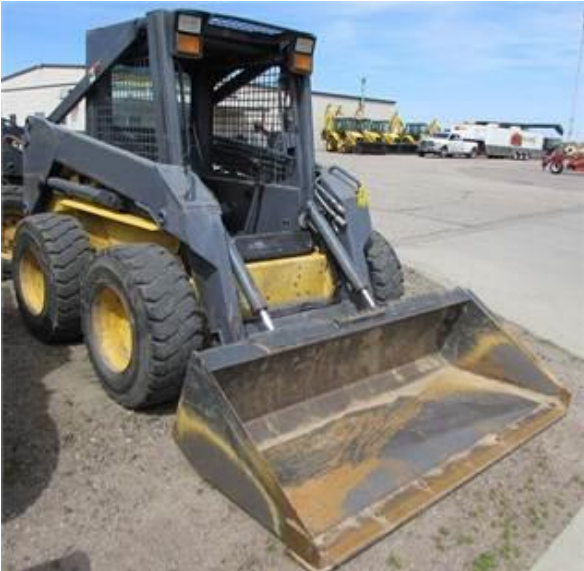
Figure 1 – Similar skid-steer as the one involved in the incident

The equipment involved in the incident was a skid-steer loader (Figure 1) that was manufactured and purchased in 1997 by the company. The loader was equipped with a four cylinder turbocharged diesel engine and four rubber tires. The approximate dimensions of the skid-steer loader, with the bucket attachment, were 127 inches long, 75 inches high, 65 inches wide, with a 42-inch wheelbase. The loader had a three-sided enclosed operator's cab, which was accessed through the open front and one seat for the operator (Figure 2). The back of the cab could also be used as an emergency exit.

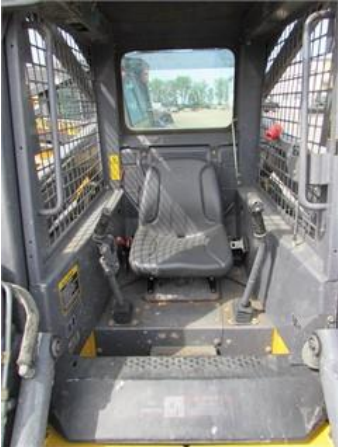
Figure 2 – Cab of similar skid-steer as the one involved in the incident

A manual lever to engage the mechanical lift arm lock was located inside the cab next to the right rear side of the operator's seat (Figure 2). To engage the lift arm lock, the lift arm must first be in the raised position, and then the lock can be manually engaged, which extends the lift arm lock pins. The lift arm is then lowered onto the pins. These pins prevent the lift arm from being able to be lowered any further, either intentionally, or unintentionally, such as a by an unexpected activation of the controls or by hydraulic failure. The mechanical lift arm lock must only be engaged while the operator was seated inside the loader's cab, allowing the operator to engage the lift arm lock and then safely exit the cab. The manufacturer had applied multiple decals on the loader to warn of hazards, including the need to use the lift arm lock pins to prevent a crushing between the lift arm and loader frame.

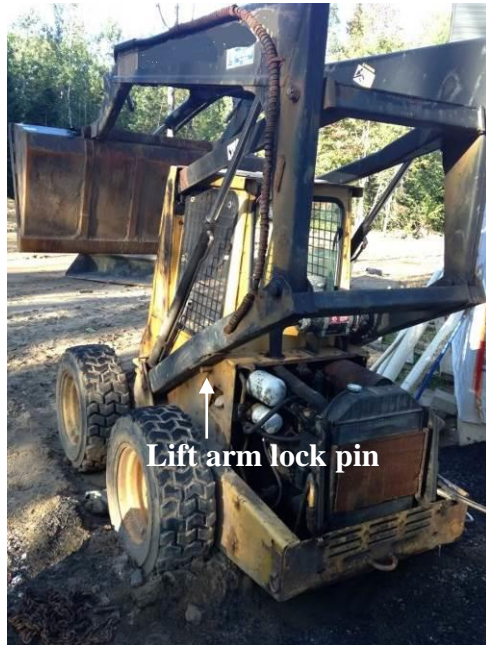
Figure 3 – Skid-steer with lift arm raised and mechanical lift arm lock engaged

The loader's lift arm was designed to wrap around the front of the machine where the attachment would connect to the lift arm. The lift arm was raised and lowered by two hydraulic cylinders located on either side of the loader. The manufacturer equipped mechanical lift arm lock would prevent the lift arm from being lowered to the ground when it was properly engaged (Figure 3).

Recommendation #1: Employers should ensure that skid-steer loader lift arm locks are engaged prior to beginning maintenance tasks that require lift arms in the raised.

when the skid-steer was brought back inside the garage, there would have been safe access to the cab and the area underneath the raised arm and the lift arm would not have come crashing down when the hydraulic line was removed.¹

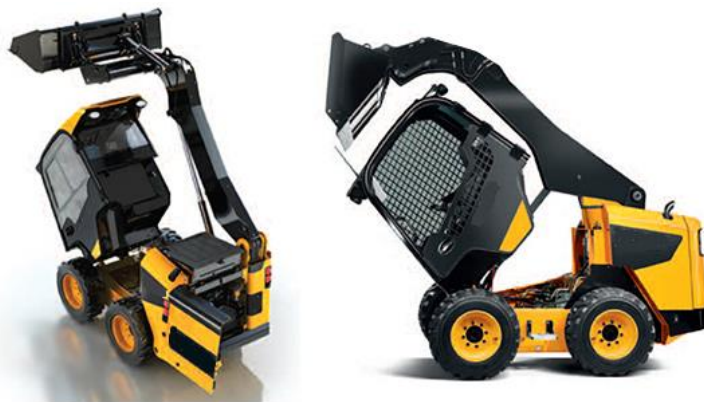
Figure 4 – Newer style skid-steer loaders with cab access on the left side, cabs that tilt forward and single lift arm design

Some manufacturers have recently altered their skid-steer loader design. The manufacturer of the loader involved in this incident now design their skid-steer loaders with a cab that tilts forward, rather than back for easier maintenance access. However, to tilt the cab, the design still requires the lift arm to be raised and the lift arm lock to be manually engaged. This design does not eliminate the possibility of being crushed between the lift arm and the loader. A couple other manufacturers have also altered their skid-steer loader design and incorporated a number of changes: cab access located on the left side of the loader, a single lift arm on the right side, and a cab that tilts to the front for maintenance access (Figure 4).⁷ Cab access on the loader's left side combined with the single lift arm on the right side does eliminate the tripping hazard of climbing over the front of the loader. The single lift arm on the right side combined with a cab that tilts to the front reduces, but does not eliminate, the time a worker could potentially be underneath a

raised lift arm because to tilt the cab the lift arm still has to be in the raised position. Optimally to reduce the tripping and crushing hazards described above, skid-steer loaders could be designed with a single lift arm on one side, access to the cab on the opposite side of the lift arm, and a cab that can be tilted while the lift arm remain completely lowered to the ground.
