## Effective Partnering to Increase Access to Water on the Navajo Nation

### **Engineers with the U.S. Public Health Service carried out a series of missions in the Navajo Nation during the coronavirus pandemic to increase water access and public health through the construction of centralized watering points.**

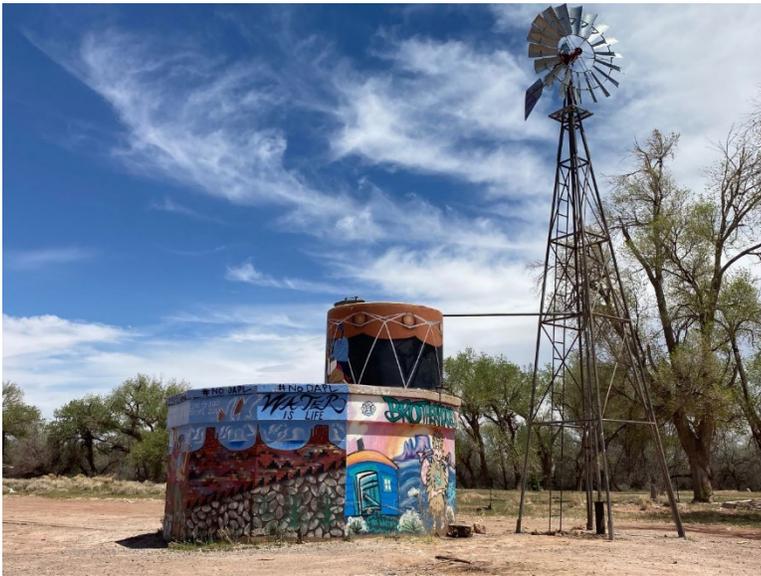
The Navajo Safe Water Access Mission surveyed, constructed, and educated personnel on proper operation of distribution water points to increase the availability of clean water and support public health throughout the Navajo Nation. Photo by Capt. Kris Neset, USPHS

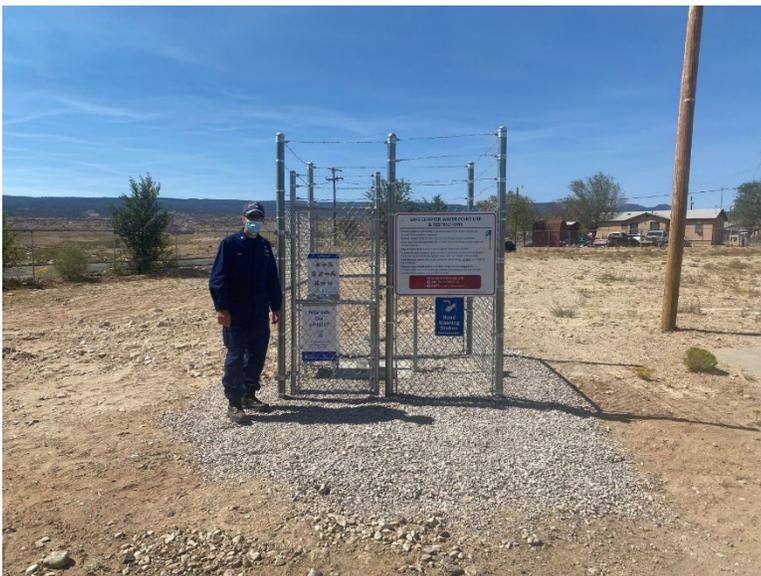
The Safe Water Access Mission reduced the average round trip to a transitional water point in the Navajo Nation from 52-mi to 17-mi. Photo by Lt. Mike Buck Elk

The work completed resulted in a significant reduction of travel time to and from watering points for households without piped water. Prior to the Safe Water Access Mission, an average household round trip to a watering point was 52-mi. This was reduced to 17-mi. The Public Health Service officers demonstrated how a practical, hands-on engineering and public health focused response can improve critical sanitation deficiencies during an infectious disease event.

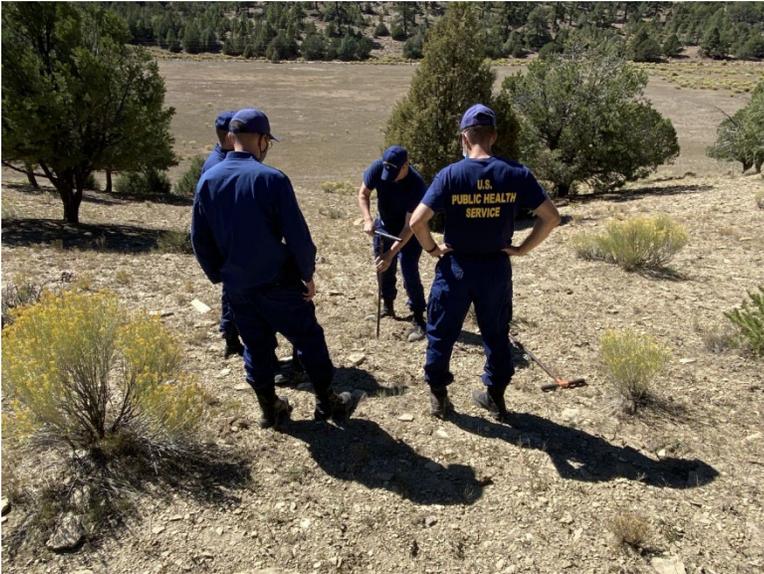
As a follow on to the Safe Water Access Mission, Public Health Service engineers assessed over 600 Navajo homes, categorized their onsite water and wastewater systems, and completed construction bid packages for priority sites. Photo by Capt. Steven Bosiljevac, USPHS

A total of three teams assessed over 600 Navajo homes from September 2020 to December 2020 and completed construction bid packages for 78 sites that will be ready for construction once funding resources are fully available. Team members collected homeowner information; developed GPS surveys of each home site using ArcGIS; and conducted a household assessment of plumbing that included enumerations of household residents, bedrooms, bathrooms, and status of electrical power. They also conducted a soil analysis for septic system design and designed water cistern and onsite septic systems. Information and photos were entered into the Survey123 Program for engineering reports.

Home sites were categorized by a three-tier system. Tier 1 (30 percent) had indoor plumbing and were ready for construction of individual water and wastewater facilities. Tier 2 (45 percent) did not have indoor plumbing ready and/or home site lease was not filed. Tier 3 (25 percent) were homes that were ineligible because they were already served with water and wastewater facilities, were abandoned, or were no longer located on the site.
