# NJ FACE INVESTIGATION REPORT

FACE 09-NJ-099

## Hispanic Construction Worker Wearing Fall Protection Dies after Falling 40 Feet from Roof

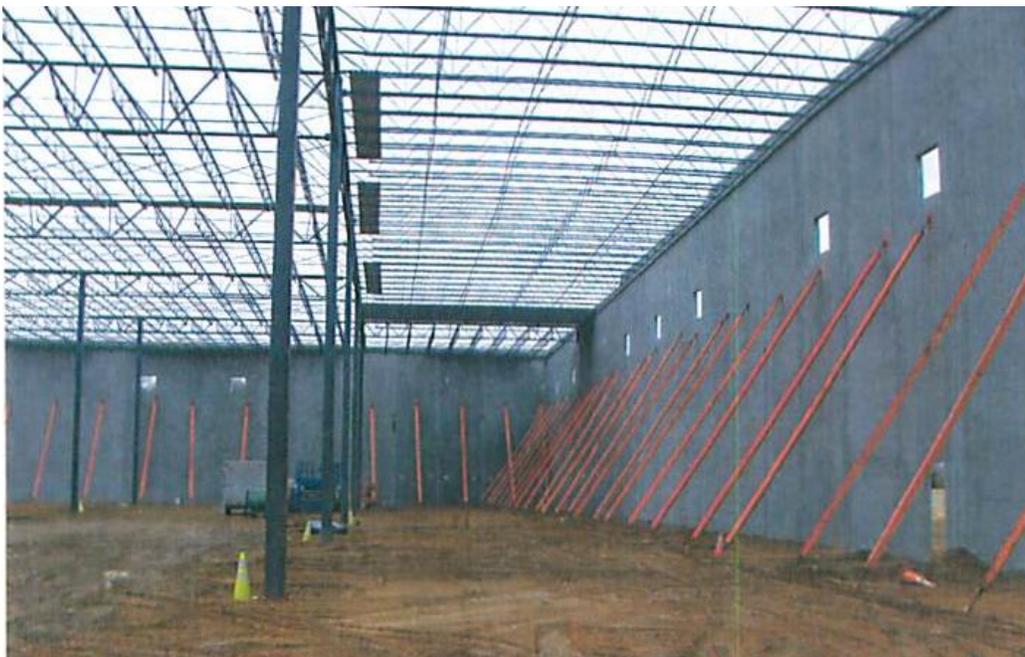
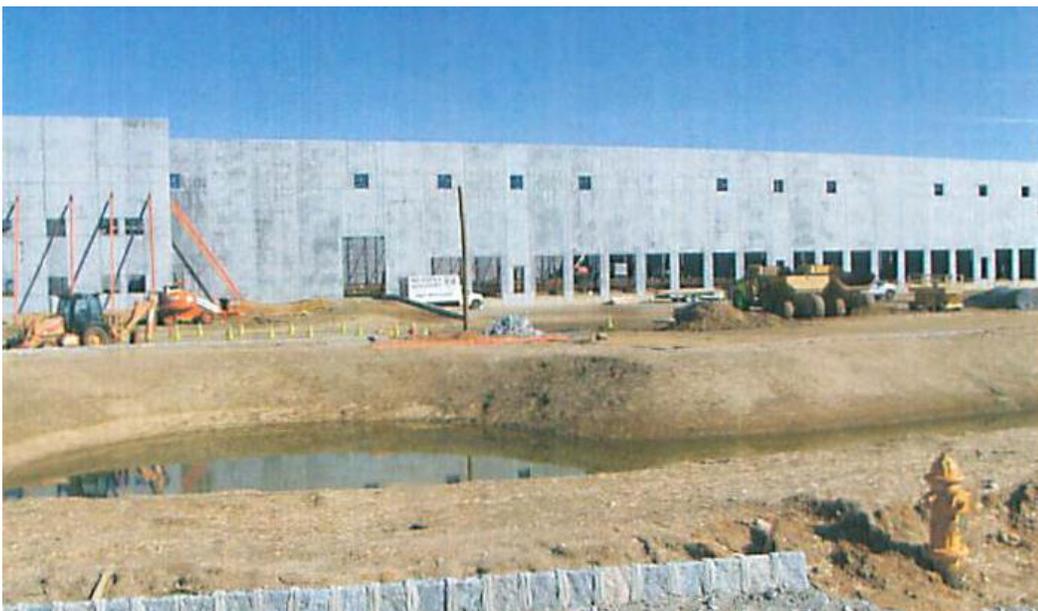
**FIGURE 1. Incident site; inside and outside views of construction site.**

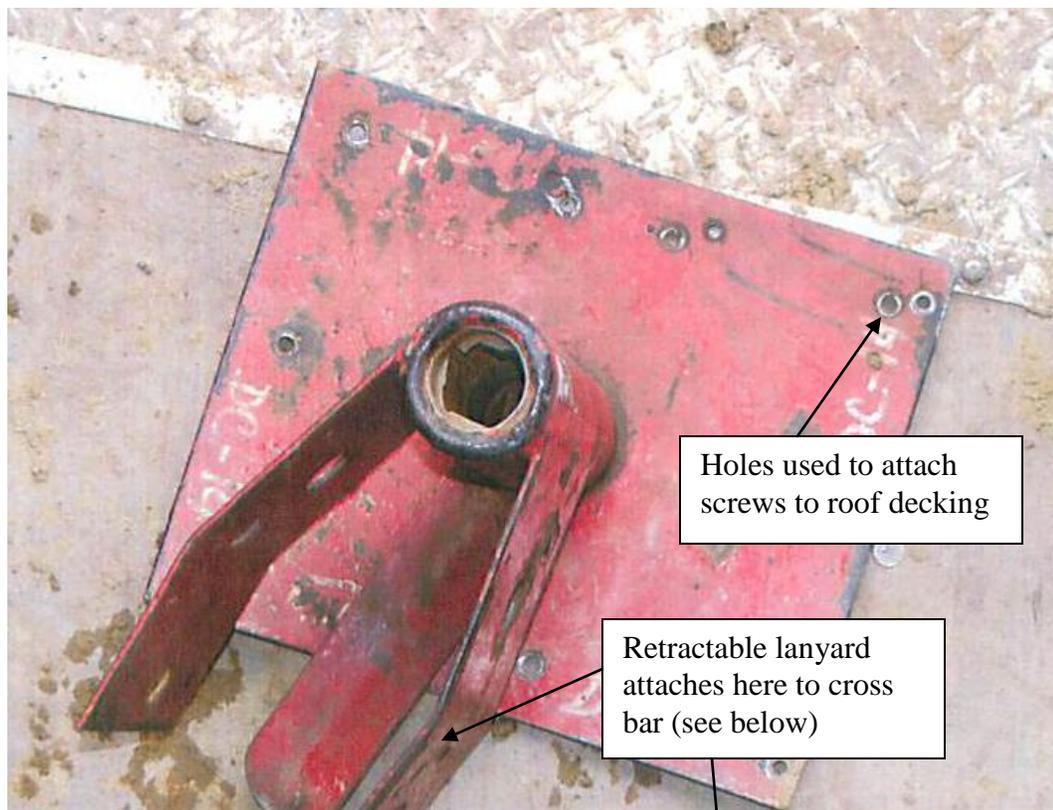
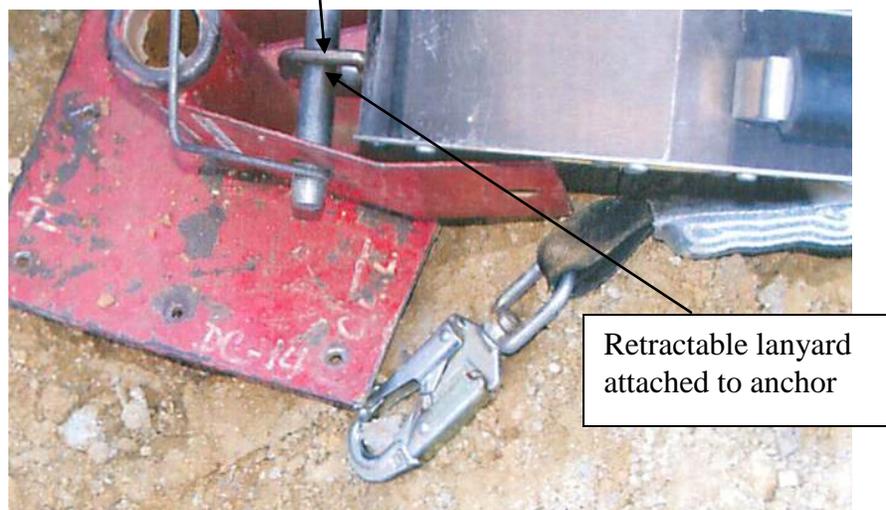
Worker # 1 (the deceased) was at the leading edge position and wore a retractable lanyard clipped into a 12" x 10" metal roof anchor device or anchor plate. The plate has 5" x 9.5" metal attachments that are affixed to an 8" stem in the plate (see Figure 2). At the end of the attachments is a crossbar, to which the retractable lanyard is clipped. It was noted that this clip and the clip point was undamaged and remained connected throughout the incident (i.e., the retractable lanyard device remained connected to the anchor). In addition, the folded fabric portion of retractable lanyard had its plastic covering and stitching still in-tact. The anchor plate was attached directly to the leading corrugated decking sheet, approximately 18" from the edge. A standard drill was used to attach the anchor plate with ¾" (thread length) screws. According to the manufacturer's instructions, installation of the plate requires 1" [hex washer self-drilling] screws. As determined by OSHA, the employer and employees were under the impression that the screws they used were appropriate because they were 1" in overall length. Worker #2 also wore a retractable lanyard, but his fall arrest system was attached to a beam clamp (Figure 3) and was not exposed to the leading edge hazard.

**FIGURE 2: Anchor device used by the victim.**

According to the manufacturer, the type of anchor used in the incident was intended for use on flat metal roofs and would not adequately arrest a fall if attached to a corrugated roof. The employer was using the manufacturers' directions for a slightly different anchor plate, one that was smaller and meant for flat surfaces.

The employee who installed the anchor plate confirmed that screws that were found at the scene were those that he had used during installation. The threaded portions of the screws were  $\frac{3}{4}$ " in length (with an overall length of 1"). However, the instructions specify that the screw thread should be 1" in length. According to an OSHA interview with the worker who installed the plate, he was under the impression that what they were using was correct since it was 1" in overall length. The extra threading allows for additional turns into the roof deck and truss and would have provided additional strength to the plate.

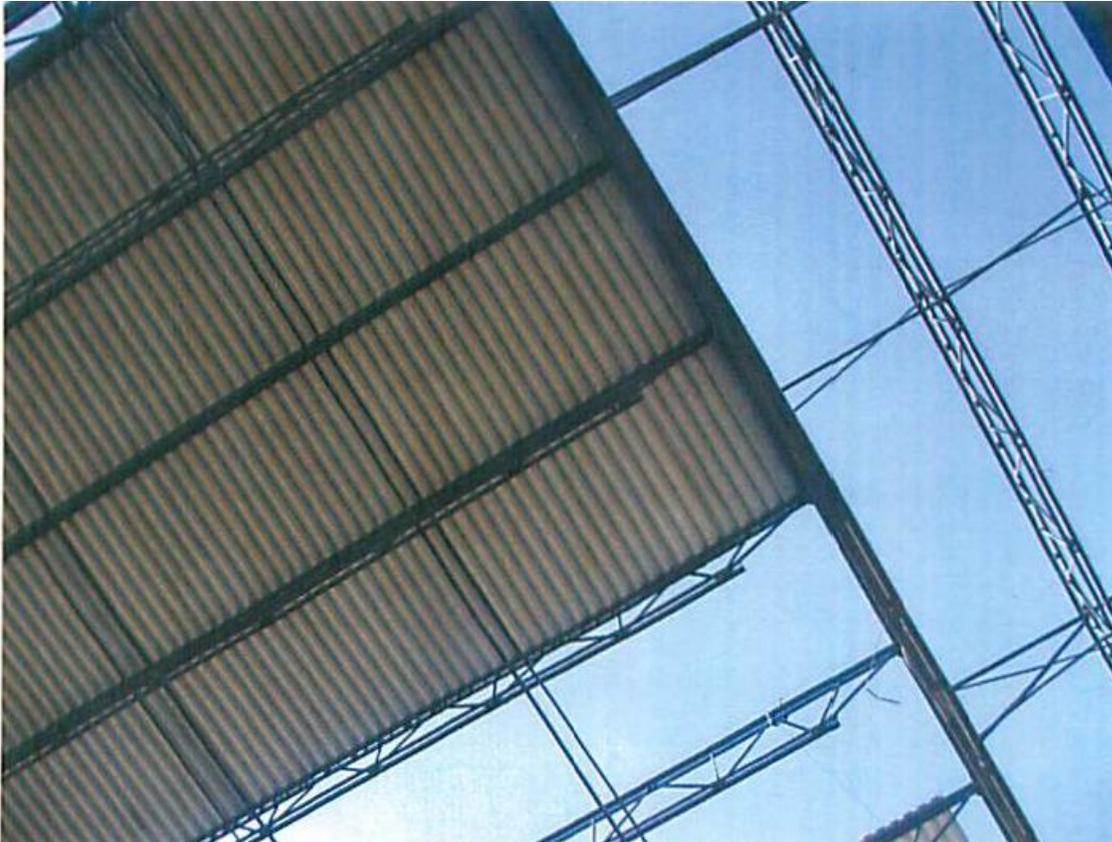
**FIGURE 3. View from underneath the roof decking where the victim fell.**

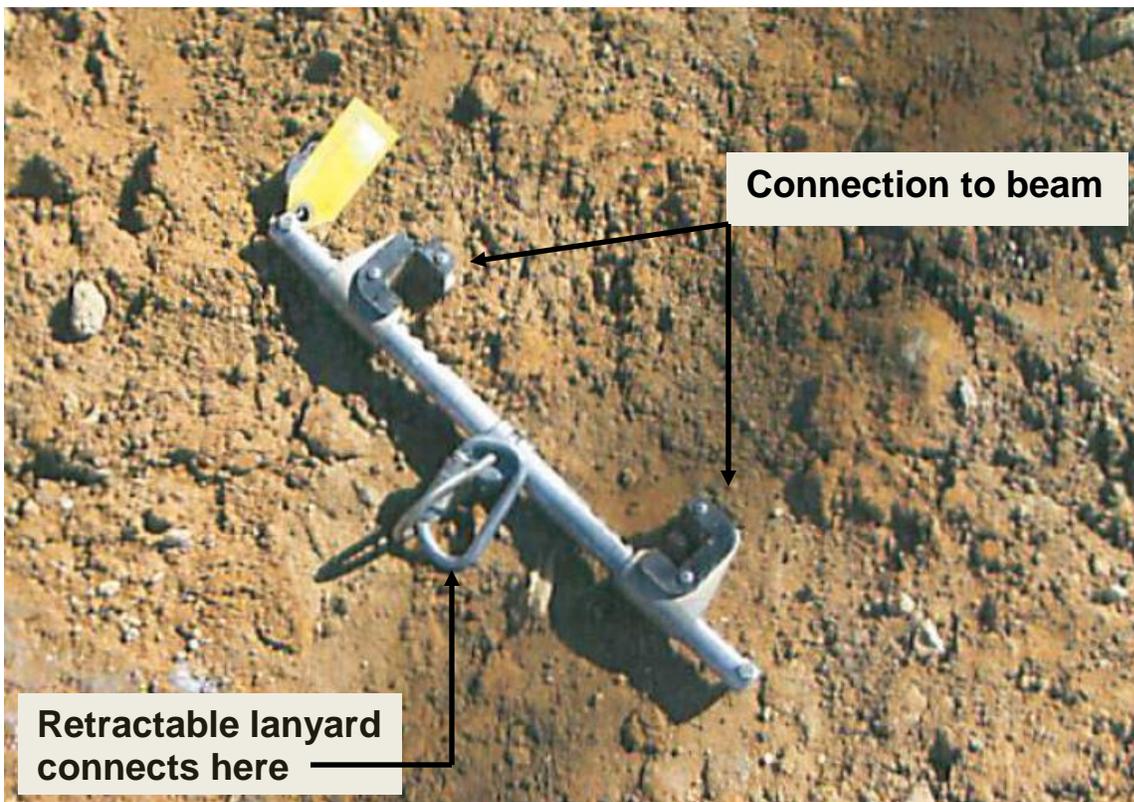
**FIGURE 3. Beam clamp to which Worker #2 was secured.**

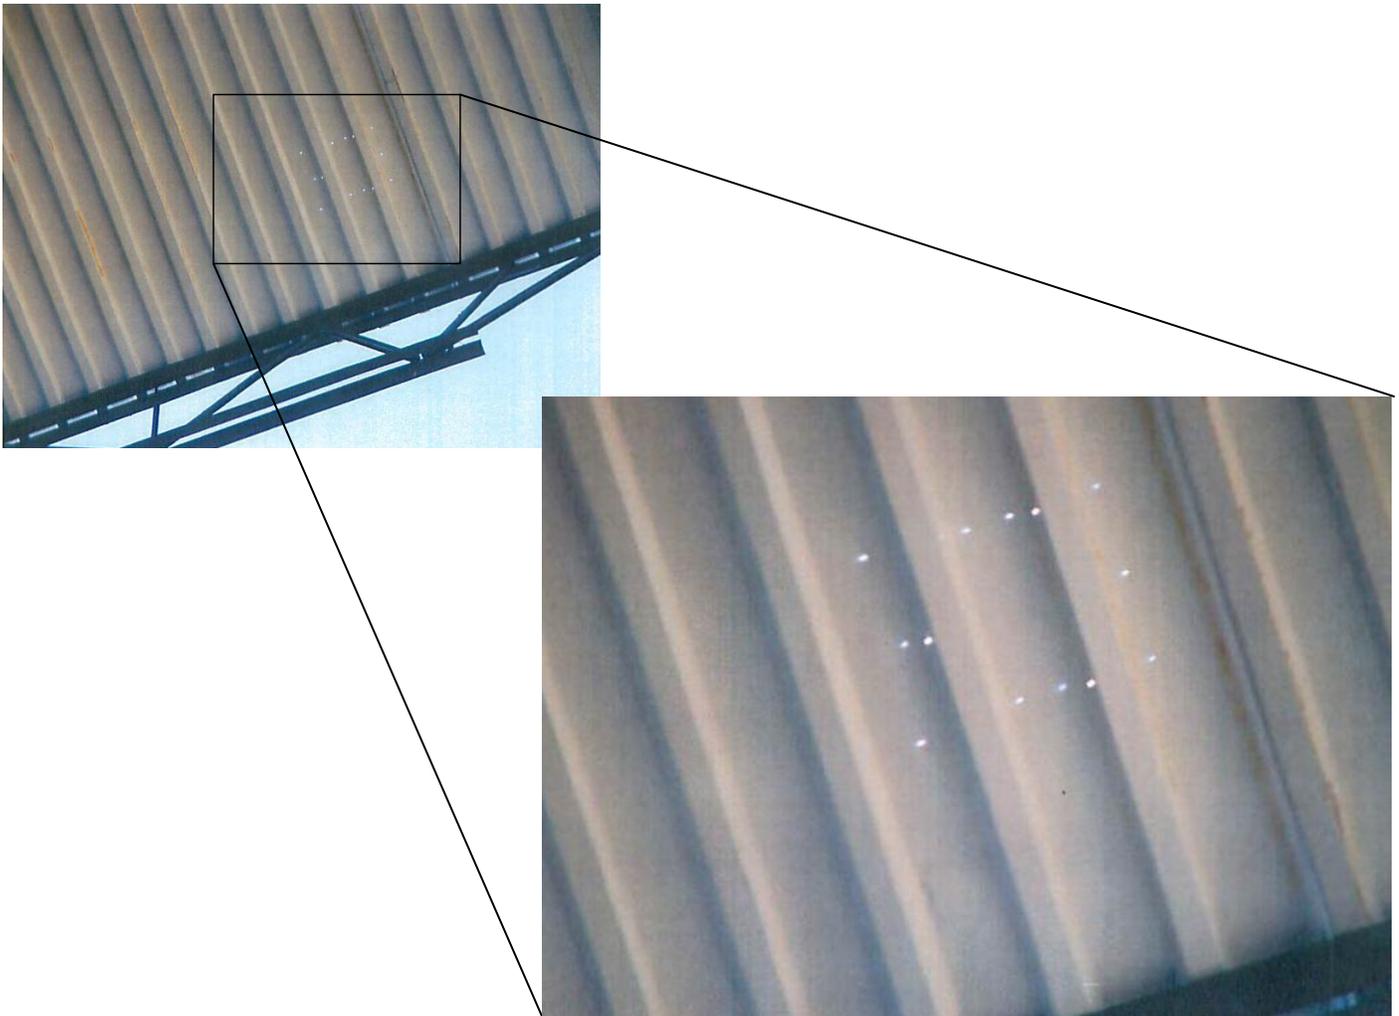
The employer's protocol for laying corrugated roofing materials requires that the leading edge of the decking not be secured until the next sheet was in place. Each metal sheet was fastened on the following end and anywhere else it was supported by a truss. The next sheet was then placed over the leading edge and attached with fasteners. This was continued until the roof was complete. On the day of the incident, for an unknown reason, the worker fell from the leading edge. When the worker fell and his retractable lanyard reached the end, the anchor plate was pulled completely out of the decking, allowing the worker to fall 40 feet to the ground.

**FIGURE 4. Close up view of roof decking to show where anchor plate was installed.**

In this case, the anchor plate was located on the unsecured, leading edge of the roof installation. Therefore, when the worker fell from the edge that was not secured to the truss, an upward force was exerted on the anchor plate, forcing the screws out of the plate. NJ FACE recommends that all employees working near an unsecured piece of roofing near a roof edge should be anchored via beam clamp (see Figure 3). This type of personal fall-arrest system would conform with CFR 1926 502(d), which states that a fall protection device should be able to support up to 5,000 lbs.
