SUBJECT: A Tree Trimmer is Electrocuted When a Tree Branch Falls onto Energized Electric Power Lines

SUMMARY
California FACE Report #11CA003

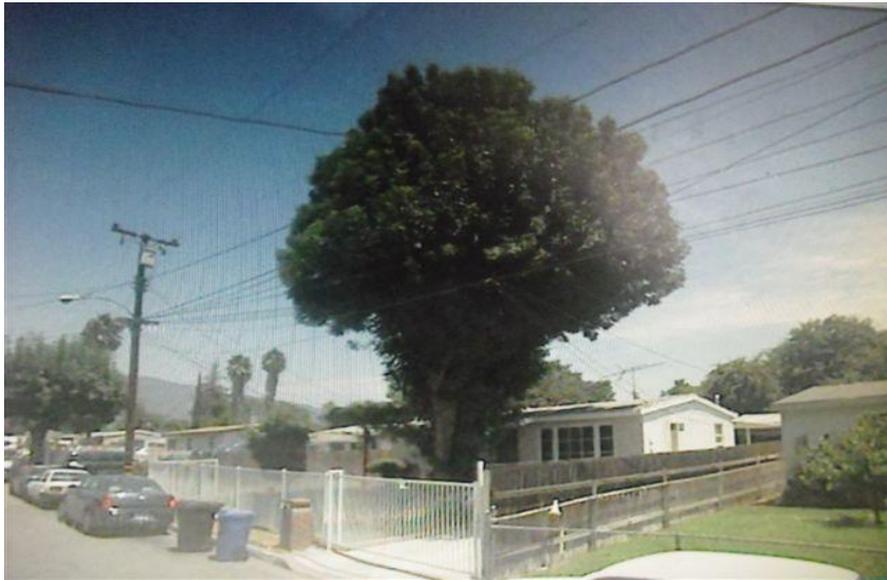
Exhibit 2. The tree and electrical utility lines.

the tree with his brother and sons. The tree was located approximately eight feet from the home and was adjacent to the 16,000 volt power distribution lines that supplied electricity to the homes on that street. The victim put on a fall protection harness and a slip line, a climbing rope, and drop line along with climbing spurs on his legs. He then climbed the tree, removed all slack in his climbing rope, pulled up a chain saw, and began trimming the branches. As the branches fell to the ground, the victim's brother and sons dragged them to a trailer attached to a pickup truck parked in front of the house. Many neighbors gathered across the street to watch the work in progress.

At approximately 3:00 p.m., the victim was about 35 feet up in the tree and cut a branch that fell onto the energized electric power line. The cut branch had not completely detached from the tree and, when it made contact with the energized power line, the electric current traveled through the branch, back to the tree, and then to the victim through his climbing spurs, climbing rope, or flip line. According to the victim's brother, the victim dropped the chain saw to the ground and fell backwards in his harness as his legs straddled a larger branch of the tree.
