FATALITY ASSESSMENT AND CONTROL EVALUATION

Operator of a Trailer Tipper Fatally Struck by a Tractor Trailer at a Landfill Case Report 16NY009

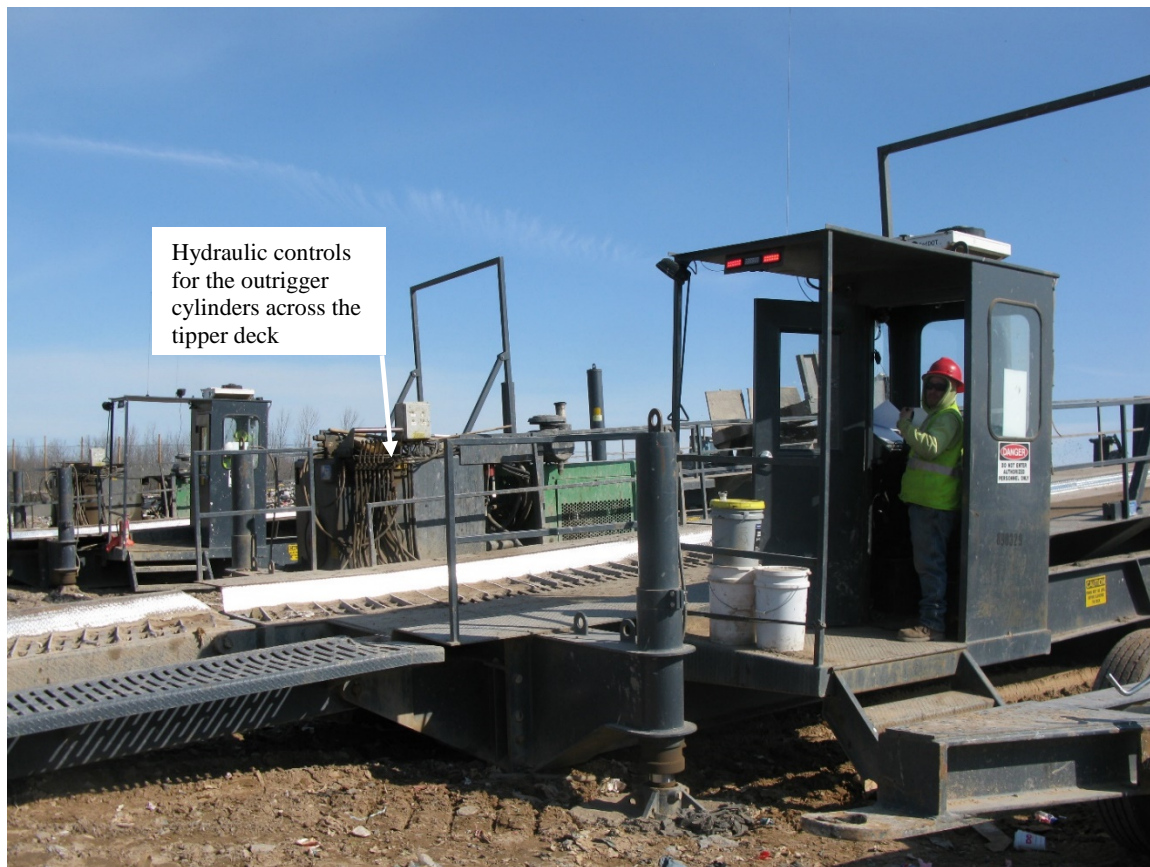
The base of the tipper had metal railings on both sides and a backstop at the hinged end of the movable platform. To get on the tipper, a tractor trailer had to back onto the platform with its rear trailer doors facing the hinged end until it hits the backstop. The tipper had six outrigger cylinders to support and level the structure. The hydraulic controls for the outrigger cylinders were at the left side of the deck when facing the hinged end (Photo 2). The operator only needed to operate the outrigger cylinders when setting up the tipper. There was an operator's cab at the right side of the deck and all the tipper controls along with a CB radio were inside the cab (Photo 3). An operator could only hear the CB radio

Photo 2. Hydraulic controls for the outrigger cylinders were on the left side of the deck and the operator's cab was on the right side.

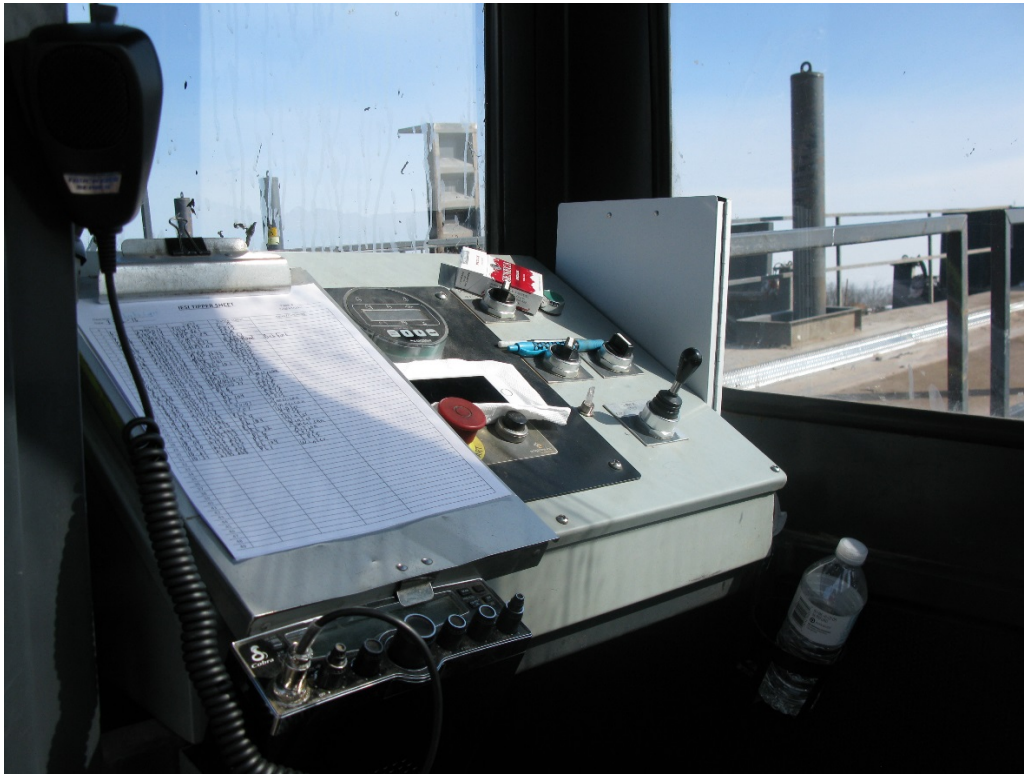
when he was inside the cab. There was no radio communication for a tipper operator once he left the cab and was out on the tipper deck.

Photo 3. Tipper control panel and a CB radio inside the operator's cab.

Discussion: The bulldozer operator in this case tried to warn the victim when he saw the “army truck” trailer backing up, but he could not reach the victim since the CB radio was inside the operator’s cab and the victim was on the deck. Landfill employers should provide a secondary communication method such as a walkie-talkie for the working face staff to communicate with the equipment operators and other pedestrian workers. The operators should be required to always carry the walkie-talkie when they are outside the operator’s cab.

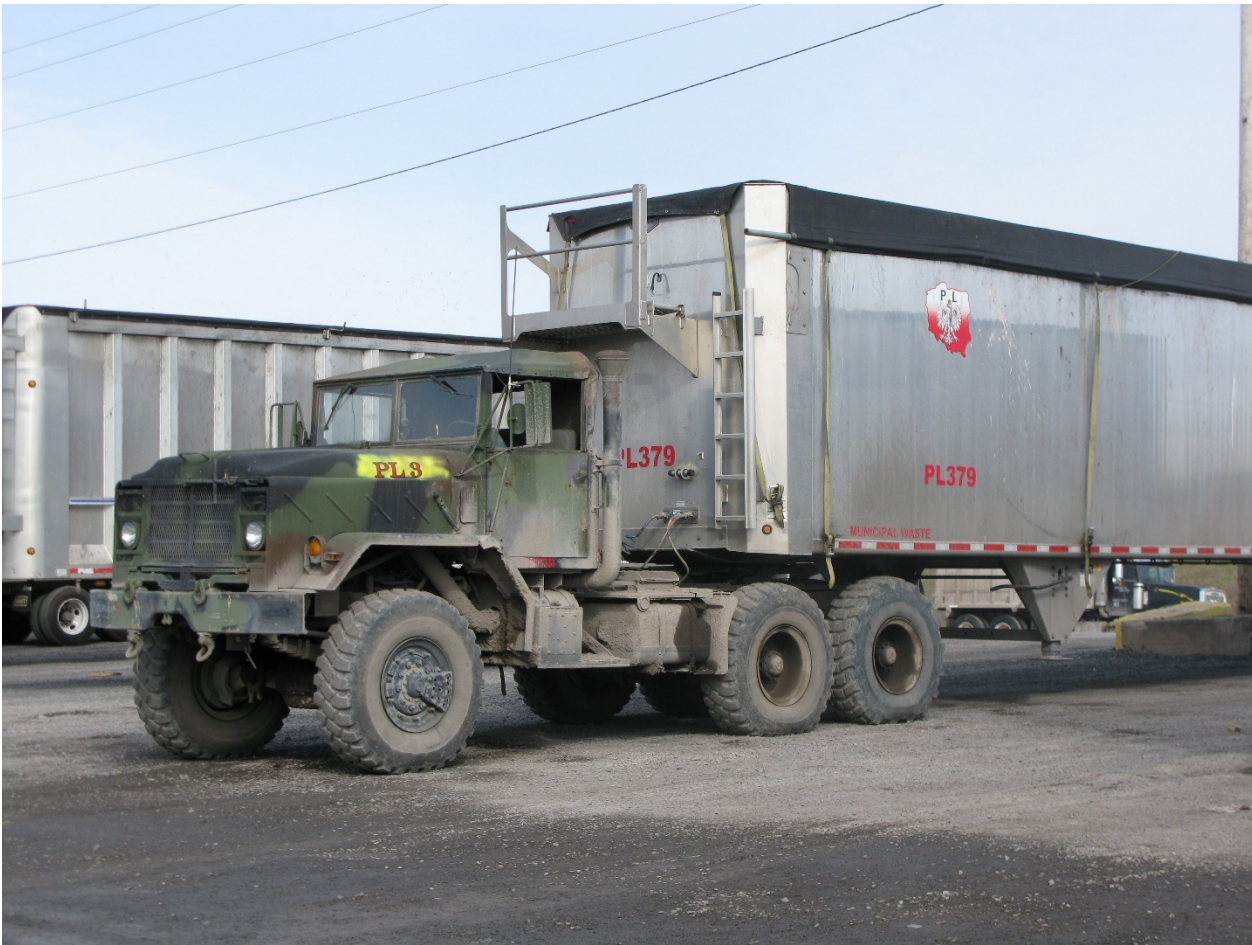
A large trucking company trucked municipal waste from New York City to the landfill. Once arriving at the landfill, a driver had to go through the landfill process to deposit the waste. First, the driver had to go through a radiation detector and a weigh station, then do paper work with a scale operator before driving to a working face where the driver may have to wait in line to get on a tipper. After depositing the waste, the driver had to go through the weigh station again before leaving the landfill. The entire process could take up to two hours. To reduce the drivers' down time, the trucking company purchased military surplus tractors, referred to as "army trucks" (Photo 4), and hired a local subcontractor to take care of the landfill process.

Photo 4. A military surplus tractor (“army truck”) was used to haul the trailer and deposit waste in the landfill.

The “army trucks” did not have audible backup alarms, although the mirrors on the trucks worked. The tractor radios did not work most of the time due to the incompatible electrical voltages between the tractor and the radio. The “army truck” drivers reportedly often drove up to a working face and backed up to a tipper whenever they saw that the tipper was empty without getting the radio communication from a tipper operator.

Discussion: In this case, the only available communication method between the tipper operator and a delivery driver was through a CB radio. The radios on the “army trucks” did not work and the trucks’ backup alarms were broken. Landfill employers should require that all visiting vehicles have radios and backup alarms that are working properly. Vehicles without working radios and backup alarms should not be permitted to enter the landfill.

Discussion: The solid waste trucking company in this case purchased the "army trucks" that did not have working radios and backup alarms. The radio communication was critical at a working face to ensure the safety of the landfill operators and the delivery drivers. Trucking companies should make sure that the waste tractor trailers have all the required safety features and communication devices required by the landfill. Trucking companies should provide training to their drivers to ensure that they follow the landfill safety procedures and policies when depositing wastes at the landfill.

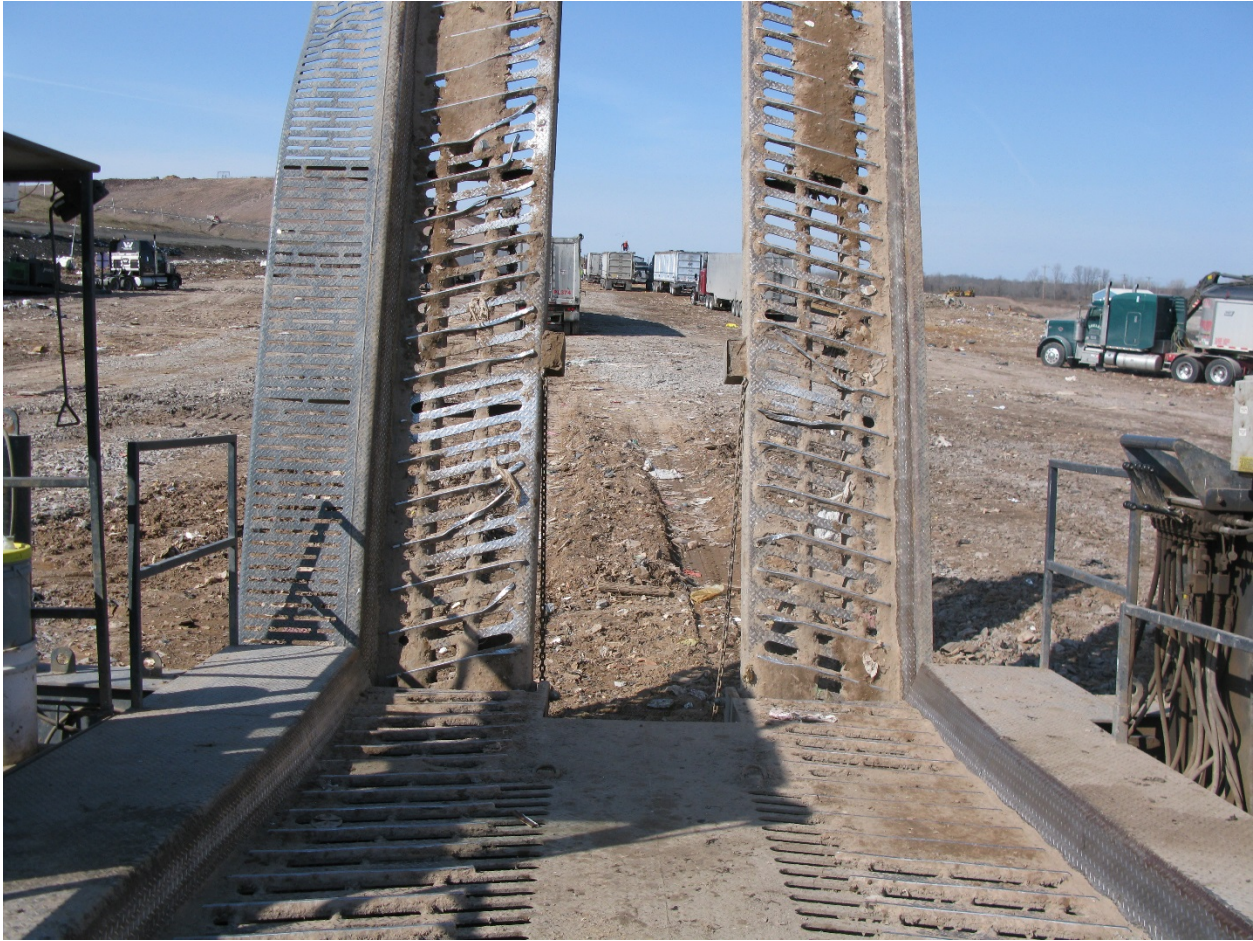
After the incident, the landfill began requiring that the tipper operator raise and tilt the metal access ramp to stop tractor trailers from backing onto the tipper deck every time a tipper operator is outside the operator's cab and on the deck (photo 5).

Photo 5. The access ramp is raised to stop the tractor trailer from backing onto the tipper deck when operator is outside the operator's cab.

Recommendation #1: *Landfill employers should implement measures to prevent tractor trailers from backing onto the tipper deck when a tipper operator is on the deck.*

Discussion: A landfill tipper operator performs multiple tasks on the deck such as cleaning, trouble shooting, and maintaining the equipment. Every time the operator is on the tipper deck, he is potentially exposed to fatal crushing hazards due to tractor trailers backing onto the deck. Landfill employers should consider implementing the following measures to prevent tractor trailers from backing onto the tipper deck when the operator is on it:

- Set up a physical barrier to block the deck;
- Radio all delivery drivers at the working face that the deck is closed;
- Use a visual signal such as a flashing red light to show that the deck is closed;
- Coordinate with other landfill vehicles such as bulldozers to block the path to tipper deck.

Landfill employers should ensure that no operator leaves the operator's cab unless these control measures are in place.
