## FATALITY ASSESSMENT AND CONTROL EVALUATION

### Farm Worker Dies during Grain Bin Auger Entanglement Case Report: 04NY121

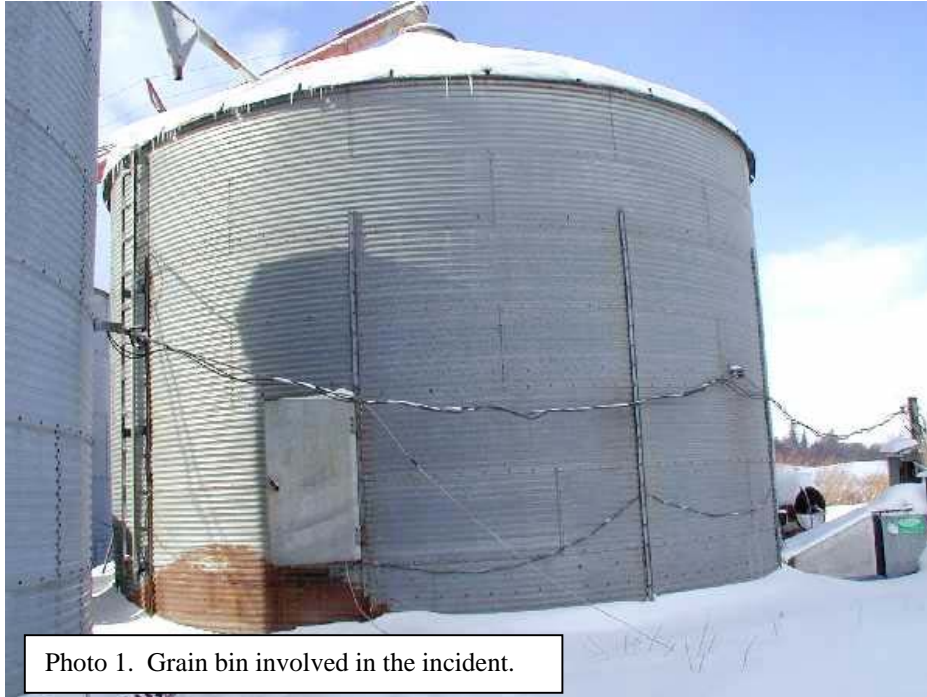
Photo 1. Grain bin involved in the incident.

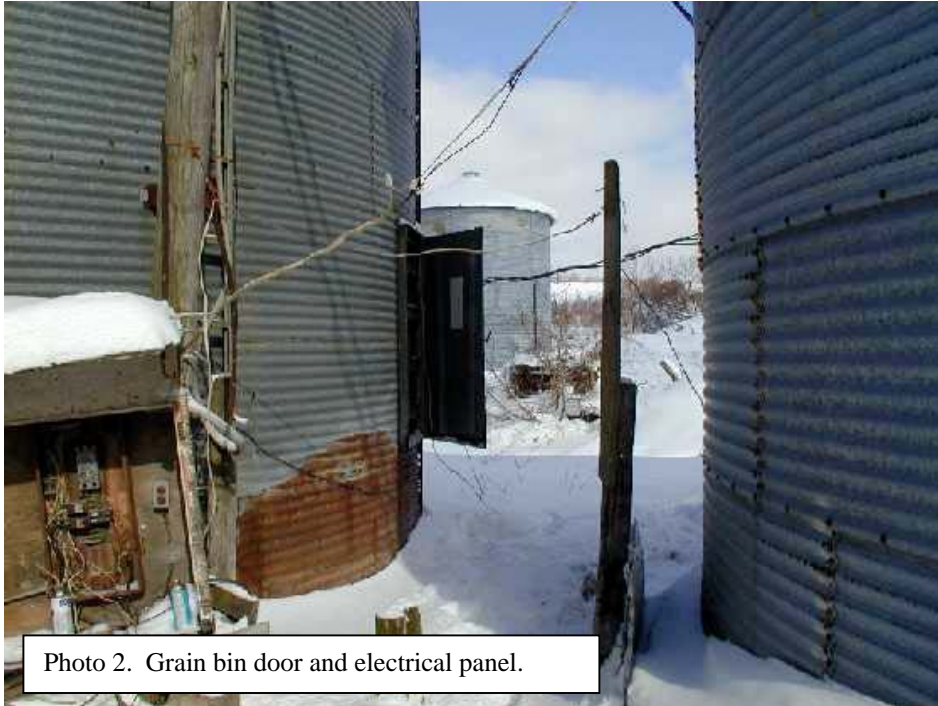
remove it from the bin. When a considerable amount was piled against the auger, the worker would go outside the bin and re-energize the electricity to the auger motor which would transport the material up and out of the bin (Photos 2 & 3). This method would require repeated shoveling, sweeping, and re-energizing until all of the remaining grain had been removed from the bin.

Photo 2. Grain bin door and electrical panel.

**Discussion:** Establishing and following proper lockout/tagout procedures helps to ensure that augers are not energized when workers are inside grain bins performing maintenance or cleaning. During this incident, it appears that the victim energized the sweep auger himself and then reentered the grain bin. In similar incidents, it is also important to protect workers from having equipment inadvertently energized by other workers, who may not be aware of the location of coworkers.
