**FROM:** Iowa FACE      Case No. 2005IA013      Report Date: 17 August 2007

**SUBJECT:** Tractor moving large round bale on loader forks overturned onto farmer

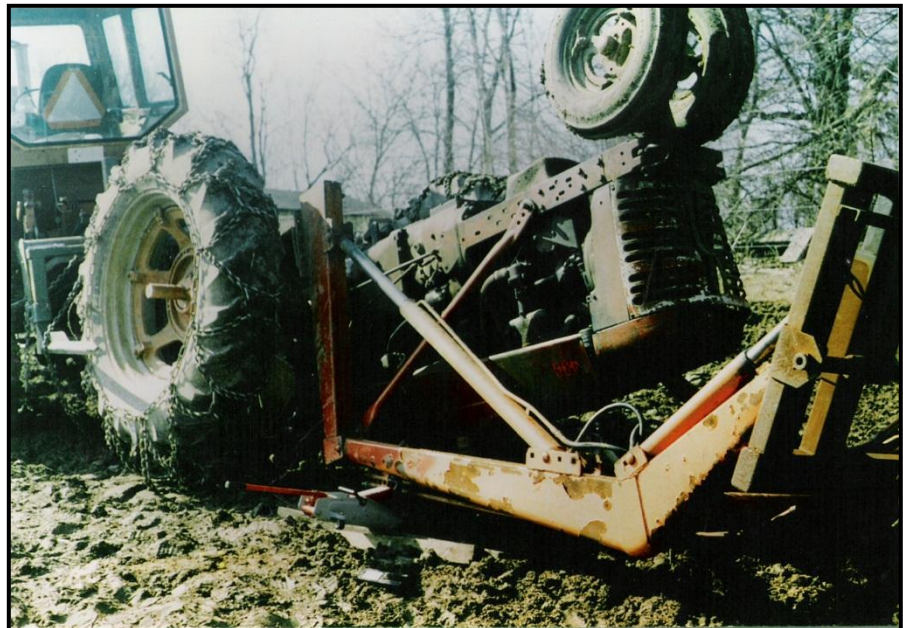
**Photo 1** – Front quarter view of overturned tractor as it was being moved from the scene. The victim was pinned under the left rear wheel of the tractor.

Tracks on the slope behind the tractor indicated the left rear wheel intermittently came off the ground over a distance of about 30 m (100 ft) of travel before it overturned. Approximately 45-60 m (150-200 ft) from the manger, the tractor tilted to the right and continued overturning onto its top. The farmer had reportedly managed to jump clear or been lucky enough to avoid injury in a couple of previous tractor overturns. Jumping again, or pitched from the operator's station by the forces of the overturning tractor, this time the farmer landed prone and the left rear wheel of the tractor came to rest across his upper back pressing his face into the muck.

Several factors contributed to this overturn incident. The rear wheels were set to a narrow width. No ballast weight was in place on the tractor. A homebuilt set of forks was affixed to the loader instead of a grapple, spear, or other attachment typically recommended for handling large bales. The load was imbalanced as indicated by the loss of contact between the left rear wheel and the ground as the tractor moved forward down the grade. The load was carried high which raised the center of gravity for the tractor-loader-load combination.

**Recommendation #3** – *Front-end loaders should not be installed on narrow-front-axle tractors that do not have ROPS.*

**Discussion:** Previous FACE cases have highlighted the particularly risky combination of a front-end loader mounted on a tractor which has a narrow (tricycle configuration) front axle. The popularity of narrow front axle tractors declined in the 1960s but many tricycle front-end tractors

are still in productive use today. They are more prone to overturn than wide front axle tractors and should not have front-end loaders or other attachments installed on them that can significantly and adversely change the center of gravity for the entire tractor and attachment combination. For example, a heavy load in a raised loader bucket shifts weight from the rear wheels of the tractor to the front and at the same time raises the center of gravity of the tractor-loader-load combination, adding to the risk and relative ease with which such a combination can overturn.
