**FROM:** Iowa FACE                      **Case:** 2007IA081                      **Report date:** 9 July 2009

**SUBJECT:** Farmer killed when large round bale tumbled from forks in loader bucket

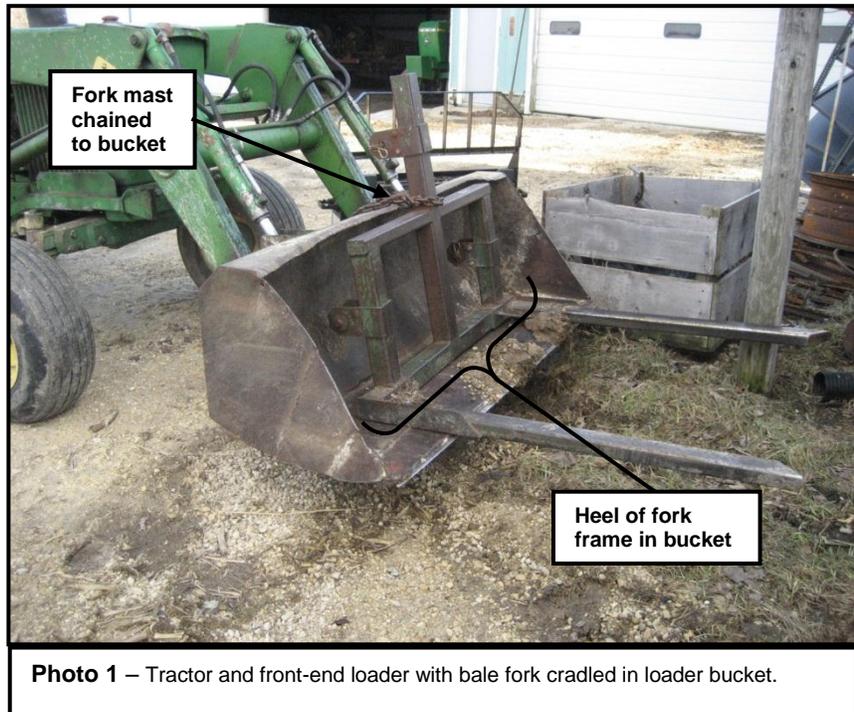
Late in 2007, a 60-year-old farmer died while operating his tractor when a large round bale of cornstalks spilled from the forks in the tractor's front-end loader bucket onto him. The loader had been modified by the temporary installation of a 3-point hitch bale fork placed in the tractor's loader bucket. The heel of the bale fork's frame was loosely cradled against the inside curvature of the bucket. The vertical mast of the bale fork's frame was chained at the top center of the loader bucket (Photo 1).

Rows of large round cornstalk bales had been placed along the edge of the farmyard for wintertime use. The ground was snow-covered and slippery in the area where the cornstalk bales were stored. Chained to the inside of the loader bucket was the framework for a forklift attachment designed for use on the 3-point hitch of a tractor. The victim steered the tractor forward, sliding the forks of his makeshift bale handling attachment lengthwise under a bale. He

1. *Use front-end loader attachments specifically designed and properly installed for the task to be performed.*
2. *Use tractor-loader combinations capable of performing the task, with wheel base settings and ballast weight as recommended, and carry loads low when moving them.*
3. *Select storage locations for large round bales so they can be easily and safely accessed and moved when needed.*

**Discussion:** The bale handling equipment used in this incident was a general purpose front-end loader bucket with a fork attachment chained into it. While the 3-point fork attachment may have been designed for use in handling large round bales on the tractor's 3-point hitch, it was not for installation in a loader bucket. Loader manufacturers and others provide attachments such as bale clamps, grapples, and spears specifically designed for lifting and moving large round bales. When installed properly these attachments hold the bale securely as it is raised, lowered, and moved in transport. Operator manuals for tractors, loaders, and bale handling equipment carry installation and safety practice information to be read and followed.

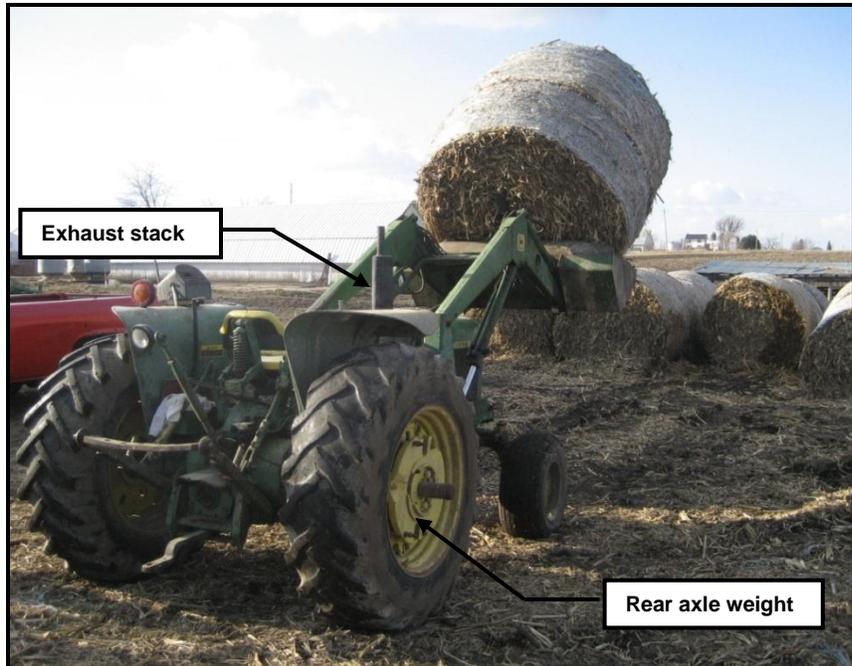
raised the loader and began backing away up a slight grade. The weight of the bale on the forks extending ahead of the loader bucket counterbalanced weight on the rear axle of the tractor. Investigators estimated the distance from the center of a bale on the raised forks to the center of the rear axle to be approximately 15 ft (4.6 m) (Photo 2). The farmer raised the bale higher to gain better traction on the slippery surface and perhaps to keep the bale above the other bales as he moved the tractor back and forth. Raising the load added additional weight to the rear axle for improved traction by shortening the horizontal distance between the center of the bale and the front axle of the tractor. Each time the tractor rear wheels lost traction the farmer moved the tractor forward a short distance then backward once again. It is possible he also actuated the raise-lower and/or tilt controls for the loader bucket as he shuttled backward and forward. Finally, as he stopped going backward and shifted to go forward one last time, the bale tumbled onto him in the operator's station.

found him slumped forward from the tractor seat to the left between the steering wheel and left wheel fender with the bale on top of him. The loader was reportedly raised as shown in Photo 2. The 3-point hitch bale fork in the bucket rotated rearward, pivoting around where it was chained at the top edge of the bucket so that the forks now pointed downward along the sides of the tractor. The exhaust stack of the tractor was not damaged in this incident indicating that the loader had been high in the air and that the bale had missed striking the exhaust stack as it tumbled rearward toward the operator.

**Photo 2** – Re-enactment showing the equipment involved and the orientation and approximate height of the raised bale before the incident. Note the arrangement of remaining bales illustrating how they were stored.

**Discussion:** Snow and the slight slope were contributing factors to insufficient traction. The loss of traction was a critical indicator of insufficient tractor and/or ballast weight, and loading (downward force on the rear axle) which was too light even with fluid in the tires and axle weights installed. The center of the round bale load on the forks was well ahead of the front of the loader bucket resulting in leverage that amplified the light rear axle weight problem.

The safe operating practice of carrying front-end loader loads low has multiple advantages. It reduces the risk of overturning the tractor, which is also helped by wheels set as widely spaced as possible for the task to be performed. It also aids in preventing the inadvertent spilling of an unsecured, raised load into the operator's station due to shifting motions, control actuation, rough terrain, or otherwise.

**Discussion:** The storage location and his approach to retrieve stored bales, which was also influenced by the equipment selected for the task, led the farmer to back the tractor up a slight incline. That incline became very slippery due to normal winter weather conditions. Placing round bales intended for use during the winter where they can be easily and safely accessed and moved under a wide range of environmental conditions should be part of planning as the bales are being stacked in a storage location.
