Fatality Investigation Report

OR 2007-17-1

Highway worker crushed by swinging backhoe boom

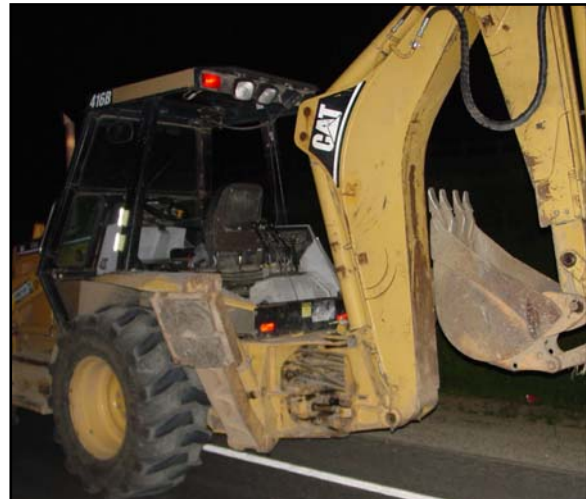
The construction worker was crushed at the pinch point on the backhoe between the rear boom arm and the raised stabilizer.

At the rear, the backhoe excavator arm was fully retracted and the stabilizer arms were not yet lowered into place. As the journeyman walked along the left side of the backhoe, he tossed one of the pin pullers and a large lag bolt onto the floor of the cab. The pin landed on the foot pedal that controlled the boom swing, and the boom instantly swung sideways and crushed the journeyman operator against the raised rear stabilizer.

Recommendation #1. Workers on the ground near an operating backhoe must never stand in the pinch point of the backhoe boom.

Stay away from an operating backhoe. A swinging backhoe boom is a common source of injury (see references for other state FACE reports of similar incidents). To avoid the hazard, the operator must always shut down the machine and secure the attachments before exiting the cab. Never put the machine in idle to exit. Workers on the ground must not approach within reach of a backhoe excavator or loader until they signal the operator to shut down the machine and receive acknowledgment from the operator. Backhoe operators must ensure that no one is on the ground within the working area of the machine.
