NJ FACE INVESTIGATION REPORT

FACE 08-NJ-012

Entrapment in an Intermodal Cargo-Container Spreader Kills Worker at Seaport Terminal

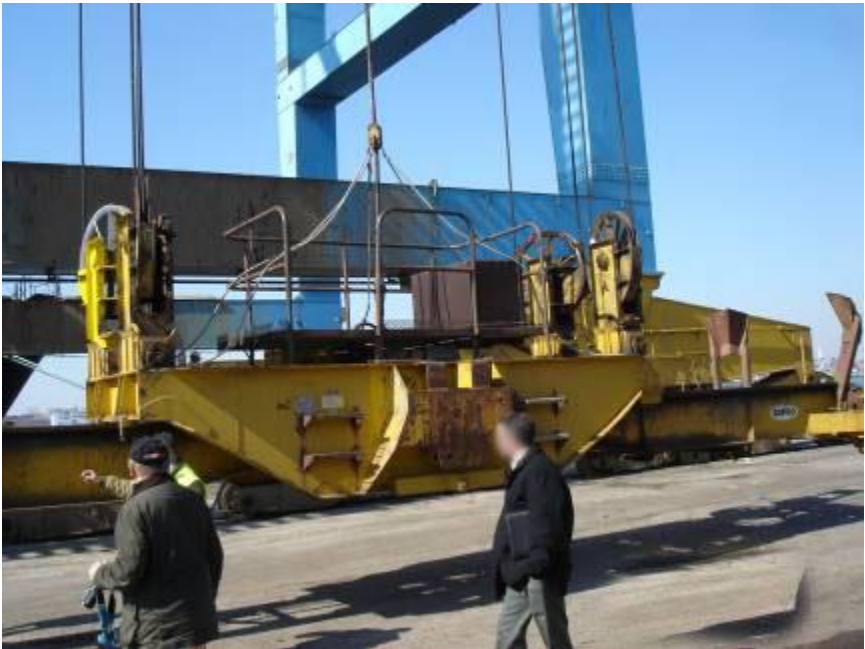
Figure 2 - The spreader involved in the incident lowered to the approximate height for lubrication of the guide rails.

The guide-rail lubrication procedure involved a crane operator lifting the spreader to approximately five feet above the ground so that the spreader was at “eye level” for the three employees stationed on the ground. The crane operator then opened and closed the spreader while the three other workers walked under the spreader and sprayed lubricant on the guide rails. When the telescoping sections of the spreader became stuck, the ground crew used hand signals to tell the crane operator to strike the spreader against the pavement in an attempt to knock the stuck section free.

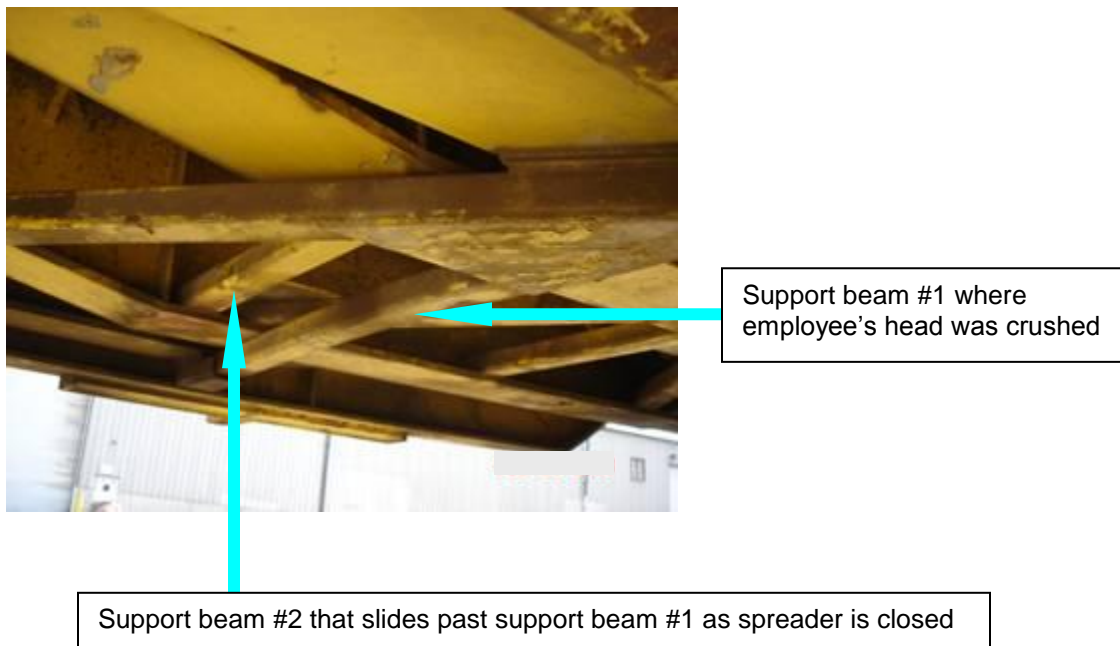
On the day of the incident, the decedent was spraying lubricant onto the guide rails when his head became positioned between two support beams under the two telescoping sections of the spreader. His head was crushed when the support beams slid past each other as the spreader was being closed (Figure 3).

Figure 3 - Entrapment point where employee’s head was crushed.

Recommendation #1: Lubrication procedures for intermodal cargo-container spreaders should be designed so that employees can perform this task without reaching into moving parts of the spreader. These procedures may require both specific tools and well designed work practices.

Discussion: Work practices for the lubrication of spreaders should be designed to eliminate any need for workers to reach into moving parts of the spreader. For example, in this incident the workers accessed the guide rail surfaces by standing under the spreader while it was freely suspended above the ground and reached upwards into the moving sections of the spreader to apply lubricant. This practice allowed for several potential hazards, including the possibility of the crane operator lowering the spreader onto an employee working underneath, the spreader falling onto the employee in the event of an uncontrolled release, and employees becoming entrapped within the spreader as they reach upwards. This procedure allows for employees to misjudge where they are in relation to the spreader because the height of the spreader above the ground varies each time the spreader is positioned for lubrication and because there is no immediate reference point for the employees working under the spreader.

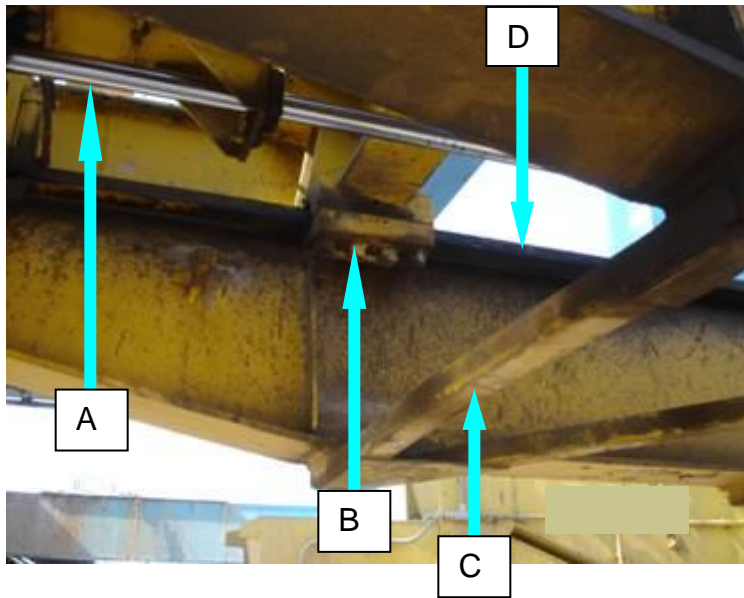
The guide rails of the telescoping sections slide through guide blocks in the middle section and allow the sections of the spreader to maintain alignment when being opened and closed. In addition, the telescoping sections of the spreader have structural support beams on the underside of the spreader (see Figure 4).

Figure 4 - Guide rails of the expandable section, which are lubricated, and the structural support beams on the underside of the spreader.

- A = hydraulic piston used to open and close telescoping sections of spreader
- B = guide block of center spreader section
- C = structural support beam
- D = top side of telescoping section guide rail

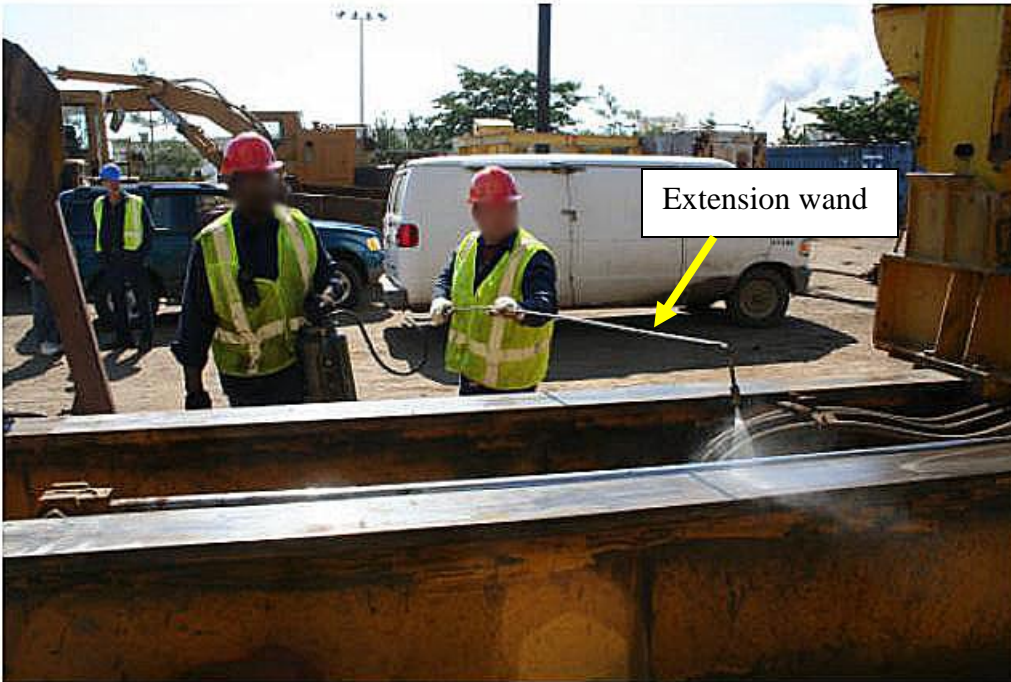
Figure 5. The use of extension wands for lubricant application.

Tools specifically designed to help workers apply lubricant without reaching into the spreader should be used. FACE investigators observed mechanics reaching into the spreader because they were using hand-held aerosol cans to apply lubricant. This could be prevented by using cans fitted with flexible extension wands to apply the lubricant, thereby precluding the possibility of workers positioning body parts between moving sections of the spreader (See Figure 5). In addition, other lubricant products that might not require as frequent applications or reaching into the spreader should be considered.
