FROM: Iowa FACE Case no. 2009 IA 037 Report date: 10 October 2012

SUBJECT: Farmer caught in compression rollers of hay baler

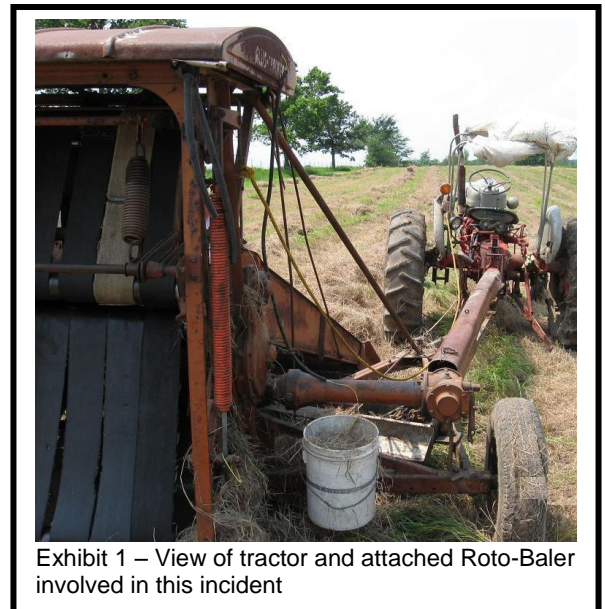
He was driving a Ford 901 PowerMaster pulling a PTO-driven small round baler (Roto-Baler) manufactured by Allis-Chalmers (Exhibit 1). Allis-Chalmers developed these balers in 1941 and they first came to the market in 1949 and were manufactured through 1974, with an estimated 74,500 units sold. This was a standard model manufactured pre-1970 (orange top, no "C" prefix on the serial number).

Exhibit 1 – View of tractor and attached Roto-Baler involved in this incident

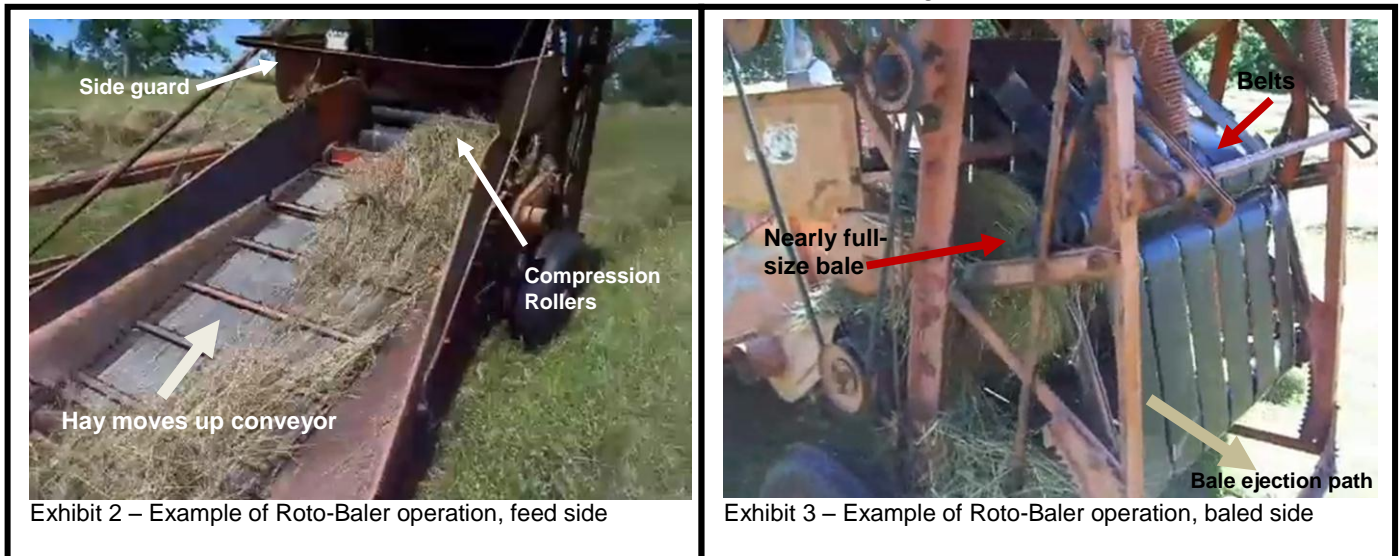
Operation of this baler requires a tractor connection via a PTO. The baler is offset behind the tractor, so the driver looks left to align the baler with the cut hay. As the baler moves through cut hay raked into windrows, forks at the front lip pull the hay up a conveyor belt (Exhibit 2) to a rotating bar that feeds the hay between two compression rollers. A belt and roller system on the back side rolls the hay into small round bales (Exhibit 3). When the bale is the right size, the stringing mechanism automatically engages at which point the operator typically stops the tractor while twine wraps around the spinning hay bale. The bale is then automatically ejected from the back of the baler and the tractor and baler move forward again.

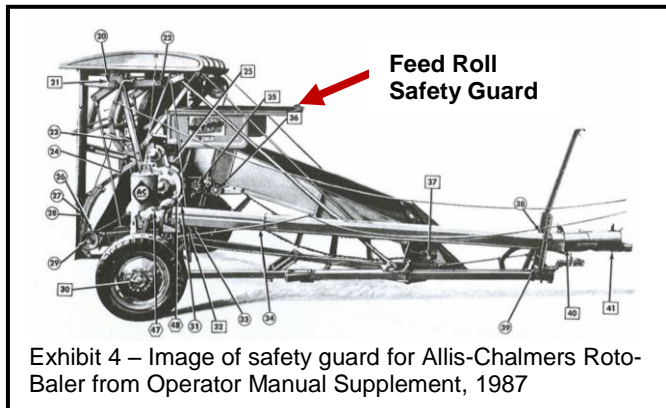
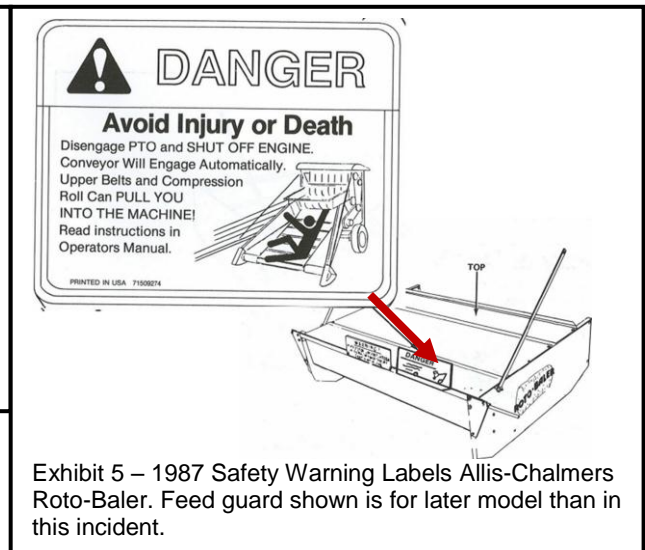
The morning of the incident, the farmer left for the field once the dew had burned off. A neighbor saw him riding the tractor at 11:45 AM. At some point between 11:45 AM and 12:30 PM, the farmer stopped the tractor (leaving it running), walked back to the back, left side of the baler, and got his hands pulled into the compression rollers at the top of the conveyor. This action pulled in his arms nearly to the elbow. As the rollers drew the victim into the baler, it pulled him into the sidewall of the conveyor, compressing and crushing his chest.

The Roto-Baler was missing a feed roll safety guard that would prevent reaching over the sidewall of the conveyor and directly accessing the in-running nip point at the compression roller (Exhibit 4). The 1987 Operators Manual Supplement (from Deutz-Allis Corporation) for the Roto-Baler also indicates the placement of a warning label that reminds farmers to disengage the PTO and shut off the engine (Exhibit 5). This manual can be located and purchased through AGCO Technical Publications (<http://www.agcopubs.com/>, part 71509280). The company's interests in farm equipment manufacturing were sold to Deutz-Fahr in 1985, and the company was renamed Deutz-Allis. In 1986, letters from this newly named company were sent to Deutz-

Manufacturers may have installed original or retrofitted safety equipment to reduce the likelihood of injury or fatality on a piece of mechanical equipment, but used equipment may have had these devices removed by previous owners or may have not been retrofitted with updated guards or labels. Consult manufacturers, farm equipment suppliers, or the internet to locate manuals. If manuals cannot be found, identify in-running nip points and other hazardous motions and actions for the equipment (Recommendation 2) and examine similar equipment from other manufacturers to determine how they guarded similar hazards. (Note: the supplemental manual for Allis-Chalmers Roto-Balers is available at the following AGCO site: http://www.agcopubs.com/operator_manual/english/71509280/roto_baler_supplement_english_refer_to_detail_in_thumbnail_.)
