Orchard Laborer Dies after Being Struck and Run Over by Dump Trailer

Investigation: # 09WA04401
Release Date: June 30, 2015
SHARP Report: # 52-34-2015

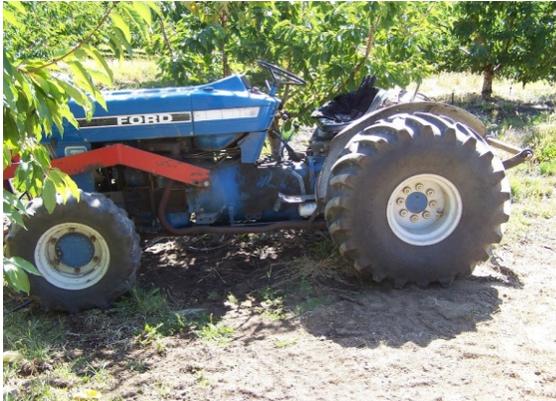
The tractor was a mid-1980s low profile Ford, model number 3910 which had been purchased used. The tractor had been previously used to tow the trailer involved in the incident. The trailer was a 1988 Cart-Away 2-axle construction dump trailer equipped

Photo 1. Ford model tractor that was involved in incident

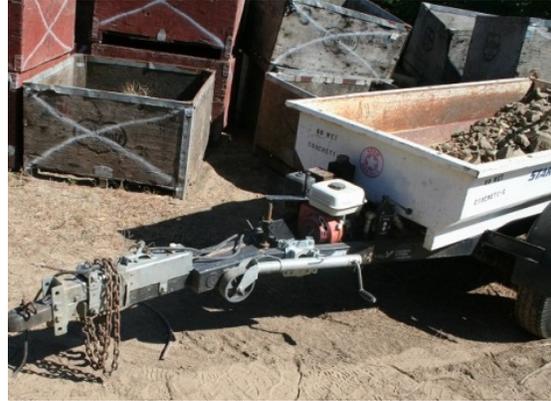
with surge brakes and a safety break away cable actuated brake. It was purchased by the employer from a rental company two years before the incident, but did not include the safety manual.

Photo 2. Construction dump trailer involved in incident

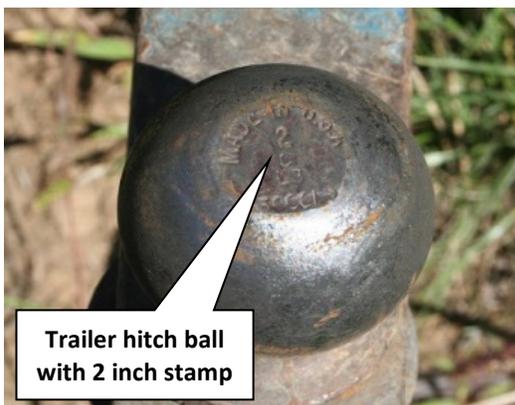
At the time of the incident the tractor had a 2 inch trailer hitch ball mounted on the bumper pull hitch while the trailer coupler was $2^{5/16}$ inch. This was the only orchard dump trailer with a coupler that required a $2^{5/16}$ inch trailer hitch; all other trailers required a 2 inch trailer hitch ball. The trailer was used on an as needed basis for the orchard approximately 2 – 3 times per year. According to the employer, the trailer most likely would not have come unhitched if the tractor was pulling it on level ground, as the difference in the ball sizes was only 5/16th of an inch.

Photo 3. The 2 inch trailer hitch ball that was mounted on the bumper pull hitch and connected to the trailer coupler

Prior to purchasing the Cart-Away trailer, all of the employer's trailers required a 2 inch trailer hitch ball. However, the Cart-Away trailer required a 2^{5/16} inch trailer hitch ball. The coupler being 5/16 of an inch larger than the hitch ball created a situation where the coupler did not stay securely latched. Trailer hitch balls and trailer tongues are stamped with the size of the connection needed, but these can be difficult to see.

- Matching trailer hitch balls and trailer couplers by size with the same color paint.
- Keep the correct size trailer hitch ball in each trailer and install when using.
- Put clear and evident labels on each trailer indicating the size of the trailer hitch required.

Following the incident the employer painted the 2^{5/16} trailer ball a different color to help alert workers of the size difference.

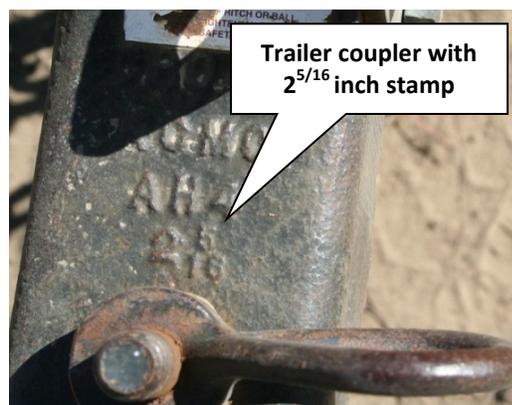
The tractor was equipped with a bumper pull hitch. This allows the trailer hitch ball to be changed without unhooking it from the tractor. It also allows multiple trailer hitch balls to be connected at one time. The orchard kept all trailer hitches in one location. The trailer was equipped with a coupler that used a screw type latching mechanism to secure the coupler to a hitch ball. The coupler was a fixed size and not interchangeable.

Photo 4. Trailer coupler and screw used to tighten to trailer hitch ball

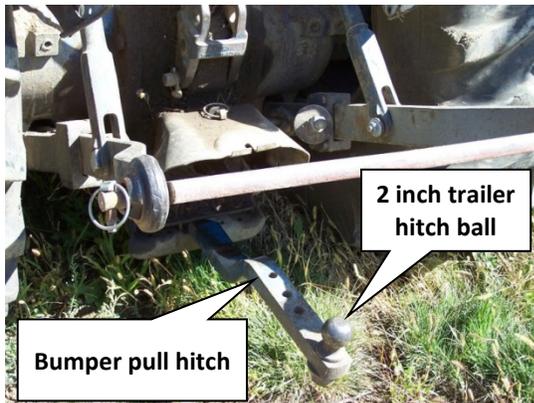
Photo 5. Back of tractor involved in incident, showing the bumper hitch and the attached 2 inch trailer hitch ball

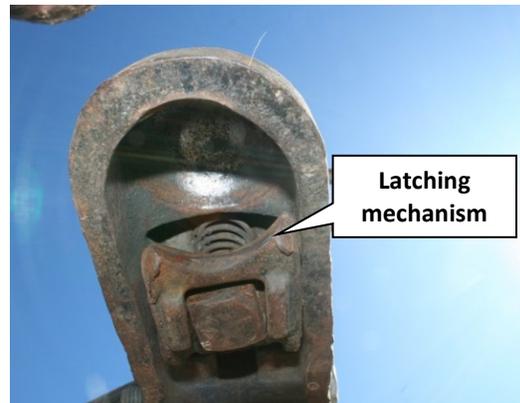
Photo 6. Inside of 2^{5/16} inch trailer coupler showing latching mechanism and screw used to secure coupler to trailer hitch ball

The tractor operator reported that he connected the trailer to the tractor and tightened the screw that clamps the coupler securely to the ball even though the trailer hitch ball was not the correct size for the trailer coupler. None of the workers checked that the trailer coupler was fully secured by attempting to lift the trailer tongue from the trailer hitch ball.

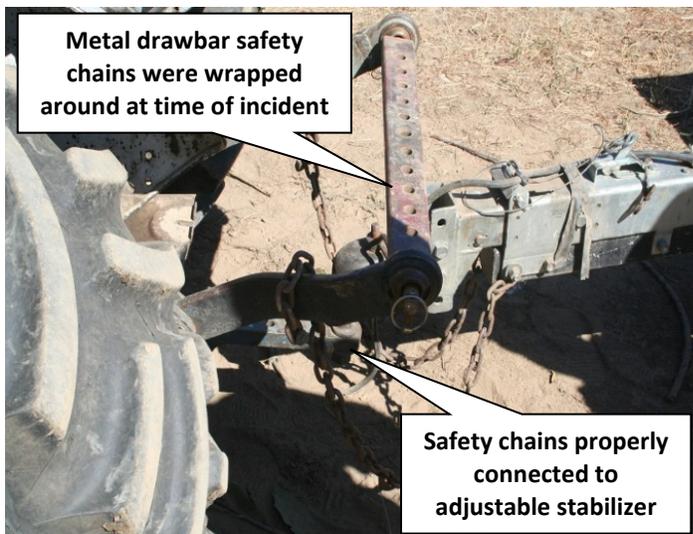
Safety chains are intended to prevent the trailer from detaching from the tractor if the trailer becomes unhitched from the hitch. The orchard's standard operating procedure (SOP) was to wrap the safety chains around the adjustable stabilizer arms and then slip-fit the hook on the end of the safety chains into the links (photo 7).

Photo 7. Example of employer's procedure for properly connecting safety chains to stabilizer arms, not the metal drawbar.

The tractor operator and machinery operator said that they usually hooked the safety chains over the metal drawbar instead of wrapping them around the stabilizer arms and connecting the hook into a chain link. Witnesses agreed, reporting that the tractor operator and a co-worker slid the safety chain hooks over the metal drawbar instead of wrapping them around the stabilizer arms and hooking the ends. This practice created an unsafe condition because the drawbar is capable of fully rotating forwards and backwards. The drawbar may have rotated allowing the chains to detach and the trailer to separate from the tractor and roll down the steep orchard road. It was also noted that the trailer surge brakes and safety break away cable were either not connected or not functioning and consequently could not stop the unhitched trailer.

This employer did have an SOP for connecting safety chains but it was not followed. To ensure that tractor operators and other designated workers follow SOPs and properly connect safety chains or other safety systems, employers should use checklists or similar tools to consistently monitor and enforce policies. Examples of procedures for a checklist should include but not be limited to the following

- Properly connecting the safety chains to a secure location on the implement hitch and tractor, leaving only enough slack for articulation.

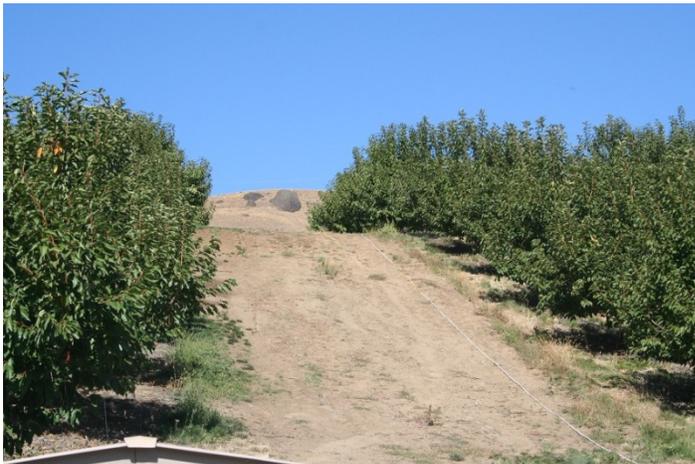
The orchard road where the incident occurred was made up of packed ground and had a steep incline. According to the police report, the weather was warm, clear, and dry. The employer did not believe any environmental issues were a factor in the incident.

Photo 8. View looking up the orchard road showing approximate where the trailer became unhitched from the tractor.

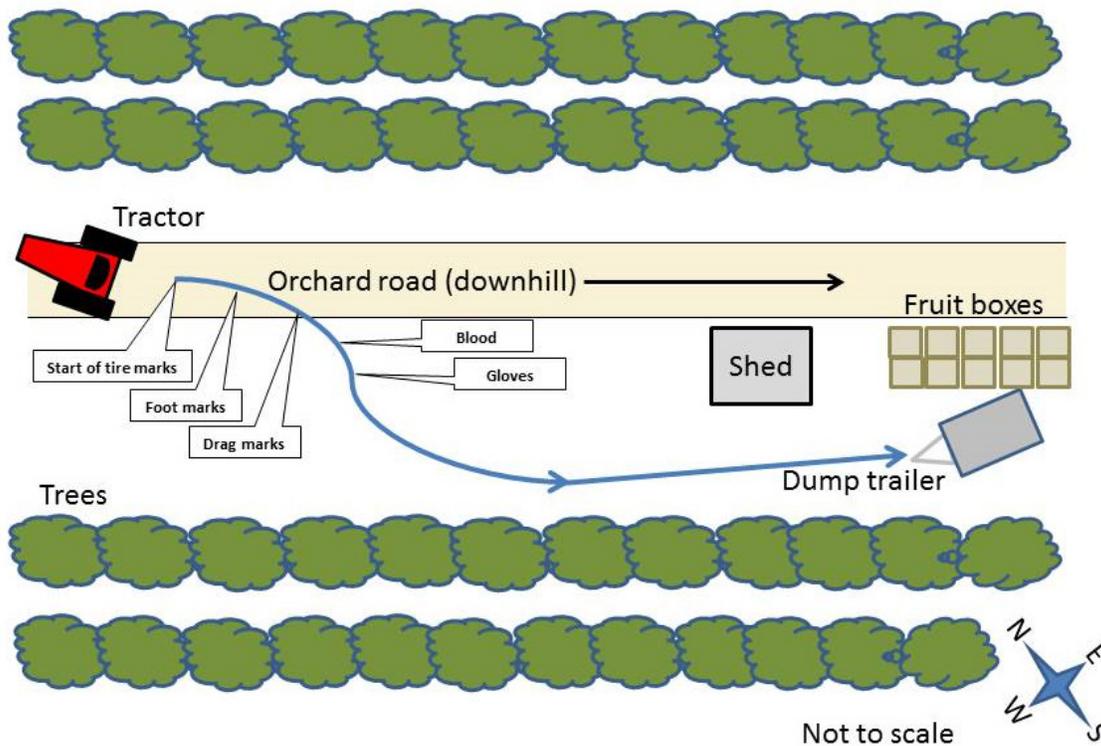
The tractor operator was towing the partially full dump trailer up the side of a steep orchard road with the intention of turning the tractor and trailer around. Near the top of the slope, the tractor started to lose traction and the trailer began to hop. The hopping caused the trailer coupler to dislodge from the trailer hitch ball. The victim, who was bent over behind the trailer picking up rocks, was struck and knocked to the ground by the runaway trailer. The trailer then dragged him approximately 20 feet.

Figure 1. Diagram based on sketch by police officer who responded to call, showing the path the trailer took after becoming unhitched from the tractor.
