Carpet Installer Dies after Falling 32 Feet at a Commercial Jobsite

Investigation: #09WA05101
Release Date: January 25, 2012
SHARP Report: # 52-23-2012

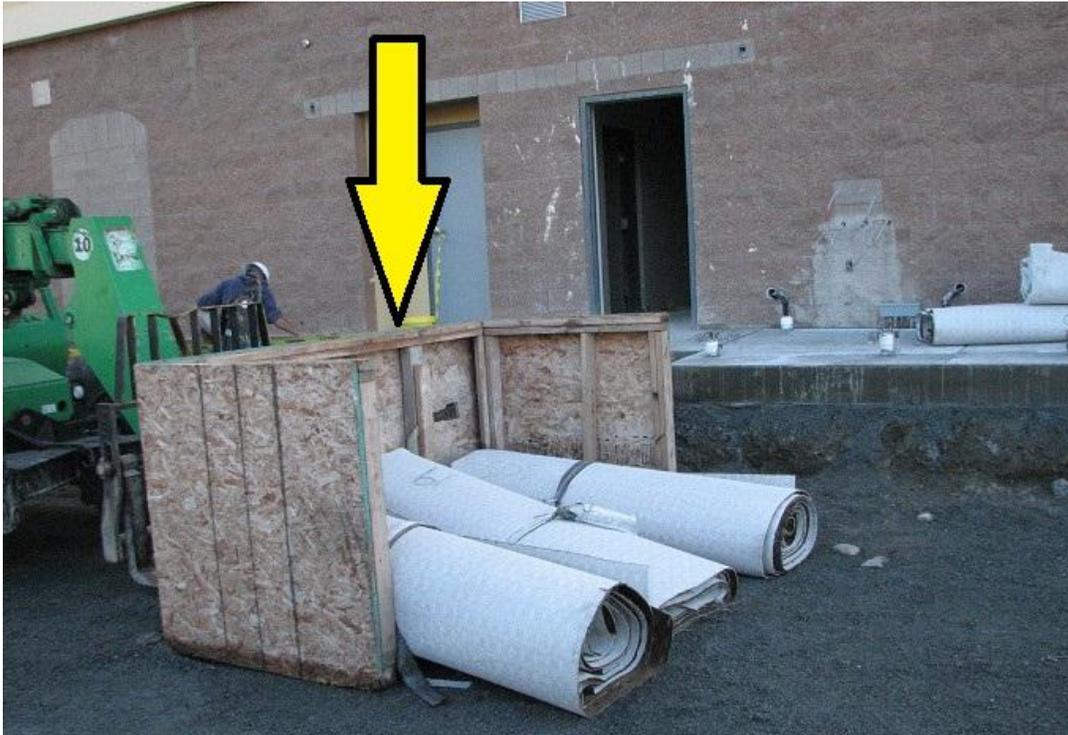
Photo 1: Three-sided skip box used to elevate carpet rolls to window

The carpet sections were approximately 12 feet long and weighed between 80–100 pounds. To load the carpet sections into the skip box, they were folded in half and then rolled up. This was referred to as ‘burritoing’ the carpet (photo 1) by the employer of the victim. The carpet rolls had an approximate diameter of 2 feet. Six rolls of carpet were loaded into the skip box.

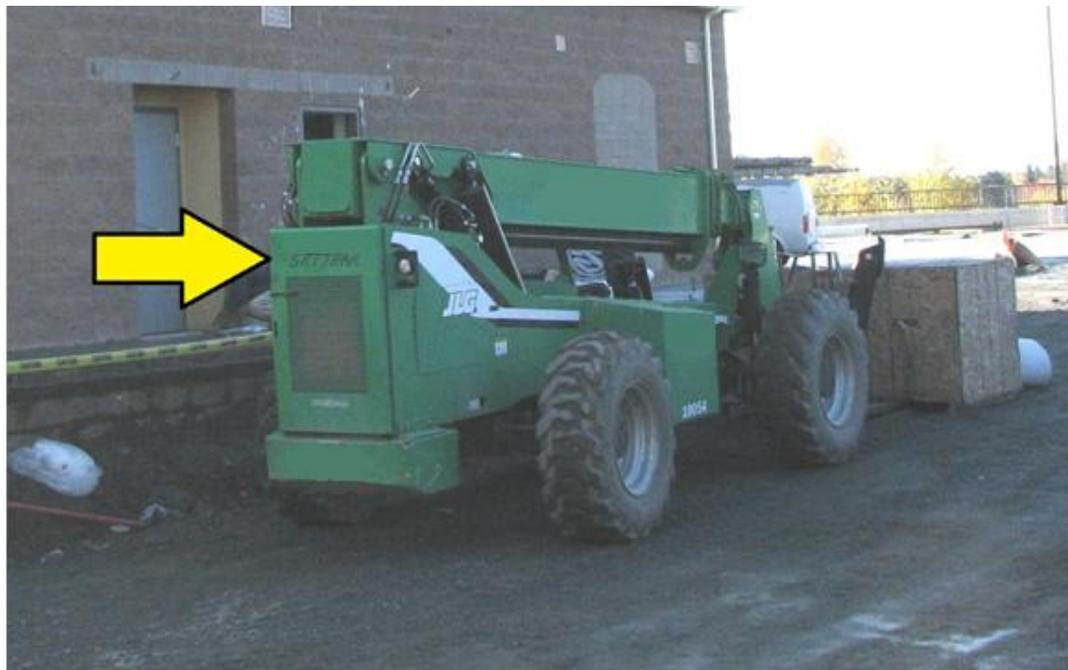
Photo 2: Telehandler used to raise the skip box

The variable reach forklift was a JLG Skytrack Telehandler model number 10054 (photo 2), a specific type of powered industrial truck (PIT), and was rented and operated by the general contractor. This telehandler had a carrying capacity of 10,000 pounds and a maximum lift height of 53 feet and 2 inches (16.21 meters). The three-sided skip box measured 4 feet high by 8 feet wide and 4 feet deep. It was believed that the skip box was built onsite. The carpet rolls extended outside the edge of the skip box by approximately 30 inches. According to the employer of the victim, this is a common method for delivering carpet rolls to the upper levels of construction sites when elevators are not allowed to be used.

On November 12, 2009 the two carpet installers arrived on the jobsite between 8:30–9:00 AM. They had been working on this site for approximately two weeks. Prior to elevating the carpet, one of the installers worked with the operator of the telehandler to load the carpet rolls into the skip box (photo 1). The carpet rolls were loaded into the box by laying them down flat on the floor with approximately 30 inches of the carpet roll protruding from the box (figure 1). The skip box was then elevated to the fourth floor unfinished window by the telehandler (photo 2).

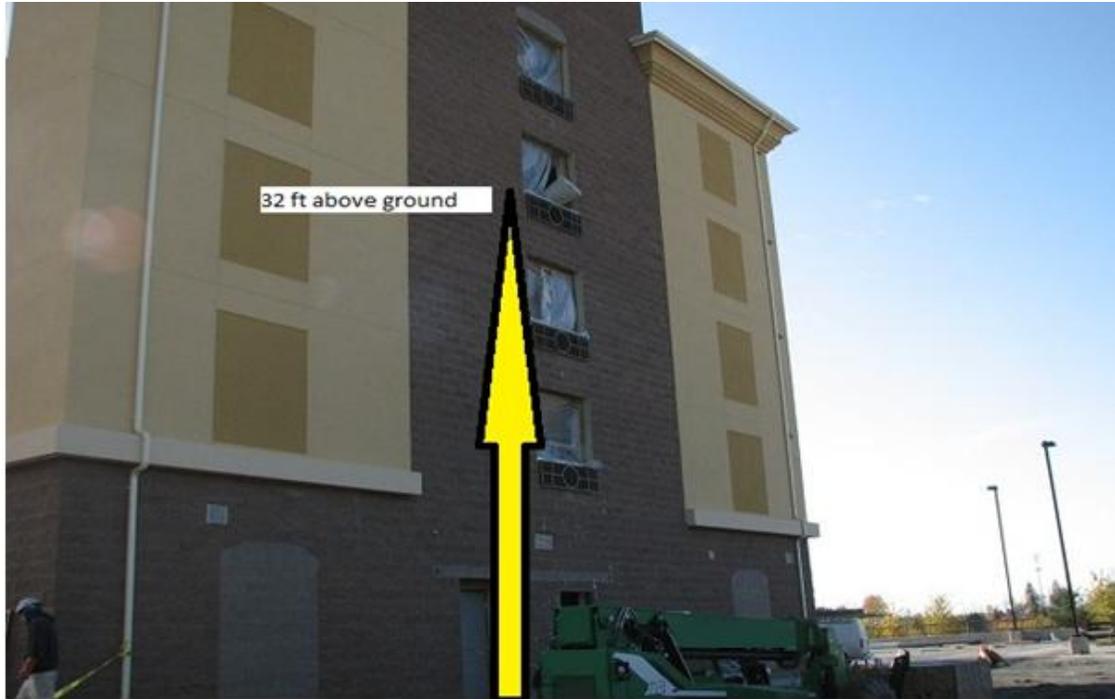
Photo 3: Incident site showing window opening from which victim fell

The unfinished window through which the carpet rolls were to be loaded into the building measured 58 inches wide by 64 inches high and had a sill height of 26 inches (photo 3 and 4). The window was approximately 32 feet from the ground. The protective guardrail that was fitted over the window was 42 inches high (photo 6). There were no warning signs, placards, or anchor points located near the window. The guardrail had no lock or means of securing it and could be removed by anyone (photo 5).

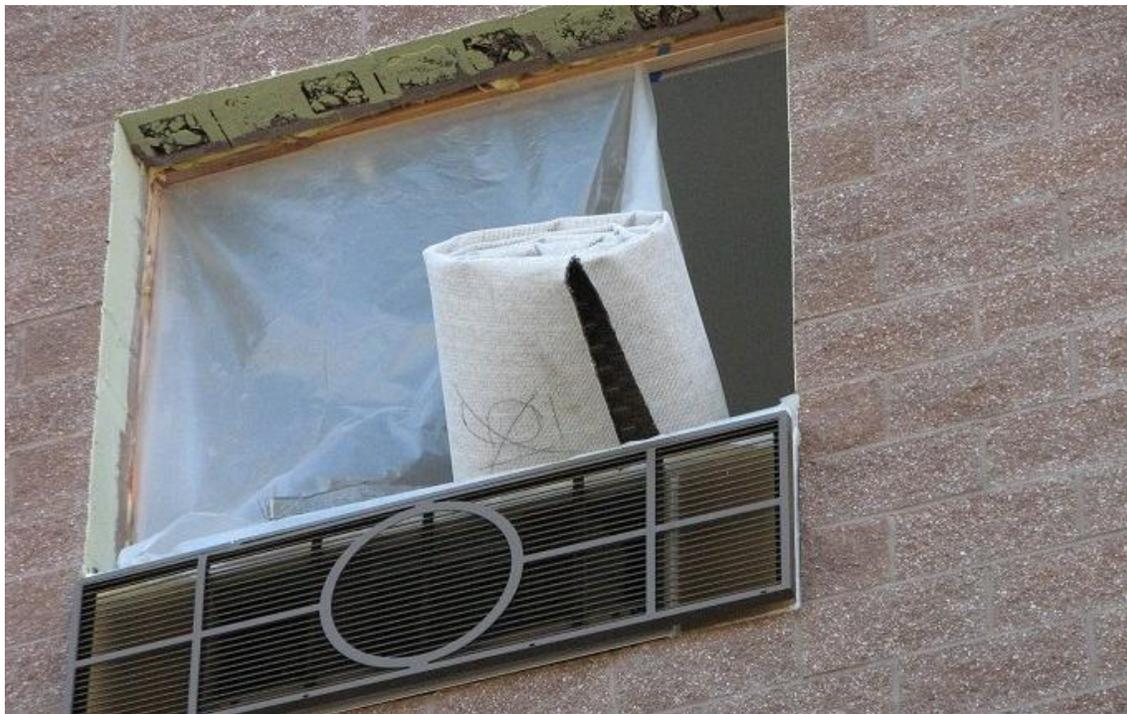
Photo 4: Close-up of window victim fell from

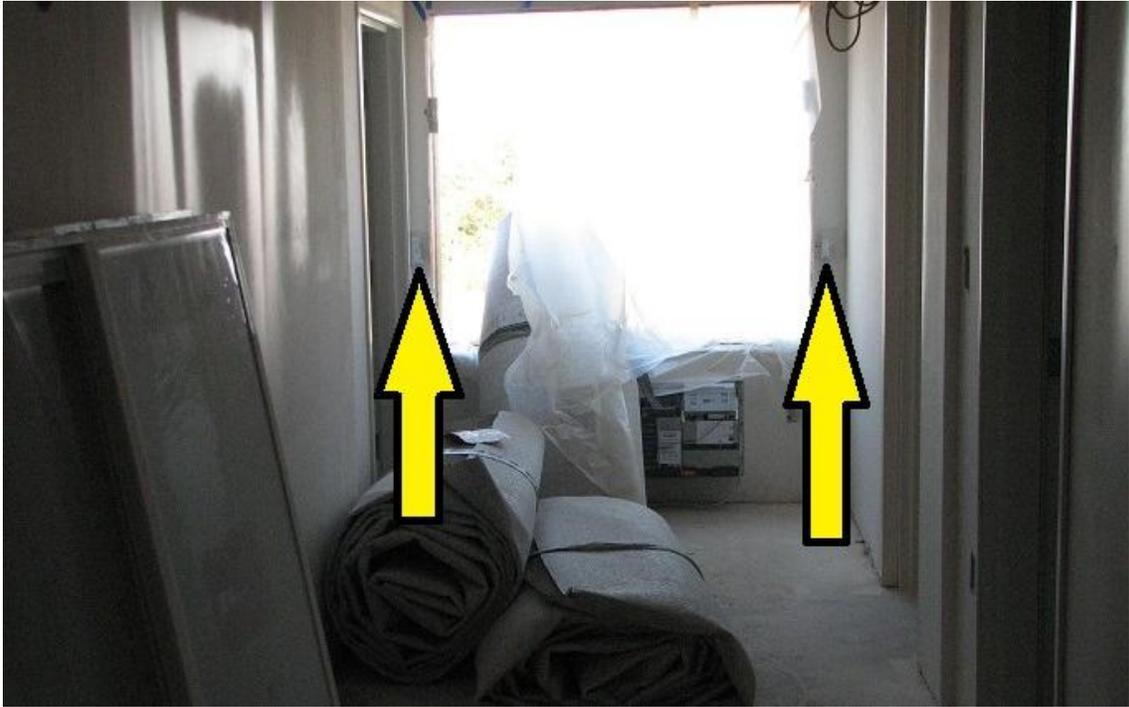
Photo 5: View of window opening from inside building with arrows pointing to brackets that held up guardrail

Due to the size of the carpet rolls, the victim needed to remove the guardrail from the window in order to move the carpet rolls into the building. Removal of the guardrail in combination with the distance between the edge of the skip box and the window created a serious fall hazard. Without a lock or other means of securing the guardrail, workers could remove it from the window, exposing others to a fall hazard. A secure guardrail system will help prevent workers from creating a fall hazard for themselves or others.

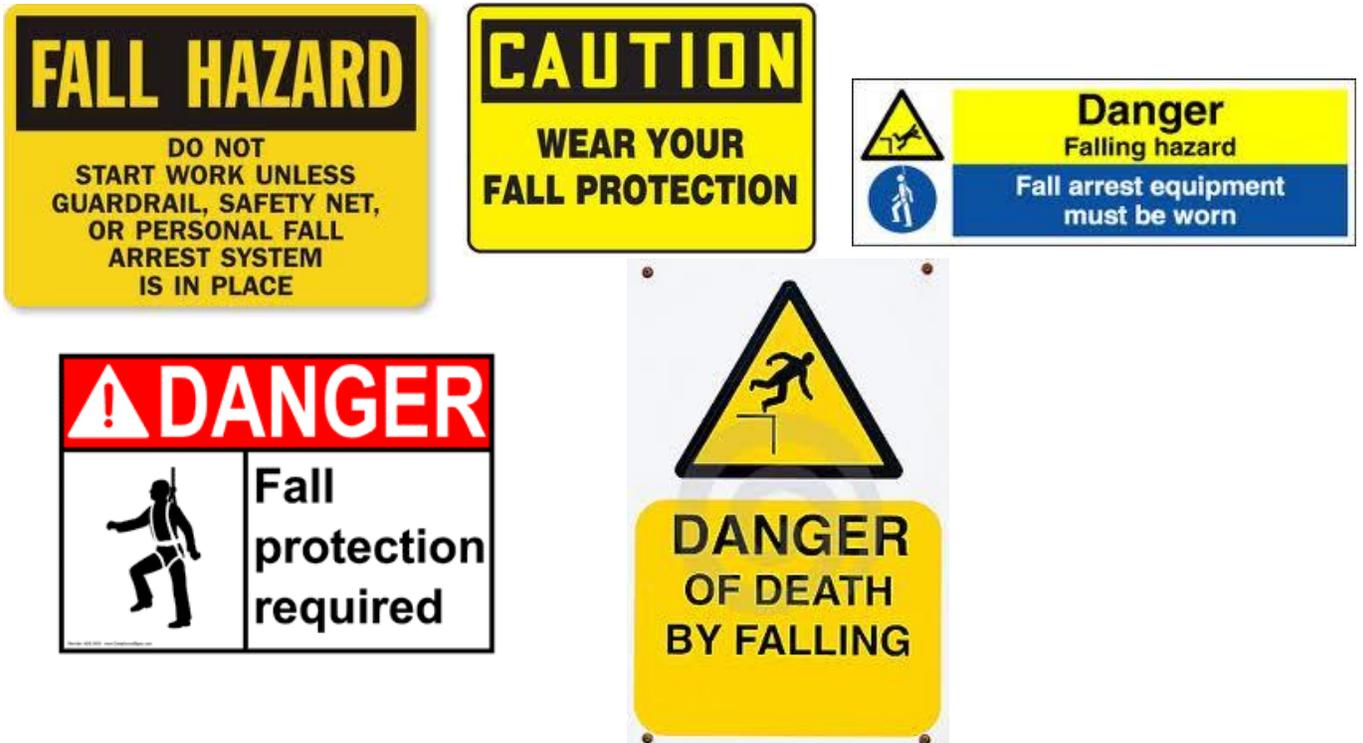
Photo 6: Examples of fall hazard warning signs

Despite the use of a telehandler to raise carpet and other materials to upper level unfinished windows, there were no signs or placards reminding workers of fall hazards and to keep their body inside the building. The use of signs provides a visual reminder of fall hazards and for workers to use fall protection⁵ (photo 6).

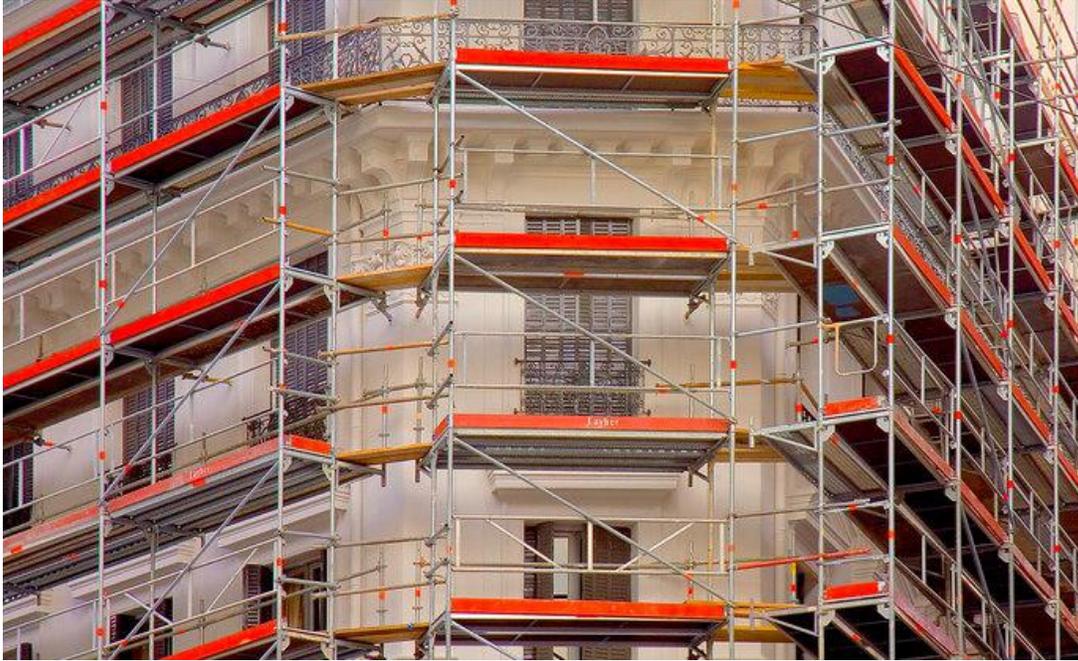
Photo 7: Example of scaffolding platform

The use of scaffold platforms (photo 7) equipped with guardrails and toe boards for unloading materials is another method to reduce fall hazards⁵. By providing workers with a larger guarded surface area to stand on while moving materials, scaffold platforms reduce fall hazards. Scaffold platforms also eliminate the fall hazard gap created by using the three-sided skip box. Common types of scaffolding are wood pole scaffolding, tube and coupler scaffolding, and tubular welded frame scaffolding. For more information on rules regarding scaffolding in Washington State, see [WAC 296-874](#)⁶.

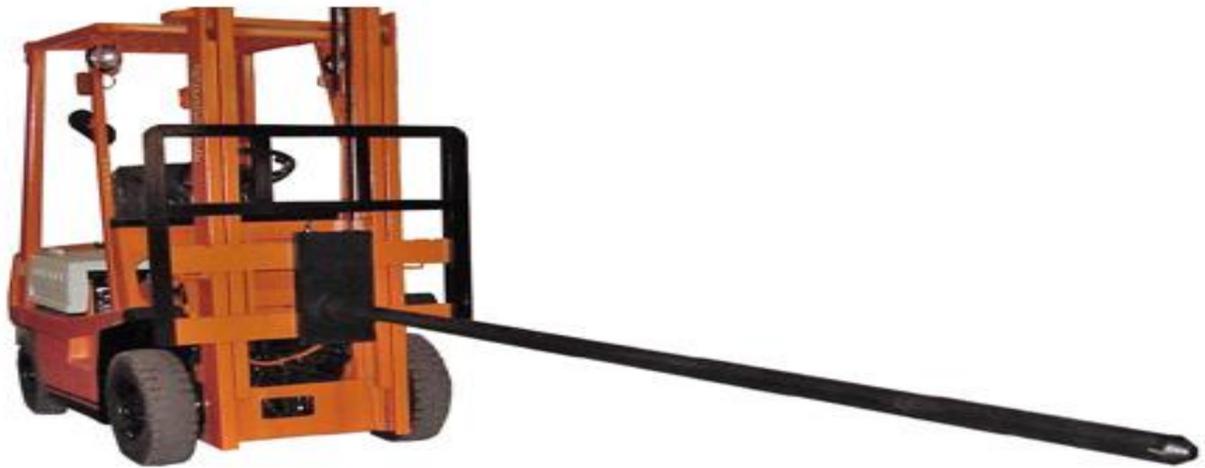
Photo 8: Picture of rug ram on a forklift

The distance between the window ledge and the skip box holding the rolls of carpet was approximately 30 inches due to the carpet roll overhang. This hazard could have been avoided with the use of carpet poles or rug rams (photo 8). Carpet poles or rug rams,

commonly referred to as a “stinger” according to the employer, allow for the carpet rolls to be elevated and placed inside the window, preventing a worker from having to reach outside the window and eliminating the fall hazard. Stingers are available in various sizes and weight capacities and can be carriage or fork mounted onto a variety of powered industrial trucks.

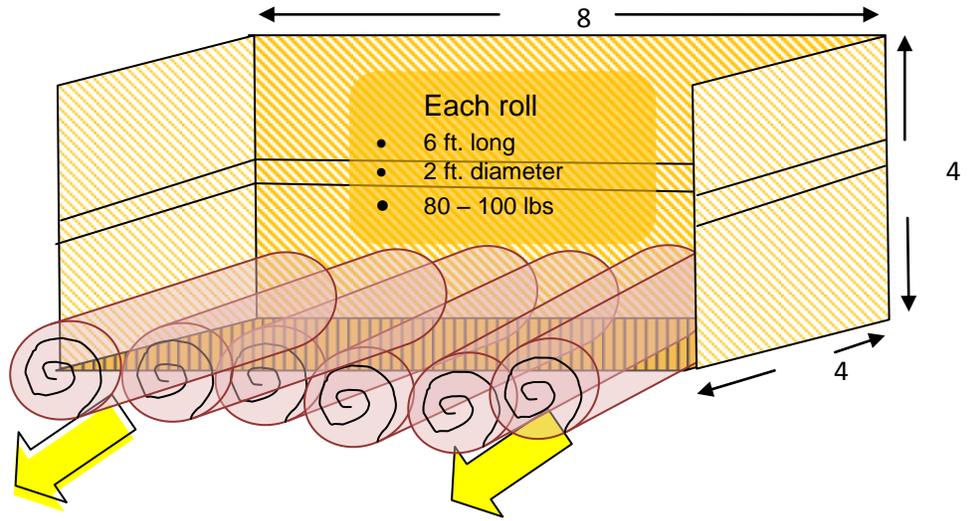
Figure 1: Diagram of the carpet rolls loaded lying down in skip box

According to the employer, this is not the preferred or typical method of loading the carpet rolls into a skip box. The employer said that the preferred method is to stand the carpet rolls upright (figure 2) so a worker can reach out and grab the top of a carpet roll and have it fall into the window opening. The reason the installers positioned the carpet rolls flat in the skip box is unknown.

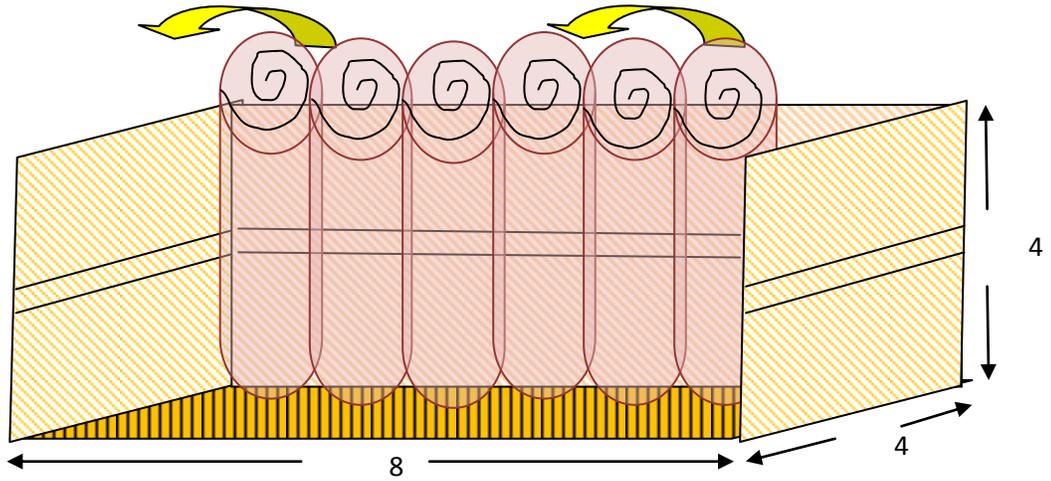
Figure 2: Diagram of the recommended way to load carpet rolls into skip box

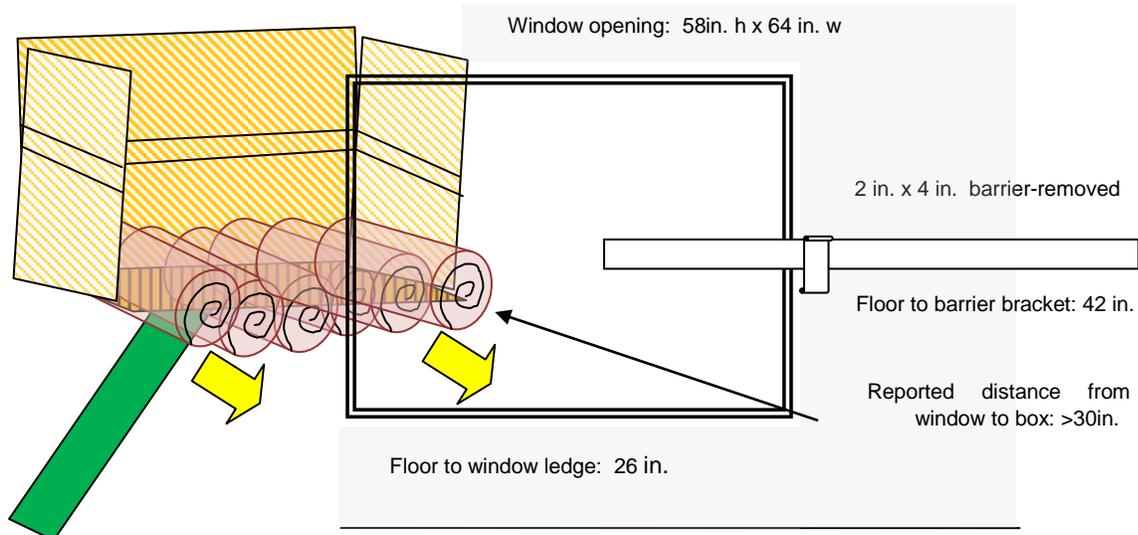
Box elevated 32ft. to 4th floor window using
SkyTrak Telehandler model # 10054

Figure 3: Diagram of the view from inside window when unloading the carpet rolls
