FROM: Iowa FACE Case No. 2010 IA 054 Report Date: 10 October 2012

SUBJECT: Construction laborer fell from ladder

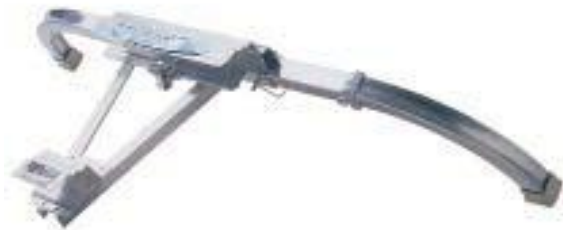
Exhibit 2. Examples of ladder stabilizers

approximately 3 feet beyond the roof eaves. The ANSI duty rating of the ladder was not known. A stabilizer bar (Exhibit 2) was affixed to the upper section of the ladder with pins and clips. A nylon tie-down strap (Exhibit 3) attached to the stabilizer bar was screwed onto the roof deck to secure the top of the ladder in position. The type and size of the tie-down strap and the screw used to secure the strap to the roof was not known. The bottom of the cleated ladder rested on dry level ground of earth and gravel, but was not staked to the ground or secured to a permanent fixture.

Neither the owner nor the coworker witnessed the helper fall, but the owner noted that in the course of the fall, the nylon tie-down strap broke and that one end of the strap still remained screwed to the roof deck. The stabilizer bar had come free of the ladder. There were grooves in the earth approximately one-half inch deep and several inches long where the ladder cleats slid sideways. The ladder itself was not found to be faulty. The owner suspected the victim lost his balance as he put the tarp on the roof or shortly thereafter and may have tried to jump to the elevated area next to the foundation retaining wall. No information was available regarding the victim's footwear or whether his footwear played a part in the fall.

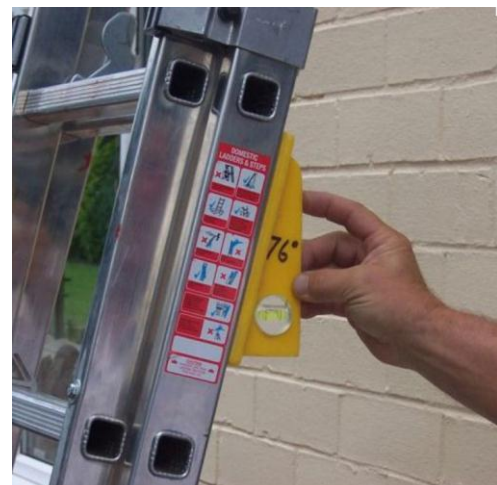
Exhibit 4. Proper height-to-base ratio and ladder angle to set up portable extension ladders

Non-self-supporting ladders leaned against a wall or other support should be positioned at an angle such that the horizontal distance from the support to the base of the ladder is one-quarter the distance of the vertical height of the ladder (i.e., the angle of the ladder should be about 75° to horizontal, Exhibit 4). If the ladder is too close to the building (too steep an angle) the ladder may tip backward; if it is too far from the building, the ladder may be put under greater stress than it was intended to handle, and ladder may slip out at the bottom.
