# MIFACE INVESTIGATION REPORT: #10MI067

## Subject: Volunteer Mowing Grass Pinned by Overturned Tractor

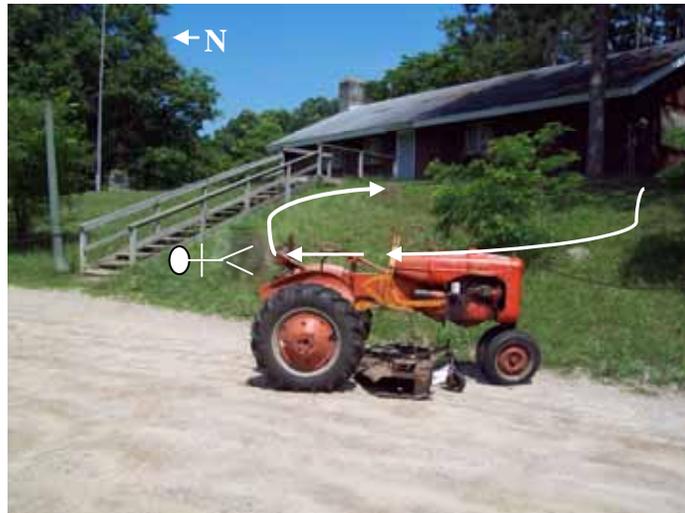
Figure 1. Overview of incident scene showing mowing path and position of decedent on hill. Tractor had been removed from decedent by emergency response.

In the Summer of 2010, a male volunteer in his 70s was killed while mowing grass for a youth organization's camp using a tricycle-type Allis Chalmers Model L59AC farm tractor, retrofitted with an after-market, home-installed underbelly power rotary mower attachment. The tractor overturned to the side on an approximately 30-degree hill and pinned him beneath it. The tractor was not equipped with a rollover protection structure (ROPS) and seat belt (Figure 1). The decedent had mowed the property for over 30 years. The following scenario has been

The decedent was found face down on the side of the hill with the tractor seat pinning his right shoulder blade to the ground. His head was pointed in a northern direction and the nose of the tractor was pointed in a southeastern direction (tractor direction as shown in Figure 1). Emergency response arrived and rendered aid. The decedent was declared dead at the scene.

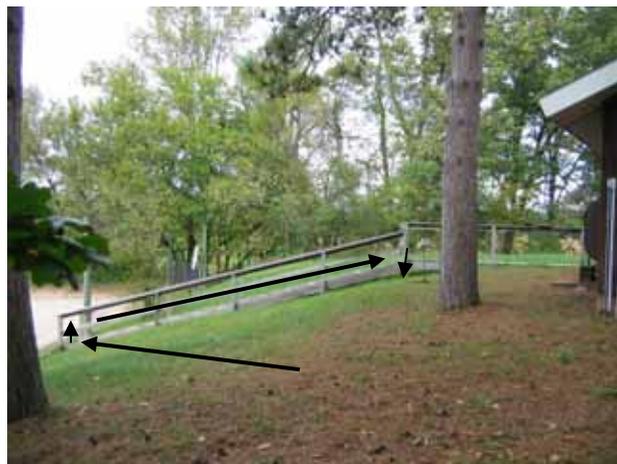
Figure 2. At top of hill, facing north looking through two trees near the building.

The camp was located at the end of a road on the east side of a cul-de-sac. The camp building was five feet away from the nearest tree. There was 16 feet 6 inches between the two trees shown in Figure 2. The ground was fairly level approximately 16 feet from the building and then the slope of the hill commenced. The hill undulates and there was a knoll approximately 10 to 12 feet from the edge of the road. The decedent had mowed this property for over 30 years.

Using the police photos indicating the pattern of the mowed grass, the following scenario has been developed. The decedent arrived at the camp and drove the tractor to the top of the hill behind the building. Starting from the top of the hill, he drove the tractor downhill between the two trees and then turned north toward the bottom stairs leading to the building. He then ascended the 30-degree hill and as he was turning the tractor southbound at the top of the hill, the outside wheel lost its traction and the tractor overturned to the side (Figure 2). His tractor, according to his family members was in first gear. His tractor speed was unknown.

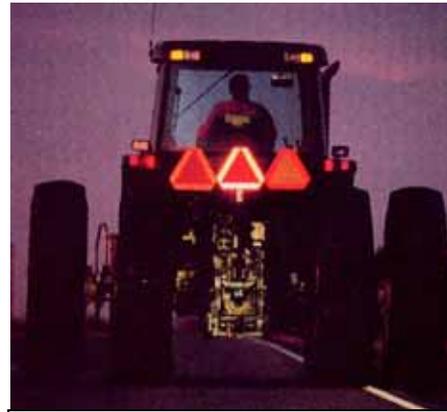
Figure 5. Center SMV emblem equipped with ASAE 276.6 recommendations

The new SMV emblems have fluorescent material aiding daytime visibility and reflective material aiding nighttime visibility (Figure 5). Replacing worn SMV emblems is important because the orange fluorescent center portion of the SMV emblem fades and turns color over time, changing from orange to yellow, pink or white. This portion is the most vulnerable to light and moisture degradation because fluorescent dyes decompose.

Retro-reflective material as found in the outer border of the SMV emblem reflects the headlights of vehicles approaching from the rear at night. Retro-reflective material holds up longer than fluorescent material. The retro-reflective readings on SMV emblems meeting the new ASAE standard are over ten times greater than most of the readings on SMV emblems currently in use. Figure shows a comparison of older and newer SMV emblems. The SMV on the left is a new sign under the old standard, the SMV in the middle is a new sign under the new standard, and the SMV on the right is an old sign under the old standard.
