# MIFACE Investigation Report: #10MI082

## Subject: Worker Crushed Under Car That Dislodged from Tow Straps

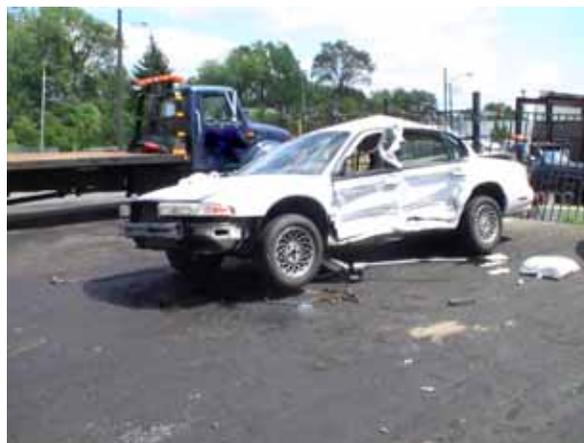
Figure 1. Incident scene showing car, hydraulic jack and chains on ground.

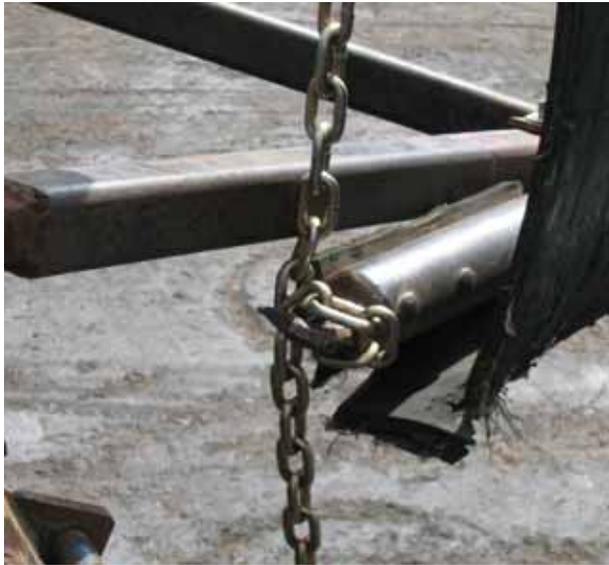
Figure 2. Wrapped tow chain on tow sling anchor bar grab hook.

The owner indicated he instructed the operators to secure the car for towing as follows (Figures 2-4):

- Extend the boom and lower and position the tow sling against the vehicle.
- Place the “J” hook on the axle or frame of the vehicle.
- Wrap tow chain (not just placed) on the tow sling anchor bar grab hook.
- Wrap the tow chain on the lifter bar’s grab hook.
- Feed the tow chain through the “O” ring on the tow mast.
- Hook tow chain from the tow bed to the vehicle.
- Activate winch hydraulic lift to lift the vehicle from the ground.

The company owner correctly instructed employees to use two tow chains secured to the towed vehicle, but he was incorrect as to how to secure the tow chains to the tow truck itself. He correctly trained his employees to wrap the tow chain around the lower grab bar. He was incorrect in instructing them to loop the end of the chain through the “O” ring on the tow mast. The ends of each tow chain should be attached to the tow truck at a sturdy point, such as a D-ring or T-slot on the truck frame, not to the tow mast. Figure 11 shows the tow chain hooked tightly into the anchor bar grab. Next the chain is wrapped around behind and to the inside by the rubber tow strap. In the third picture, the right side of the chain should be attached to the towed vehicle and the left end of the chain should be attached to the truck frame.

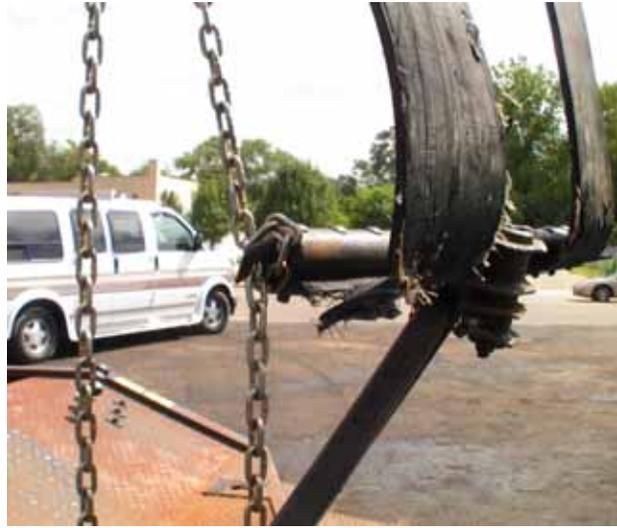
Figure 3. Wrapped tow chain on lifter bar grab hook

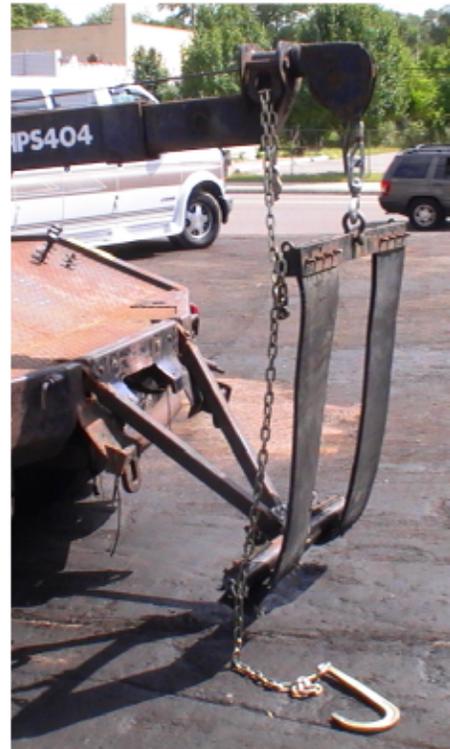
Figure 4. Completed tow chain securement to tow truck after chain fed through “O” ring on tow mast

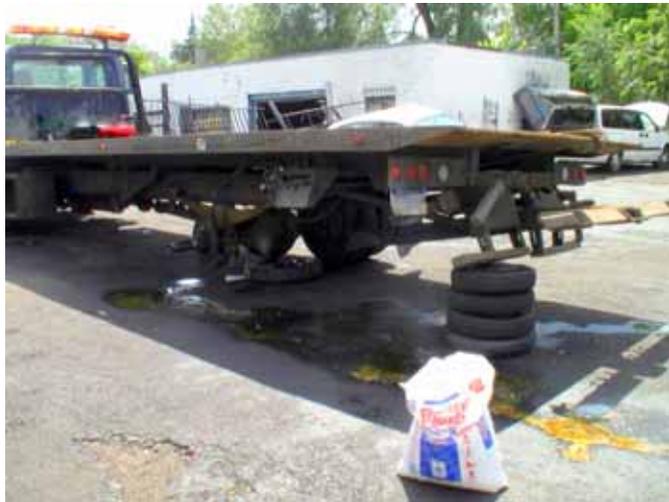
Safety stands having a yield point of not less than 1 ½ times its rated capacity were not used to support a vehicle when an employee placed his or her body under the vehicle. Inadequate support means, employees using tires and rims to support under carriage while tires are removed from the vehicle, flat bed truck (Figure 5) (for transporting vehicles).

Figure 5. Tires used as improper primary support

Secondary supports, such as an additional set of safety stands or wooden blocking should be used. The wood should be in good condition, free of rot, cracks, etc. The employees, it appears, did not routinely use appropriate secondary supports, although they were available (Figure 5 and Figure 10).

Although the company indicated that the decedent had been trained, and again reminded of the need to use the “J” hook tow chains, there was no documentation made by the employer of either event. At the time of the MIOSHA site visit, at least two vehicles on the worksite had tires with rims being used as primary (Figure 5) and secondary (Figure 10) supports, in contradiction to MIOSHA standards and stated employer training. Enforcement of the correct procedures was not taking place, in contradiction to employer statements for correcting unsafe work practices.

MIFACE recommends that the employer re-instruct the workers and shop supervisor about the correct use of safety stands as secondary supports.

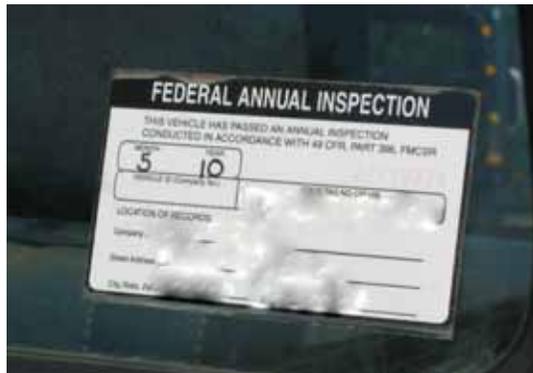
tow truck involved in the incident had been inspected in May, 2010 (Figure 6). The mechanic did not document any inspection of the hoist/winch/sling lifting mechanism.

Figure 6. Vehicle sticker (identifiers removed by MIFACE) on tow truck involved in incident

The Ford Super Duty tow truck had its required annual maintenance inspection. The maintenance inspection did not include the winch boom arm and the lifting components such as the slings and cables. The winch boom arm supporting bracket showed cracking, broken welds and deformation. The tow slings were very worn (Figure 12). The portable hydraulic jack used to lift the vehicle from the decedent was missing two steel wheels on the rear section. The portable hydraulic jack was defective and should have been taken out of service when it was found to be defective.

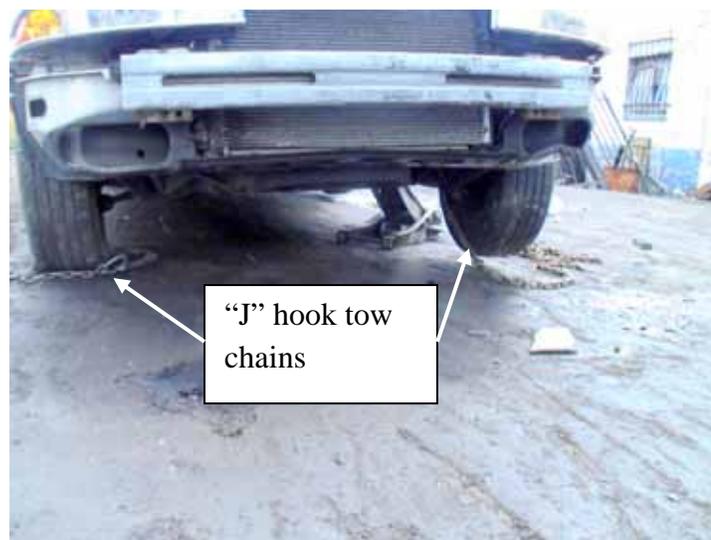
The event was unwitnessed. The decedent started the truck to activate the hydraulic boom lift using the controls at the rear of the tow truck. He raised the vehicle to approximately three to five feet above the ground. His method of securing the wrecked vehicle to the tow straps/"J" hook tow chains was unknown. From MIOSHA photographs taken at the scene, the decedent attached one "J" hook tow chain to the driver's side frame near the driver's side tire. The second chain is seen lying on the ground next to the passenger side tire – it is unknown if the second "J" hook tow chain was attached or if it fell from the vehicle when the vehicle fell to the ground.

Figure 7. Location of "J" hook tow chains on ground near front tires

- One end of each tow chain should be secured to an appropriate tow truck attachment point not to the lift assembly.

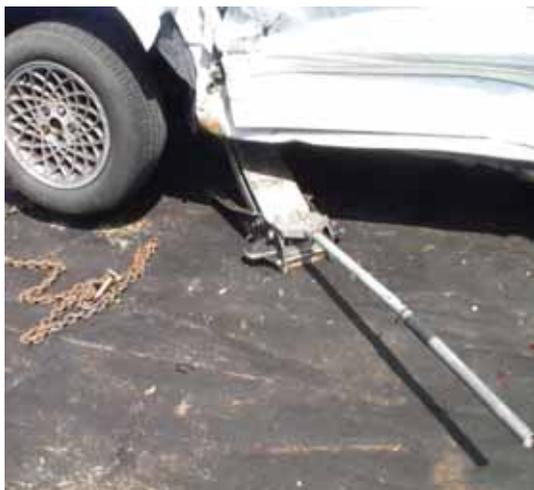
Defective tools were not removed from service: Rear wheels missing, portable silver hydraulic floor jack.

The rated capacity was not permanently marked on the jack: no rated capacity, portable silver hydraulic floor jack

Figure 8. Defective floor jack used to lift car from decedent.

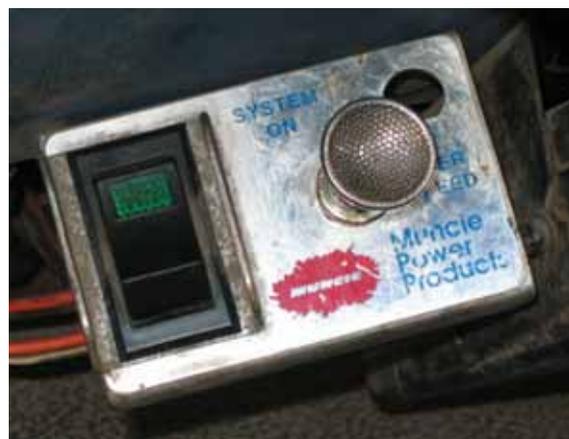
During the site visit, the company owner instructed a tow truck driver to position the wrecker involved in the incident in the position it was in when the incident occurred. The company owner demonstrated how employee training regarding attaching a tow chain was conducted and how the truck’s safety features worked. The owner demonstrated that the wrecker’s hydraulic controls were operational only when the wrecker was running and the safety switch located inside of the truck cab was not activated. The company owner demonstrated that when the truck was running and the safety switch was activated, the hydraulics would not operate. He also demonstrated that when the truck was off, the hydraulic controls to raise and lower the vehicle were not operational.

Figure 9. Safety switch in tow truck cab

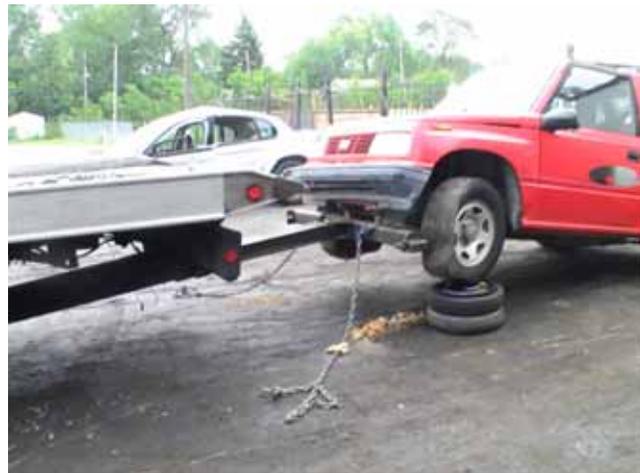
Figure 10. Use of tow vehicle to raise vehicle and improper secondary support for a different vehicle on the employer's worksite

This incident demonstrated the need for appropriate secondary supports to minimize the risk of a raised vehicle falling and pinning someone underneath it. After the vehicle is raised (either by a floor jack at the lifting point recommended by the car manufacturer or the tow slings), at least two properly labeled vehicle support safety stands, such as safety stands, of the same size should be placed on opposite sides of the vehicle. Safety stands must be used in pairs. The vehicle should be slowly lowered to determine if the safety stands are in the correct position and will support the vehicle. When all of the vehicle weight is on the safety stand, the vehicle should be shaken to ensure that it is securely supported. Safety stands should be placed on a hard, level surface capable of sustaining the load. The safety stands may cause indentations in an asphalt pavement, so a supportive surface, such as a piece of wood that can dissipate the weight should be used.

Loads placed on safety stands should not exceed 50 percent of the rated capacity of the safety stand (i.e. if a safety stand rating is indicated by the manufacturer as 8 tons, the maximum permitted load is limited to 4 tons).

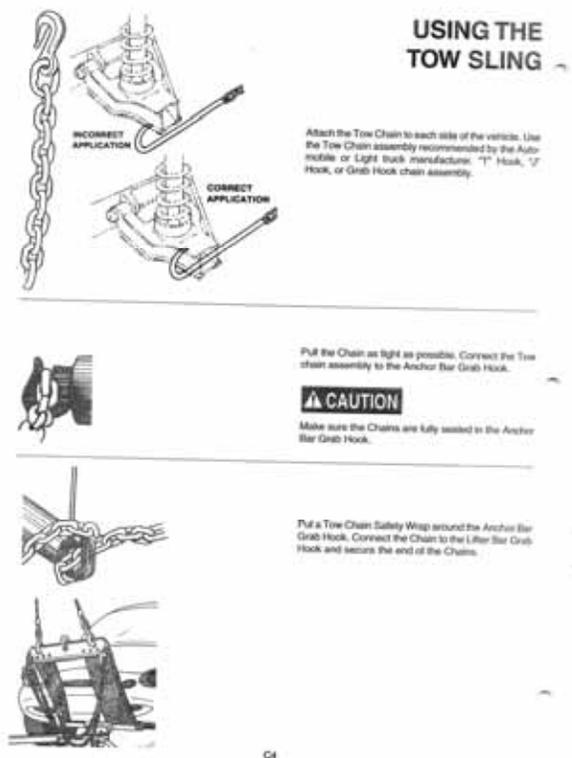
Figure 11. Tow sling and tow chain attachment instruction

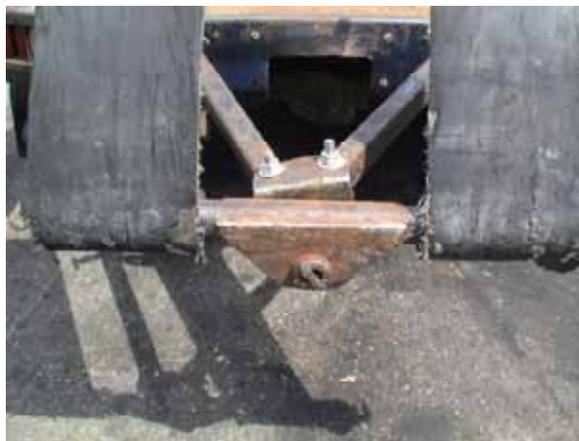
Figure 12. Worn condition of tow slings

- The employer should develop and implement a written safety and health program that includes the inspection of wrecker lifting mechanisms, tool inspection, and employee training.

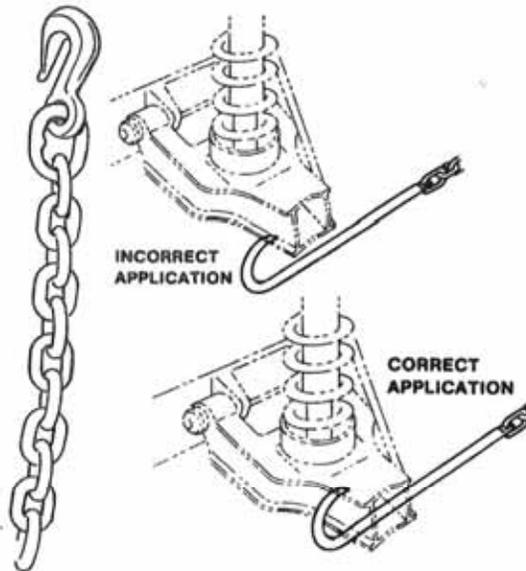
Attach the Tow Chain to each side of the vehicle. Use the Tow Chain assembly recommended by the Automobile or Light truck manufacturer. "T" Hook, "J" Hook, or Grab Hook chain assembly.

Pull the Chain as tight as possible. Connect the Tow chain assembly to the Anchor Bar Grab Hook.

Make sure the Chains are fully seated in the Anchor Bar Grab Hook.

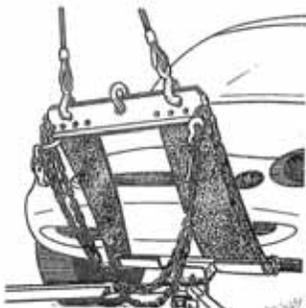
Put a Tow Chain Safety Wrap around the Anchor Bar Grab Hook. Connect the Chain to the Lifter Bar Grab Hook and secure the end of the Chains.
