FATALITY ASSESSMENT AND CONTROL EVALUATION

**A Department of Public Works Worker and a Volunteer Firefighter Died
in a Sewer Manhole Case Report
10NY060****CASE SUMMARY**

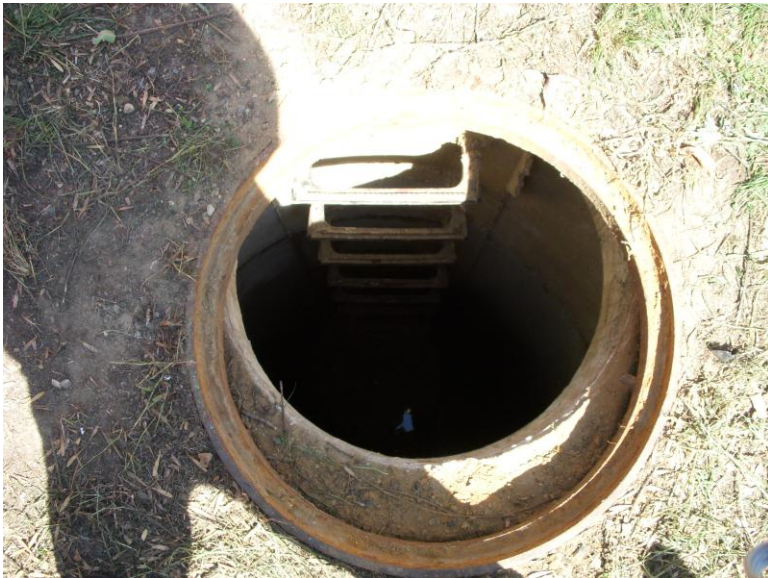
The incident sewer manhole was five feet in diameter and 18 feet deep with an opening 24 inches in diameter; the access rungs were sturdy and intact (Photo courtesy of NYSDOL-PESH).

The manhole was five feet in diameter and 18 feet deep with an opening of 24 inches in diameter. Two sewer pipes were connected at opposite sides of the vertical manhole wall in 180 degrees near the bottom. An 8 inch diameter half pipe that was cemented into the manhole floor connects the two sewer pipes. There were metal access rungs mounted on the manhole wall; all rungs were sturdy and intact. Victim I examined the manhole and commented to the others that it was clogged and he did not smell any odor. He was wearing a Tyvek suit and work boots; he was not wearing any respiratory protection. With a shovel in his hand, he started climbing down the metal rungs. The men who sat at the picnic table including the GF all saw that Victim I was entering the manhole. They all got up and walked over to the manhole to observe. As soon as they got to the manhole, they saw victim lying on the manhole floor motionless. At this point, they speculated that Victim I had slipped and fallen off the rungs and injured

Discussion: According to "Recommended Standards for Wastewater Facilities", a guide that is widely used by municipalities for designing and preparation of wastewater plans, the minimum manhole access diameter should be 24" (610 millimeter).¹² A 24" diameter opening is too small for a rescuer to enter since he most likely has to wear a lifeline, a SCBA and a harness carrying an air cylinder on his back. Because of the restricted entrance, a rescuer has to enter the manhole with the air cylinder removed from his harness and the cylinder has to be either held by assisting firefighters as in this case or lowered into the manhole for the rescuer to place it back on his harness. Either way, the extra handling increases the chance for errors that can cause dislodgement of the SCBA face piece. A Naval Base fire officer attempted to pass his SCBA ahead of himself into a ship's tank compartment attempting to rescue a worker in 1988 at Little Creek Naval Base.¹³ The officer lost his grip on the SCBA which fell and pulled his face piece from his face. He was overcome before he could re-don the face piece. The extra time on handling the air cylinder also diminishes the chance for the victim's survival.

While it is not feasible to change the existing manhole structure, it is very important that newly constructed wastewater systems have manholes with large enough access openings that allow rescuers to enter with all required personal protective and rescue equipment. During the design stage, municipalities should consult with the fire departments and technical rescue teams to ensure that the manhole access entrance meet requirement for a safe rescue, and when possible, design sewage systems requiring minimum worker entry for maintenance.
