## Fatality Investigation Report

OR 2010-6-1

# Truck driver crushed between semi-trailer and loading dock

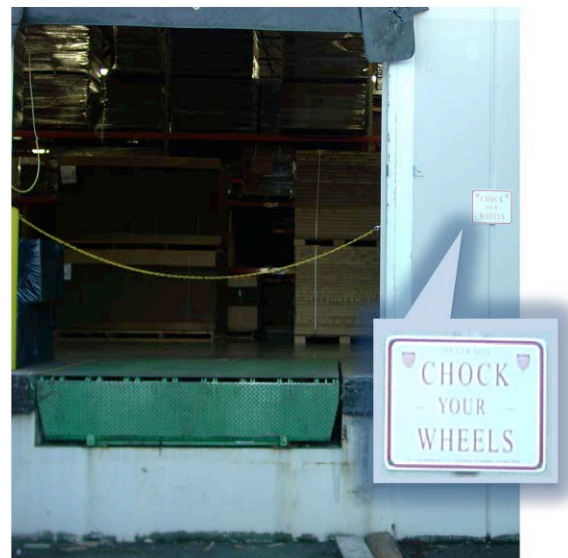
The dock involved in the incident where the driver was crushed (with “Kelly” dock plate). The white sign with red letters at right (shown enlarged) reads “chock your wheels.”

The warehouse loading dock involved in the incident included a “Kelly” dock plate to bridge and accommodate minor differences in height between the dock and trailers. There was also a nearby set of stairs and doorway for workers to gain entry into the warehouse.

**Recommendation #2: Use wheel chocks to secure trailers and tractors against inadvertent movement, especially when parked on a slope.**

- The use of wheel chocks on both tractor and trailer wheels on the 2-degree slope may have kept the tractor and trailer from moving and pinning the employee against the loading dock in this incident. Given the unlocked sliding axle and probable exclusive use of the trolley valve brake only, chocks on the tractor wheels would have been a particularly important protective practice in this case.
- Chocks should be used at every loading/unloading location.
- OSHA requires in 29 CFR 1910.178(k)(1) and (m)(7) that brakes be set and wheel chocks are required to be placed in front of the rear trailer wheels when loading/unloading the trailer using forklifts to prevent the trailer from moving away from the dock in reaction to the forklift movement. In this case, placing chocks behind the tractor and trailer wheels would have prevented backward movement of the trailer and tractor.

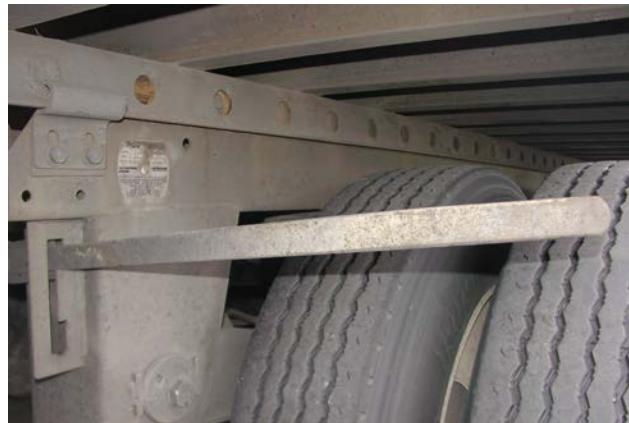
On the day of the incident, the driver had made deliveries prior to the one that resulted in his death. The company dispatcher did not indicate that the driver had reported any issues or concerns with the rental tractor or the trailer prior to the incident. This was a repeating or routine delivery at the warehouse where the incident occurred. According to interviews with witnesses, the driver had unlocked the rear-sliding axle and it remained unlocked for unknown reasons.

The lever located in front of the sliding rear axle assembly that locks the rear axle in place (shown here in the open/unlocked position). Evidence suggests that the lever was in the open position at the time of the incident, but since the vehicle was moved afterward, investigators could not physically verify the original position.

**Recommendation #3: Confirm that the sliding axle assembly is locked prior to working in or around a trailer (trailer had potential of 8 feet of movement on this model).**

- The Federal Motor Carrier Safety Administration in 49 Part 393.207 requires that locking pins be in place on adjustable axles prior to loading/unloading and regulates brakes and their use in 393.40, 41 and 42. It is not known why the axle remained unlocked, or if the driver at some point pushed the locking lever arm toward the locked position, but it did not fully engage. Drivers should thoroughly check the position of the lever arm lock for sliding axles on pre-trip inspections, and/or prior to loading/unloading.
- If the trailer had been locked to the axle, assembly prior to unloading it

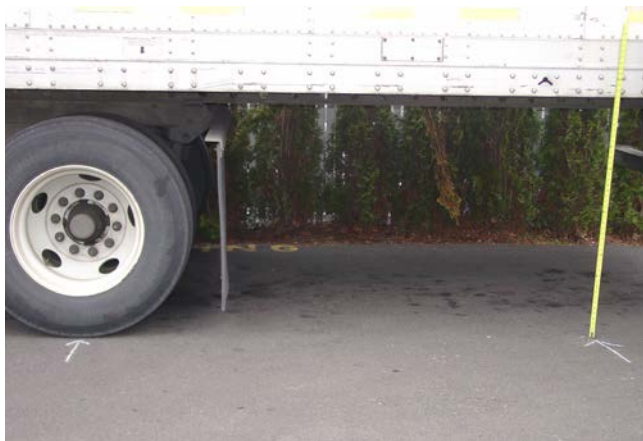
The image above shows the rear wheels of the sliding axle assembly of the trailer involved in the incident (rear of trailer to right in picture) Chalk arrows mark the potential distance (8 ft.) the trailer could have traveled over the rear axle toward the dock where the worker was crushed.

could not have slid backward over its rail. Based on the descriptions of events, it is possible that the driver only set the trolley valve brake relying on it to hold both the tractor and trailer in place while he retrieved the forgotten strap. If this was the case, the tractor could have rolled backward, also pushing the trailer backward causing it to slide over its rail over the locked trailer wheels. In that situation, it is possible that a locked slider axle could have prevented the incident (as long as the trolley valve brake holding the trailer wheels in place did not release).

- It is unknown if the driver was aware the trailer was capable of sliding 8 feet over the axle. The trailer belonged to the company, but it was not normally used for frequent local deliveries, as it was normally dedicated to night trips.
