SUBJECT: A Paint Maker Dies from Exposure to Dichloromethane (Methylene Chloride) While Cleaning a Paint Tank

SUMMARY
California FACE Report #11CA009

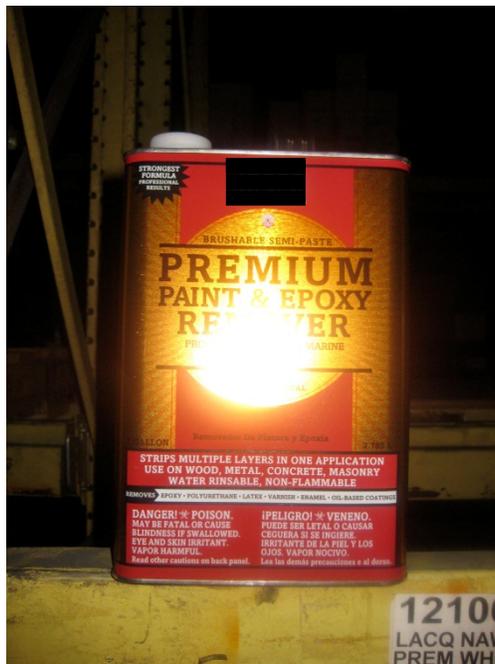
Exhibit 1. A container of the premium paint epoxy remover that was used in this incident.

The product involved in this incident was a semi-paste paint remover purchased by the company in one gallon containers (Exhibit 1). The intended use of this product included the removal of paint, adhesives, mastics, and contact cement from wood, concrete, metal, and masonry surfaces. The product contained a mixture of ingredients including methylene chloride, methanol, and Stoddard solvent. The Material Safety Data Sheet (MSDS) for this product listed the following ingredients and their concentration:

<u>Ingredient</u>	<u>Concentration</u>
Methylene Chloride	60 - 100%
Methanol	10 - 30%
Stoddard Solvent	1 – 5%

The MSDS stated that this product could be fatal and should be used only with adequate ventilation to prevent the buildup of vapors.

Methylene chloride-based paint strippers should be avoided whenever possible. If one or more of these alternative methods had been used to clean the tank at this company, the victim and surviving co-worker would not have been exposed to hazardous levels of methylene chloride.

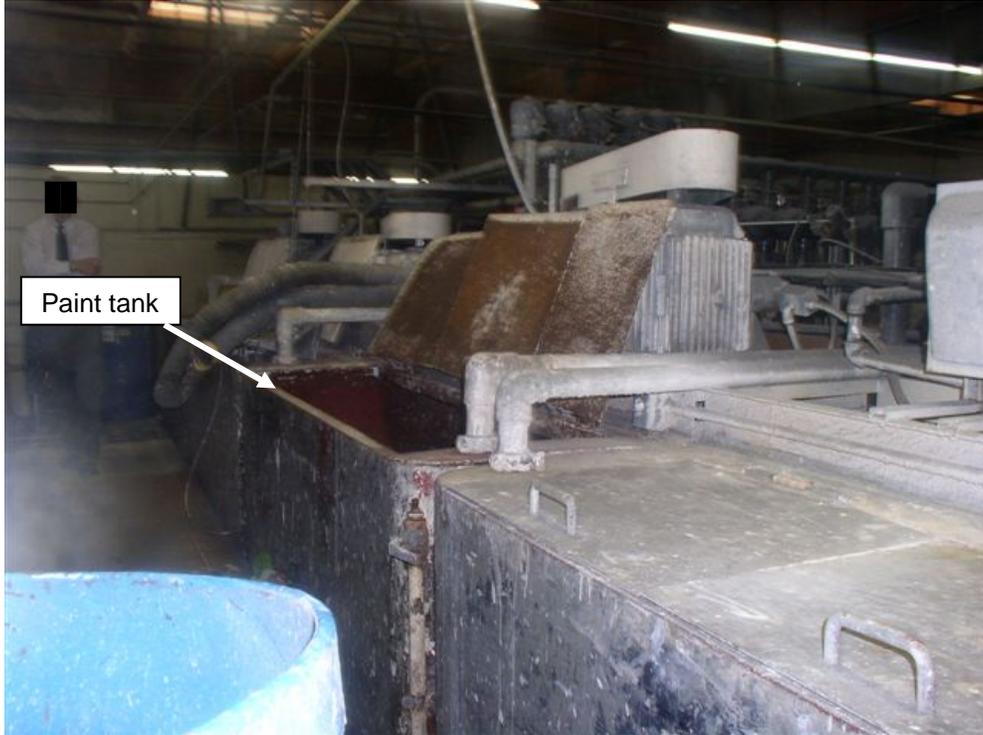
Exhibit 2. The paint tank the victim was cleaning.

platforms for employees to gain access to the top of the tanks. The tank involved in this incident measured seven feet wide by seven feet long and nine feet deep. The opening lid at the top of the tank measured two feet wide by seven feet long.

Recommendation #1: Policies and procedures are developed and implemented to clean paint tanks more frequently with water-based materials before the paint is cured. If this is not possible, the cured paint should be stripped with abrasive removal methods.

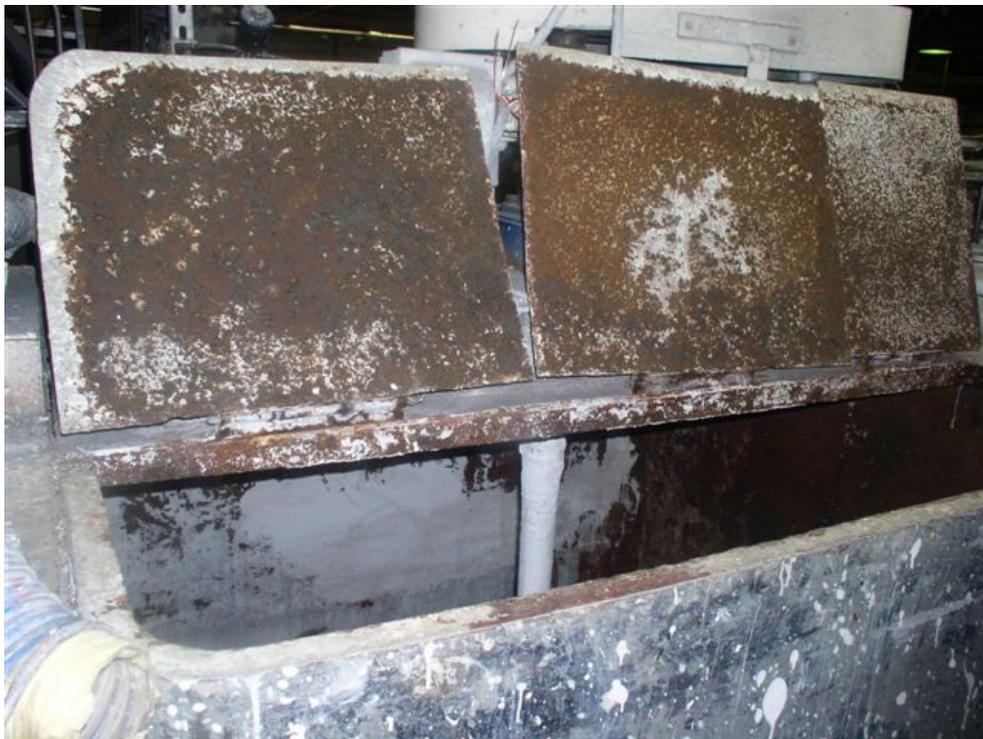
Exhibit 3. The paint tank opening.

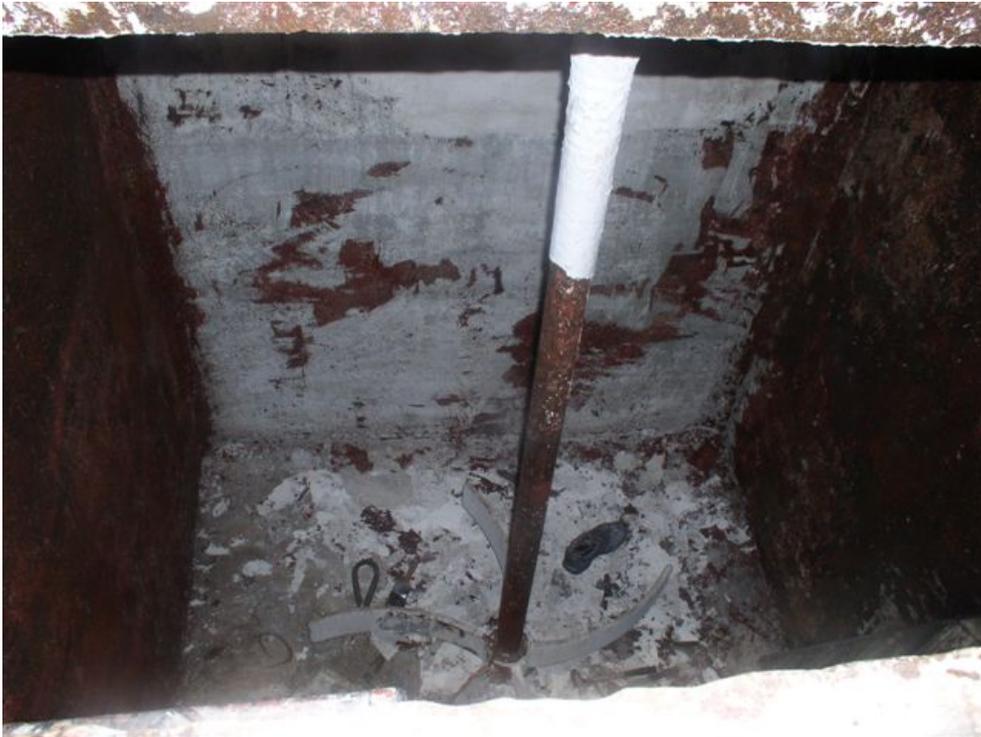
Exhibit 4. The interior of the paint tank.

The paint tanks were cleaned about once a year, usually during the holidays when production slowed down. According to the surviving co-worker, the product containing methylene chloride had been used for several years to clean the paint tanks. The process to clean a paint tank usually took several weeks. The paint tanks were cleaned by two employees working together. After a paint tank was drained of its contents, the cleaning started at the top of the tank and then worked its way down. The two workers leaned over the top of the tank and scraped off the cured paint on the tank walls with paint scrapers, reaching down as far as they could, and allowing the paint scrapings to fall to the bottom of the tank. Then they inserted a ladder into the tank, climbed inside, and continued scraping the walls. When they came to an area where the scrapers could not remove the cured paint, they applied the paint stripper that area with brushes, left the paint tank for about 10-30 minutes, and then came back and scraped the affected area. Usually, the mixture of cured paint and paint stripper fell to the floor of the tanks in clumps.

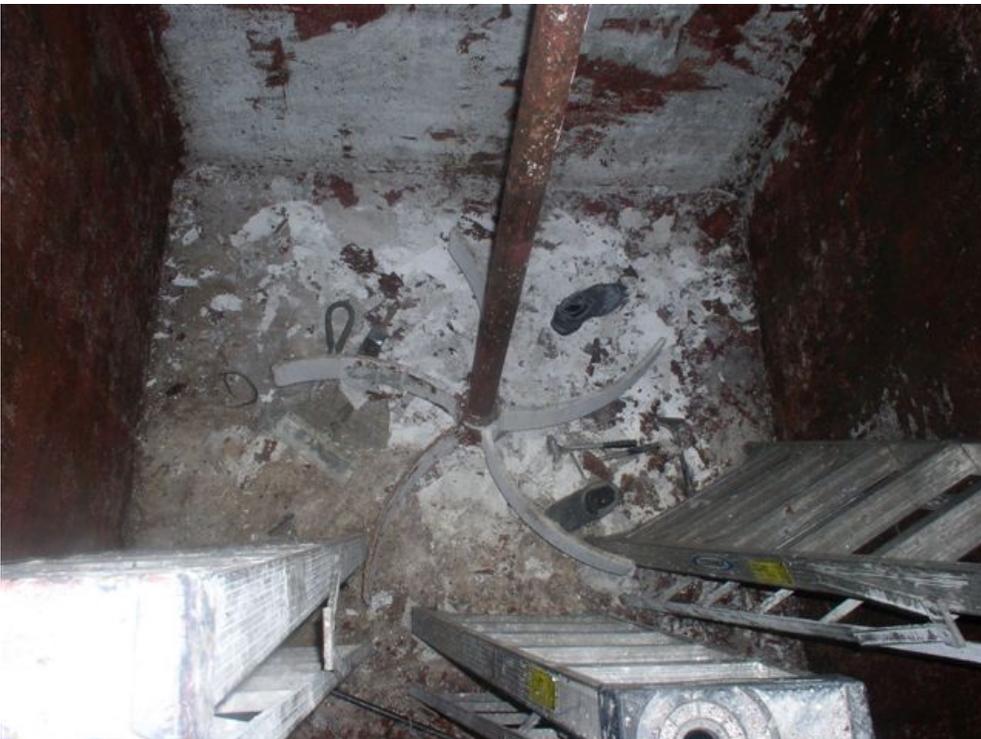
Exhibit 5. The ladders used to enter the tank.

If employees must work inside a confined space such as a paint tank, the required confined space procedures should always be followed. Confined space procedures should always include the following:

- Air testing, monitoring, and documentation.
- Proper ventilation.
- Proper personal protective equipment.
- Communications protocols.
- Proper rescue and retrieval procedures.
- Training.

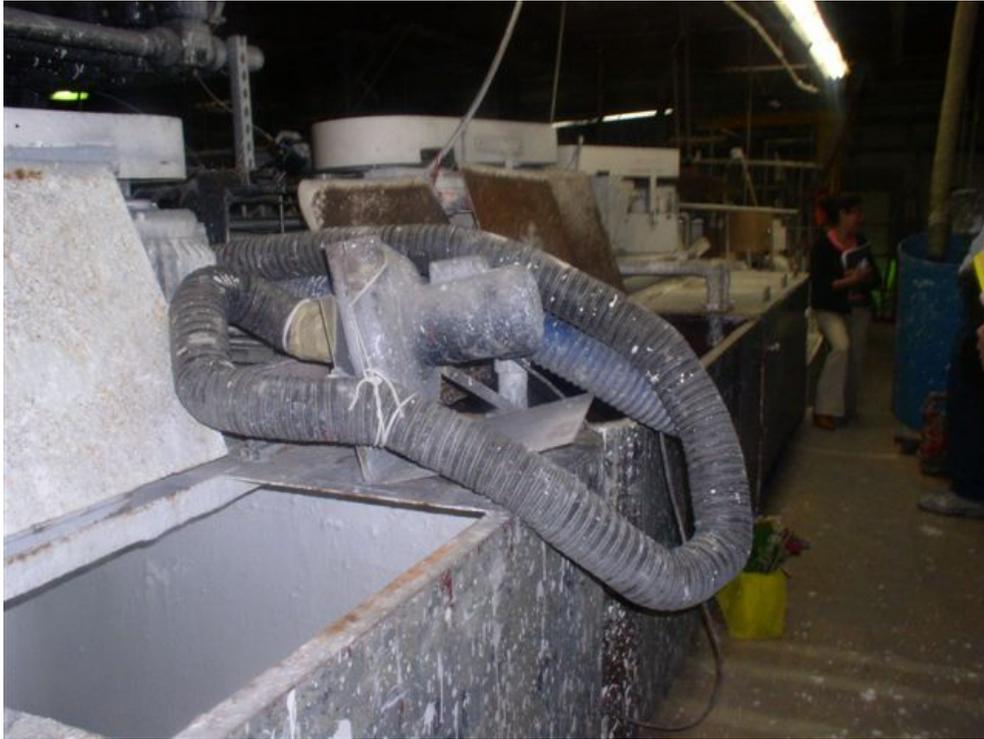
Exhibit 6. The air pump and hose that was used to remove contaminated air from the tank.

The end of a six-inch diameter flexible hose was placed four feet down into the tank to provide ventilation. The hose was connected to an air pump of unknown make and capacity in order to draw air from the tank and expel it into the general work area. There was no air testing or monitoring of the tank's atmosphere. The workers wore

half-mask respirators which were not adequate for use with methylene chloride (supplied-air required at a minimum).
