**FROM:** Iowa FACE      Case no. 2011 IA 075      Report date: 18 September 2012

**SUBJECT:** Truck driver died of thermal injuries after his tractor-trailer crashed into concrete median on the interstate and burst into flames

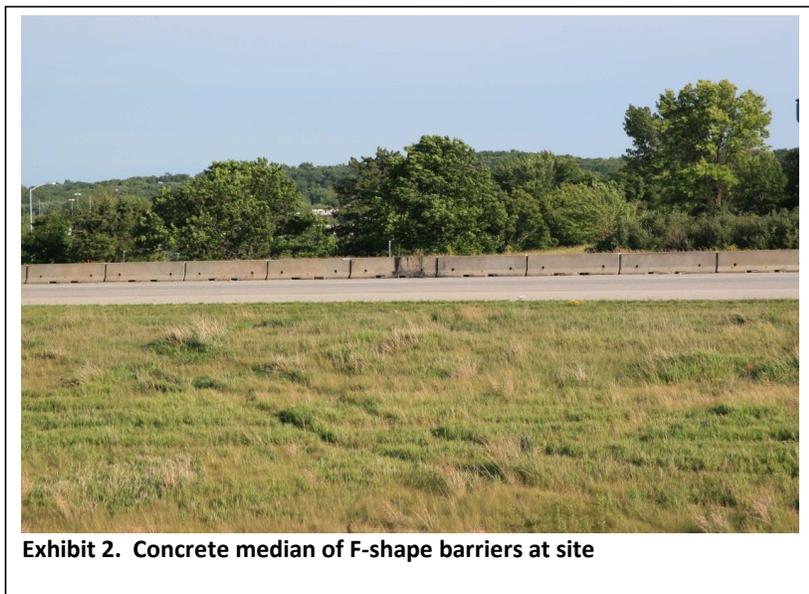
**Exhibit 2. Concrete median of F-shape barriers at site**

The driver was travelling east on a section of interstate highway that had three east-bound and three west-bound lanes (Exhibits 1 and 3) separated by a center median of concrete F-shape barriers<sup>1</sup> pinned end to end (Exhibit 2). The posted speed limit was 65 mph. There was no road construction activity on this stretch of highway.

mounted over each tank to allow a driver and passenger to enter and exit the cab. The aluminum fuel tanks are exposed, extending beyond the profile of the tractor cab and outside of the trailer's structural frame. These tanks are positioned at a height below the top of the 44-inch-high F-shape concrete barrier median; in the event the side of the truck contacts a concrete median or shoulder barrier, the fuel tank is likely to be damaged. At freeway speeds, a tractor that contacts the barrier will generate friction and heat at the exterior surface of the fuel tank, increasing the likelihood of tank failure and fire upon impact or contact.

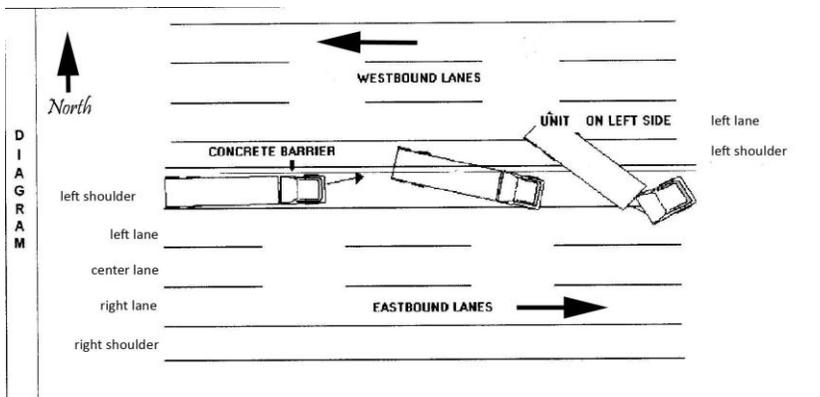
**Exhibit 3. Path of vehicle as shown on motor vehicle incident report**

The Iowa State Patrol indicated that the driver was travelling at 62 mph, and then veered left, striking the concrete median with the left side of the tractor. The vehicle continued east on the left shoulder with the driver's side of the tractor scraping against the median. The driver steered right to correct his position. Attempts to realign the vehicle caused the trailer to jackknife and orient approximately 30 degrees off of the road centerline. As the driver tried to re-center the vehicle on the freeway, the rear of the jackknifed trailer struck the concrete barrier with a force that broke the barriers, broke the rear double axles from the trailer, and drove the rear of the trailer up over the median, where it rode atop of the median before the vehicle came to rest (Exhibit 3).

The vehicle came to rest with the trailer attached and flipped onto its left side, atop the median. The rear of the trailer was extended into the westbound left shoulder and left traffic lane. Tipping of the trailer caused the tractor to twist into a position with the driver's side in contact with the concrete median, and the passenger side of the tractor elevated. The tractor cab and engine were completely engulfed in flames (Exhibit 4).

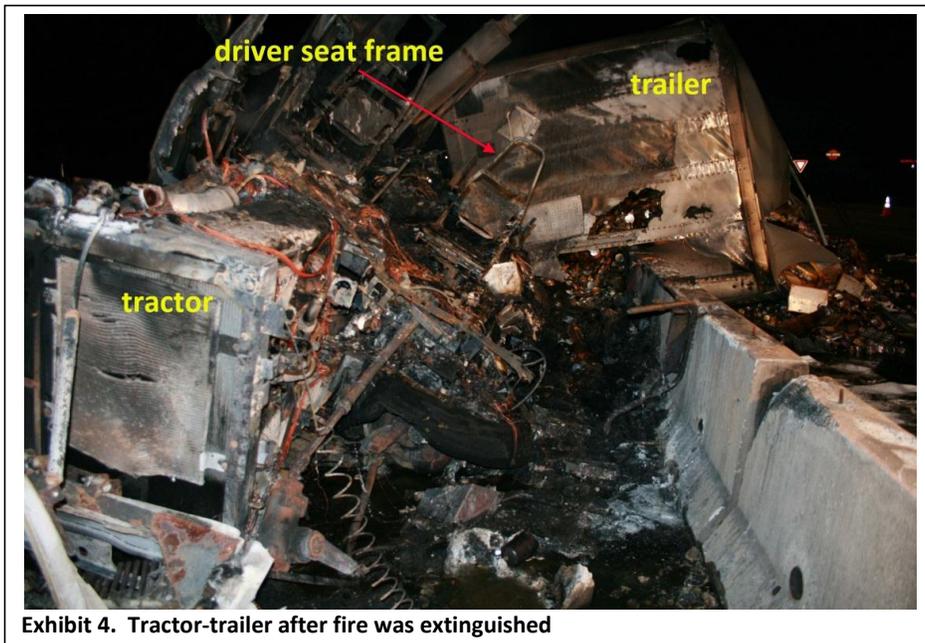
**Exhibit 4. Tractor-trailer after fire was extinguished**

When the driver's side of the tractor hit and scraped against the concrete median, the diesel fuel saddle tank (located below the cab door on the driver's side of the cab) came into contact with the concrete median barriers. Friction between this aluminum fuel tank and the concrete barriers damaged the tank and generated heat and sparks. This heat atomized the diesel fuel, and sparks ignited the atomized fuel, causing the tractor to catch fire.

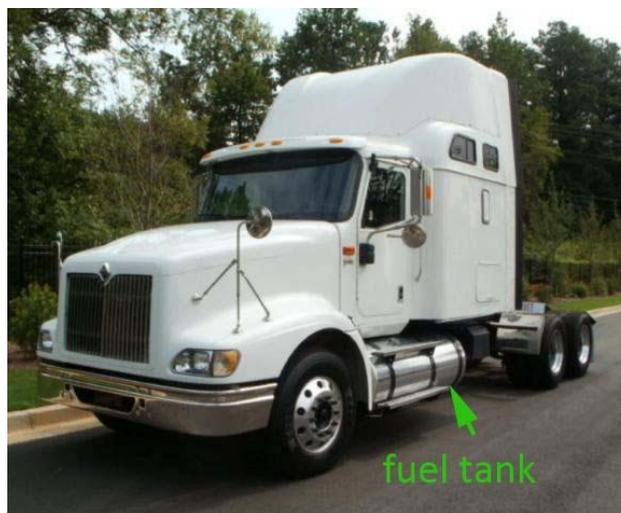
**Exhibit 5. Example of 2007 International 9400I showing fuel tank location**

The truck involved in this event (2007 International Tractor 9400I) had two diesel fuel saddle tanks of at least 100 gallon capacity each, affixed to the tractor directly behind the front axle, outside the tractor frame, and beneath the driver and passenger cab doors (Exhibit 5). Two steps were permanently

The driver had limited escape options in this incident (since the passenger side of the truck was elevated from the crash, and opened into the main path of oncoming interstate traffic), and his exit out the driver's side door was the quickest and most logical escape plan. However, this exit required him to step or jump over the fuel tank that had been in contact with the concrete median. The position of the fuel tank under the driver's door required him to travel through the fire to escape the vehicle. If the tanks were positioned further under the cab, or if they had protective framing between the fuel tank

and concrete median, the driver's side tank may have survived the damage and/or the driver may have had additional protection and time to escape.

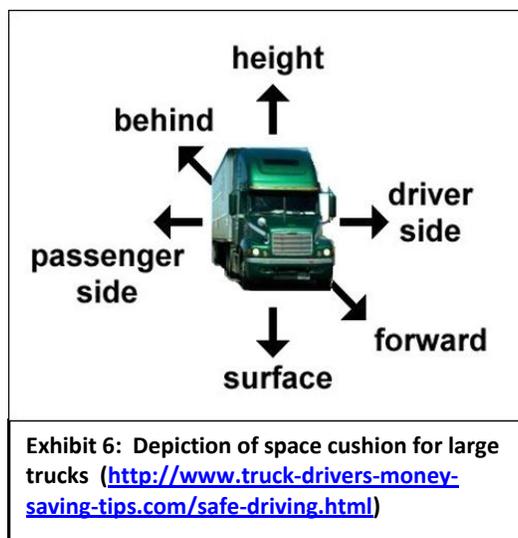
**Exhibit 6: Depiction of space cushion for large trucks (<http://www.truck-drivers-money-saving-tips.com/safe-driving.html>)**

Safe driving is critical to reduce crashes and crash-related fatalities, particularly for oversized vehicles that require more skill to negotiate highways and roads with roadway structures and other vehicles. Drivers of oversized vehicles are recommended to maintain a space cushion (Exhibit 6), which is defined as the area that surrounds the vehicle on all sides, especially the tractor sides where fuel tanks reside. In the case of this fatality, the space between the driver side and the concrete barrier was not maintained as the vehicle first swerved toward the left and then
