## **Massachusetts FACE • Occupational Fatality Report**

### **Refuse Collector was Fatally Injured when Struck by a Backing Refuse Collection Truck - Massachusetts**

**Investigation: # 11-MA-019-01**  
**Release Date: February 26, 2013**

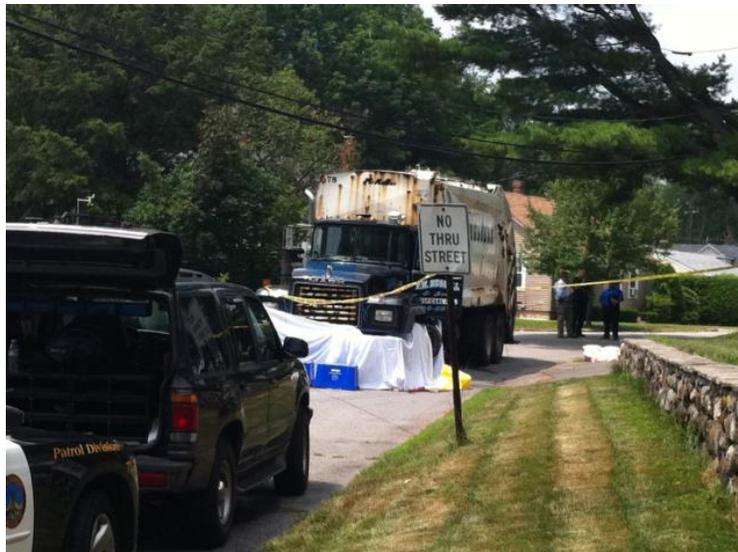
**Figure 1 – Refuse collection truck after the incident**

The refuse collection truck involved in the incident was manufactured and purchased by the company in 2002. The ten wheeled truck, with double dual rear wheels, was equipped with a rear loading hopper and a hydraulic powered compressing mechanism. The truck also had a functioning backup alarm (Figure #1).

Multiple co-workers called for emergency medical services (EMS). Personnel from the local and state police departments, fire department and EMS all arrived within minutes of the calls. The victim was pronounced dead at the incident location. After the incident the truck was examined by the state police and was found to be in good condition.

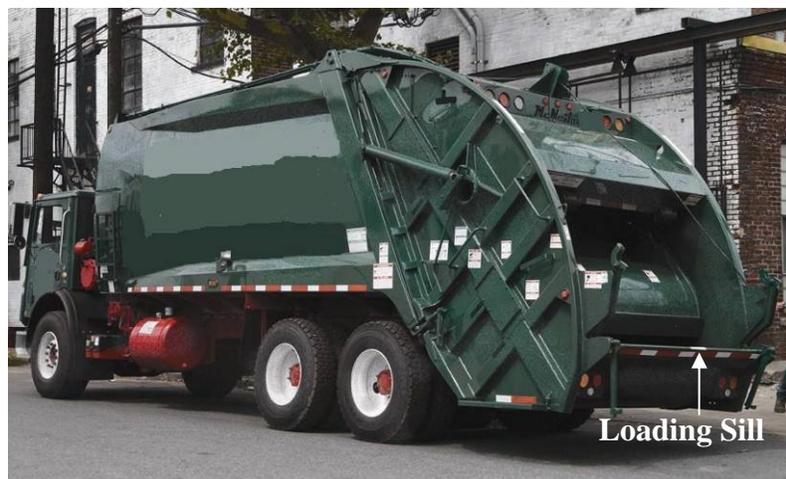
**Figure 2 – Rear view of similar refuse collection truck**

**Discussion:** In this incident, the refuse collection truck was backing down a dead-end roadway with two of the victim's co-workers standing on the truck's rear riding steps. As the truck backed, the victim attempted to climb onto the truck's rear loading sill apparently to ride the truck to the end of the street. While climbing onto the truck's sill the victim fell from the truck.

**Recommendation #1: Employers should ensure that employees never climb onto a refuse collection truck, including the rear loading sill and riding steps while, the truck is backing.**

- step off the riding steps before the driver begins to back;
- remain inside the vehicle cab or in front of the truck unless assigned to act as a spotter; and
- never cross, step behind or climb onto the vehicle when it is backing or when its backup lights are on.
