FATALITY ASSESSMENT AND CONTROL EVALUATION

**Operator Killed when
Horizontal Auger Boring Machine Overturned
Case Report 11NY043****CASE SUMMARY**

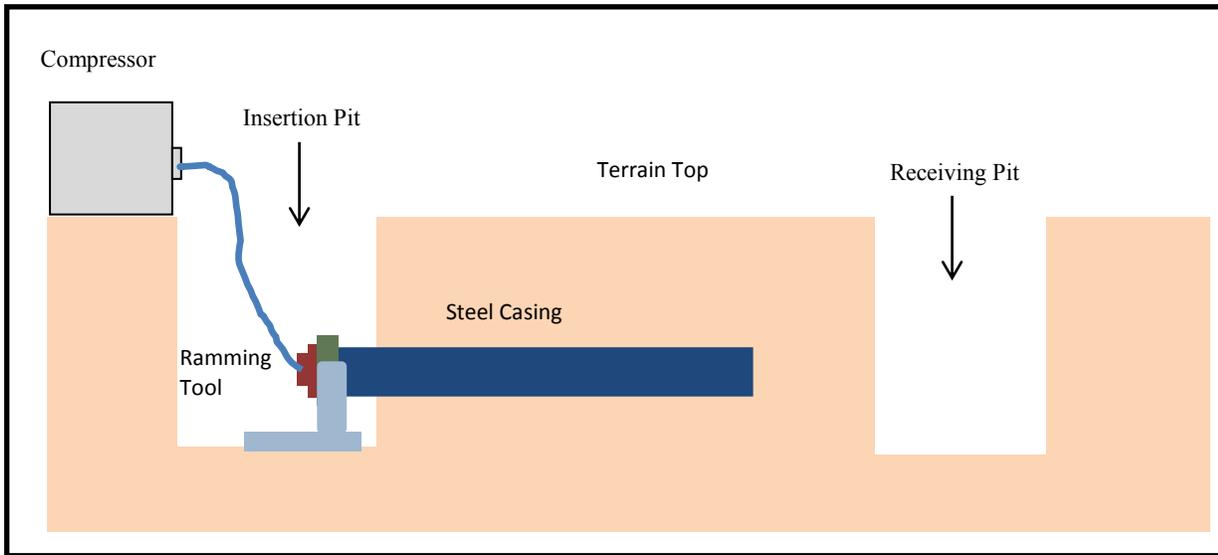
In a typical pipe ramming operation, a ramming tool and a steel casing are both placed in an insertion pit and lined up in the desired direction (Fig.1). The ramming tool that is attached to the rear of the casing drives it into the earth with repeated percussive blows. The next casing is welded to the end of the first casing and driven into the earth in the same manner followed by more casings to form a desired length. All casings have open ends; earth materials (soil and rocks) known to the industry as "spoils" fill the casings while they are driven through the earth. The spoils inside the casing line are then removed using compressed air, pressurized water or a HAB machine.

Figure 1. Typical pipe ramming setup (Courtesy of Trenchless Technology Center)

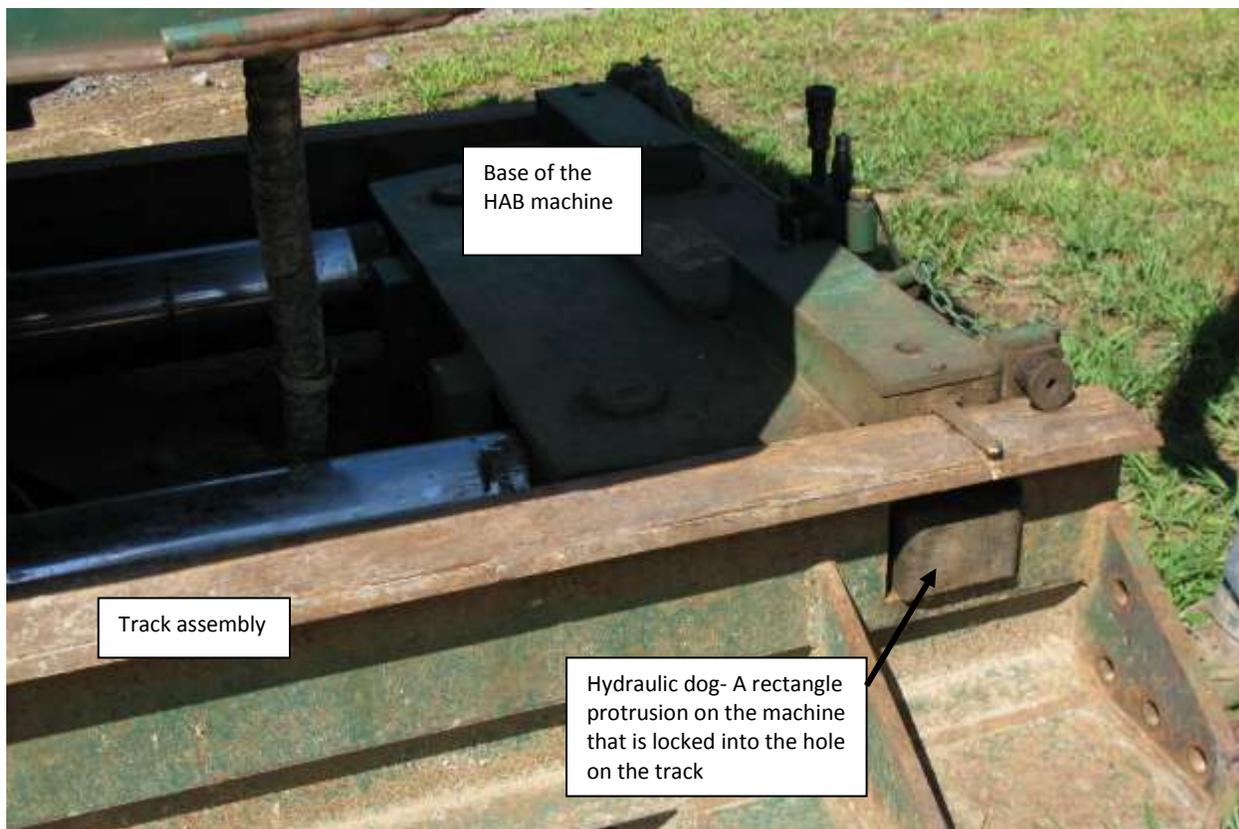
The machine was mounted on a track assembly comprised of two pairs of tracks connected by steel beams. The track assembly was approximately 32 ft. (9.8 m) long and 5 ft. wide. There were rectangular openings (holes) on the tracks. The base of the HAB machine had movable rectangular protrusions (hydraulic dogs) controlled by hydraulic power that can be locked into the holes on the tracks to prevent machine movement on the tracks (Photo 2). The dimensions of the machine were 60 in (1.5 m) wide, 144 in (3.7 m) long and 52.5 in (1.3 m) high. The centerline of the auger was 1.88 ft. above the ground. The combined weight of the machine and the track assembly (auger string excluded) was approximately 15,800 lbs. (7,167 kg).

Photo 2. The HAB machine is locked to the track assembly by the rectangle protrusions engaged into the holes on the track assembly.

To set up the machine, workers placed one-inch thick steel plates 64 in x 108 in (1.6 m x 2.7 m) on compacted soil and placed the track assembly on top of the steel plates. The track assembly was aligned with the casing and the designed grade before the machine was mounted. The track assembly was not anchored to the ground.

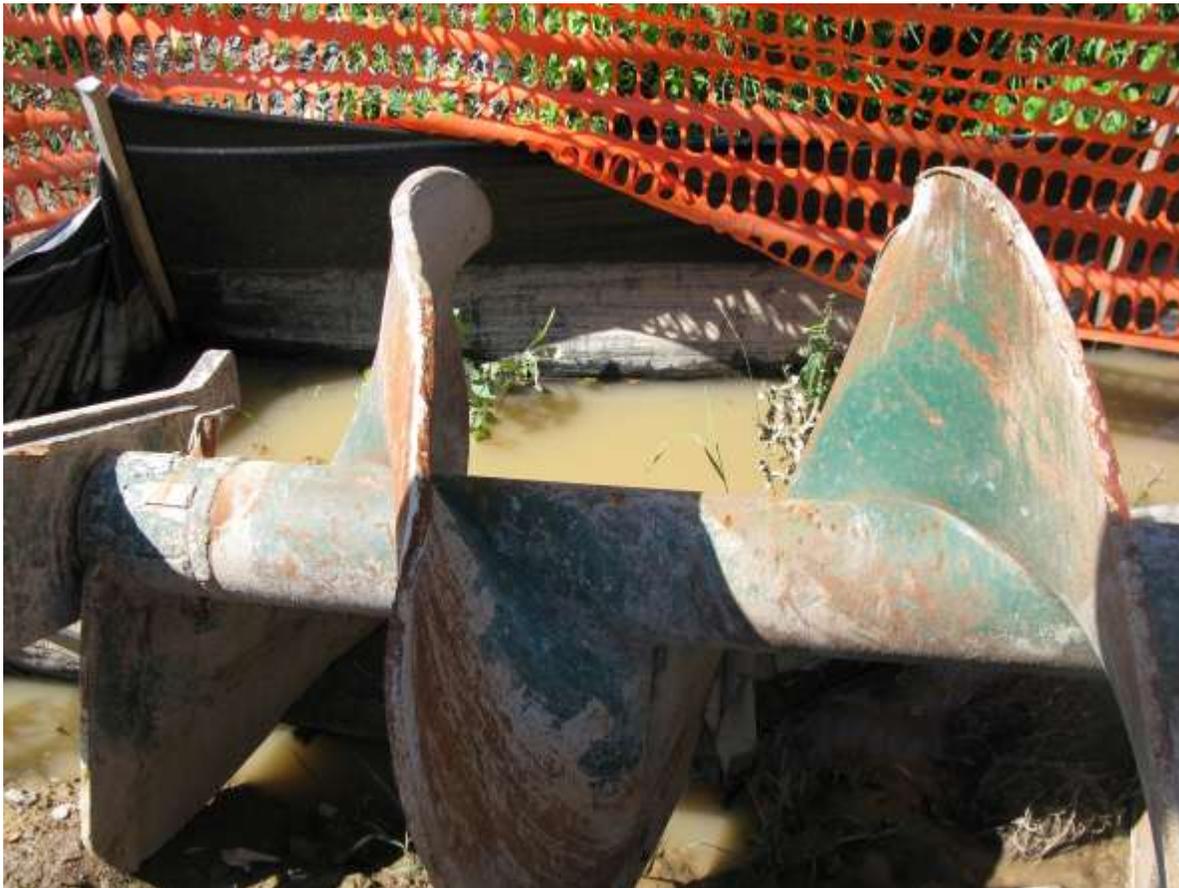
The post incident examination found that the HAB machine was operational resulting in no functional damage from the incident and the auger string was not out of alignment. The blades of the auger were bent during the incident (Photo 3) according to the owner of the company. It appeared that the auger was jammed by the spoils inside the casing. According to the OSHA investigation, there were rocky materials in the area being bored and large boulders and cobbles inside the pipe casing when the auger string was removed. The throttle position indicated that the machine was operating at or near full power when the machine overturned.

Photo 3. The bent auger blades indicate that the auger was caught by the spoils inside the casing.
