**SUBJECT:** A Maintenance Worker Dies from Exposure to Dichloromethane (Methylene Chloride) While Stripping the Floor of a Baptismal Font in a Church

**SUMMARY**  
**California FACE Report #12CA002**

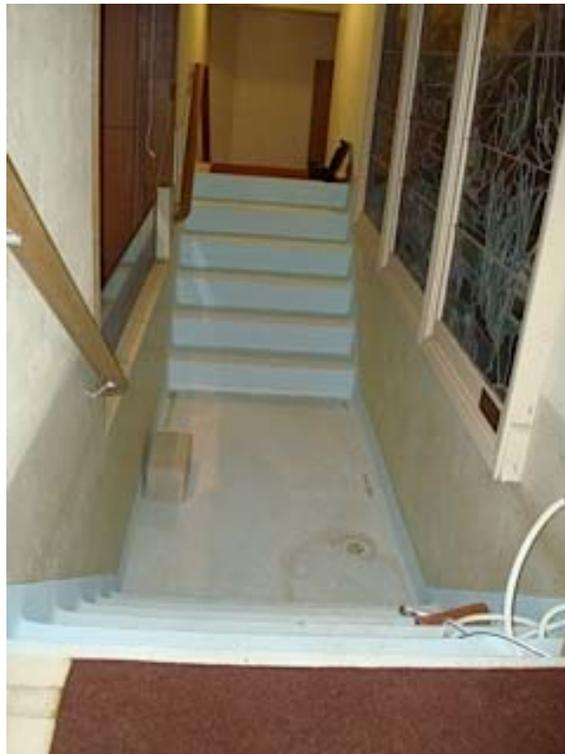
The incident scene was the baptismal font within the main worship area of the church. The baptismal font for this church was a built-in fixture of the church that resembles a large walk-in bathtub. The baptismal font was located within a narrow room (41' long x 4' wide x 12' high) with doors at each end and a large window facing the congregation to allow the worshipers to witness baptisms (see Exhibit 1). The baptismal font was

eight feet long by four feet wide. The font was made out of a common resin that had been painted. The paint coating was peeling and needed to be stripped about every 3 to 5 years.

**Exhibit 1. The floor and stairs of the baptismal font.**

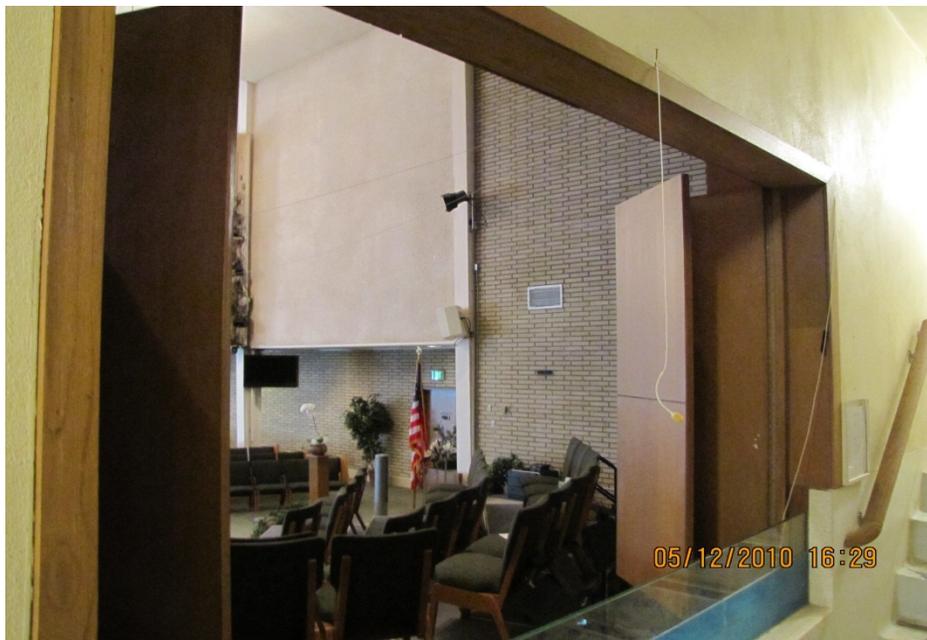
**Exhibit 2. The window within the baptismal font that opens to the church worship area.**

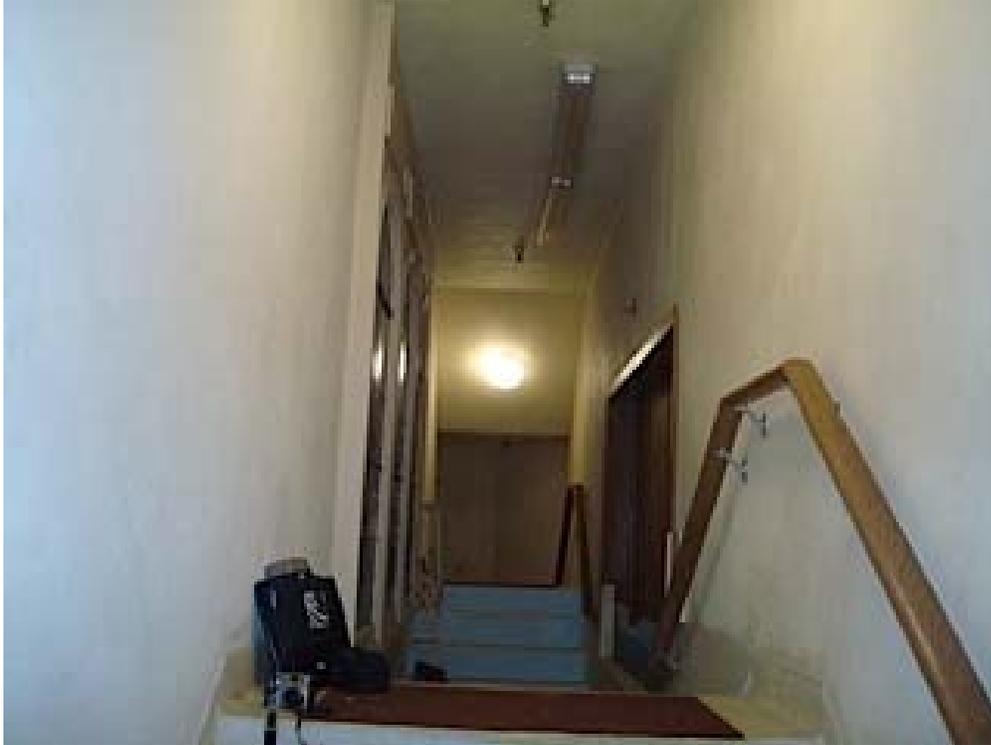
**Exhibit 3. The narrow hallway leading to the baptismal font.**

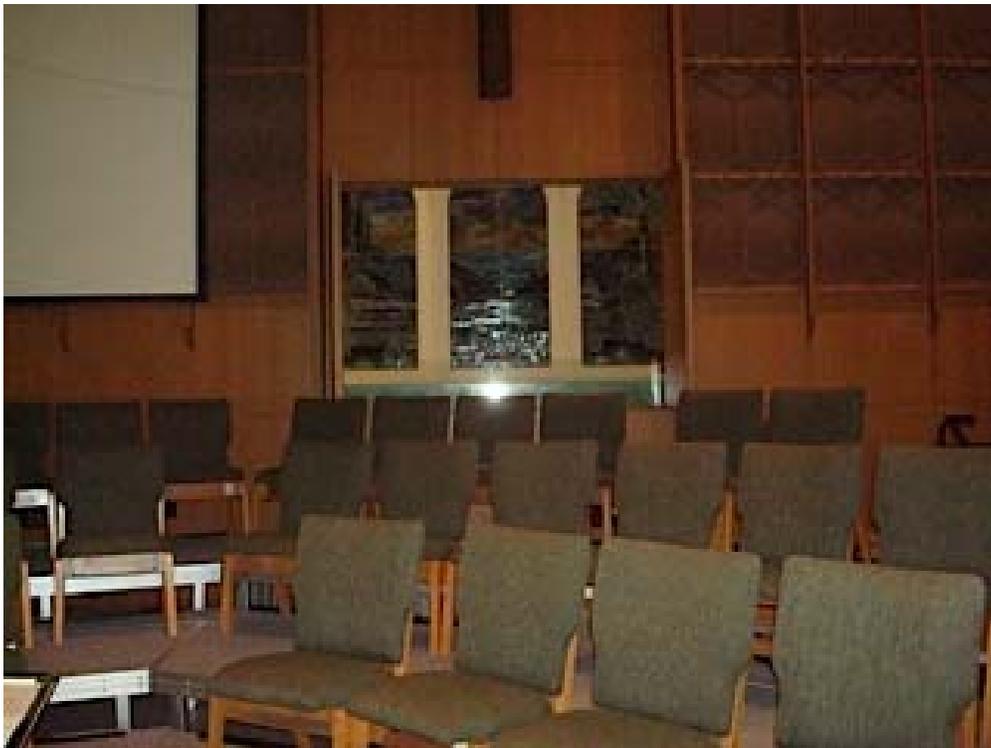
**Exhibit 4. A view of the baptismal font from inside the worship area.**
