SUBJECT: A Day Laborer Dies When He is Buried in a Trench Collapse

SUMMARY
California FACE Report #12CA004

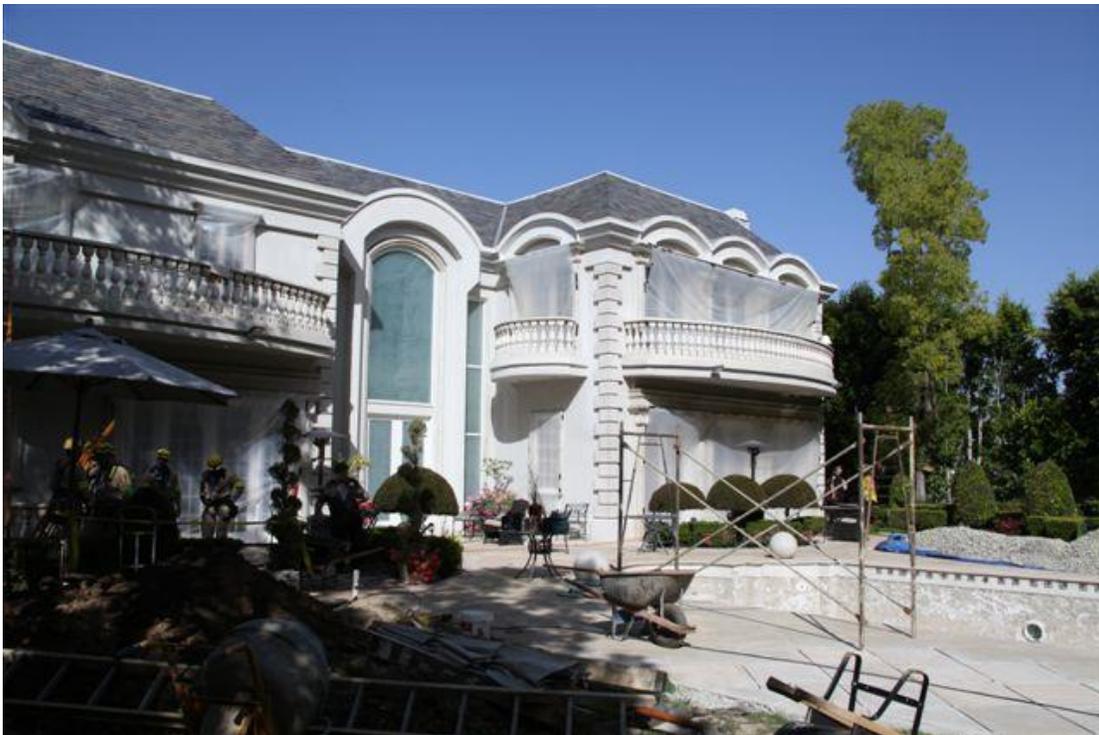
The incident scene was the back yard of a private residence. The home was a two-story, single family residence with a subterranean basement that housed the garage and other living spaces. The main floor was at ground level, and the second floor had several balconies that overlooked the back yard. The homeowner hired the victim and two co-workers to install foundation waterproofing and French drains around the foundation perimeter. This required digging trenches adjacent to the foundation. The victim and co-workers began the job about one month prior to the day of the incident. Trenches as deep as 16 feet were dug by pick and shovel around the perimeter of the foundation. The trench at the rear of the home was located between the foundation and a concrete deck. The trench ranged in depth from 6 to 12 feet, and measured two feet wide and approximately 15 feet long.

Exhibit 1. The back yard and rear of house where the incident occurred.

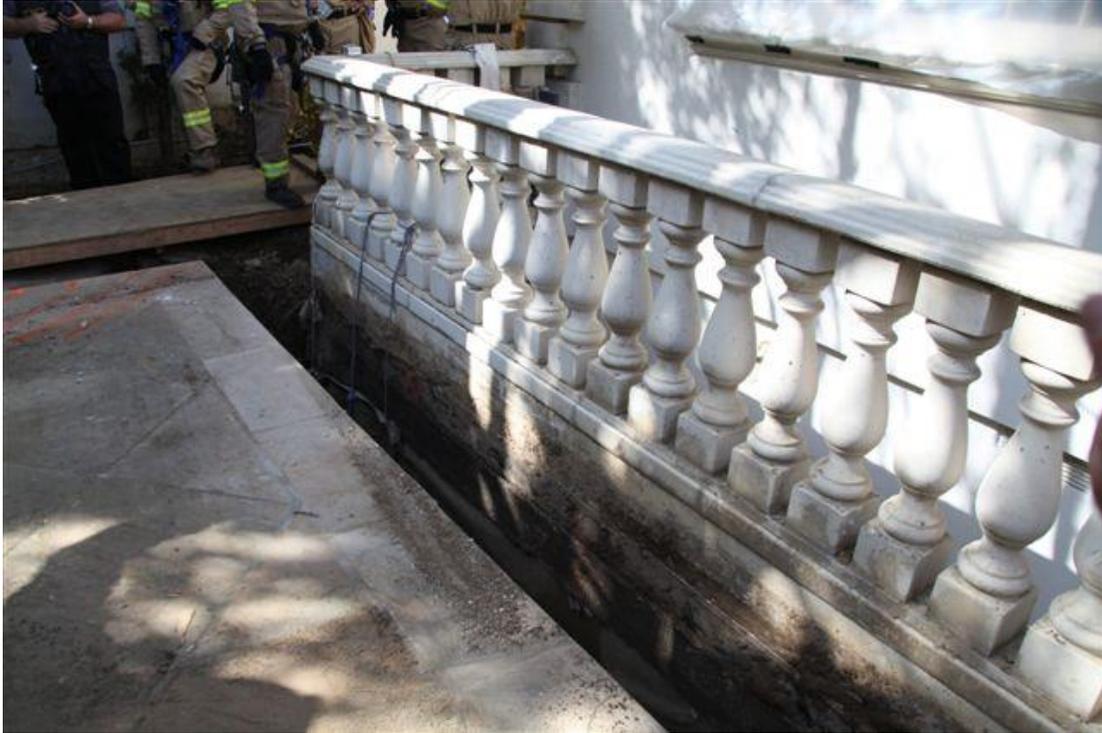
was safe and did not require any additional support. As the victim continued to dig, the soil side of the trench gave way and quickly engulfed him. The movement of the soil pinned the victim against the house foundation and buried him completely, leaving only part of his hand exposed. The co-worker yelled to the housekeeper to call 911 and then he and another co-worker tried in vain to rescue the victim. The housekeeper called for help and also called the homeowner to inform her of the incident. The fire and police departments arrived on the scene within minutes. The fire department requested the Urban Search and Rescue Unit to respond to the incident scene. The procedure to exhume the victim was extensive and took 12 hours before the victim's body was removed from the trench. The City Community Development Office stated that the homeowner did not file any construction permits or inspection reports for the work being performed at her residence. The firefighter report stated that the soil in the trench was water-saturated, making it less stable than if it were dry.

Exhibit 2. The trench.

Recommendation #3: Ensure that trenches five feet deep or greater are properly shored, shielded, or sloped.

Discussion: In this incident, the victim was working in an unprotected trench with an inclined depth from 6 to 12 feet. Any employee in an excavation, five feet deep or more, is required to be protected from cave-ins by an adequate protective system. A qualified licensed contractor will also ensure that trenches five feet deep or more are properly shored, sloped, or shielded. The type of protective system, support system, or shield system used would be determined by the soil conditions found in the excavation. This is usually determined by the employer, competent person, or a registered engineer. In this particular case the protective system could have included a trench shield (also known as a trench box), shoring, or a combination of shoring and shielding. Sloping would not have been appropriate because of the house foundation and the patio slab. Employers can also consult tables located in the appendices of the Cal/OSHA Excavation Standard (CCR, Title 8, Subchapter 4, Article 6) that detail the protection required based upon the type of soil and environmental conditions present at the site. Employers can consult with manufacturers of protective systems to obtain detailed guidance for the appropriate use of this equipment. In this incident, no protective

system had been placed at any point in the trench. Had the trench been properly shored or shielded, this incident could have been prevented.

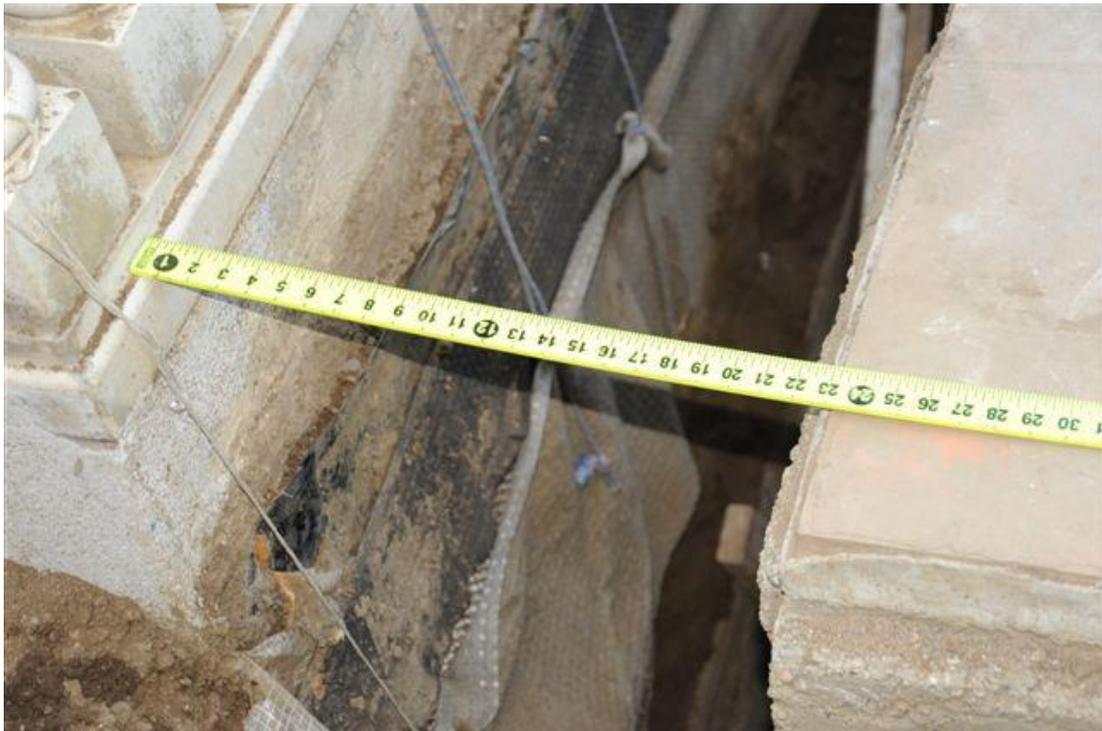
Exhibit 3. The width of the trench.

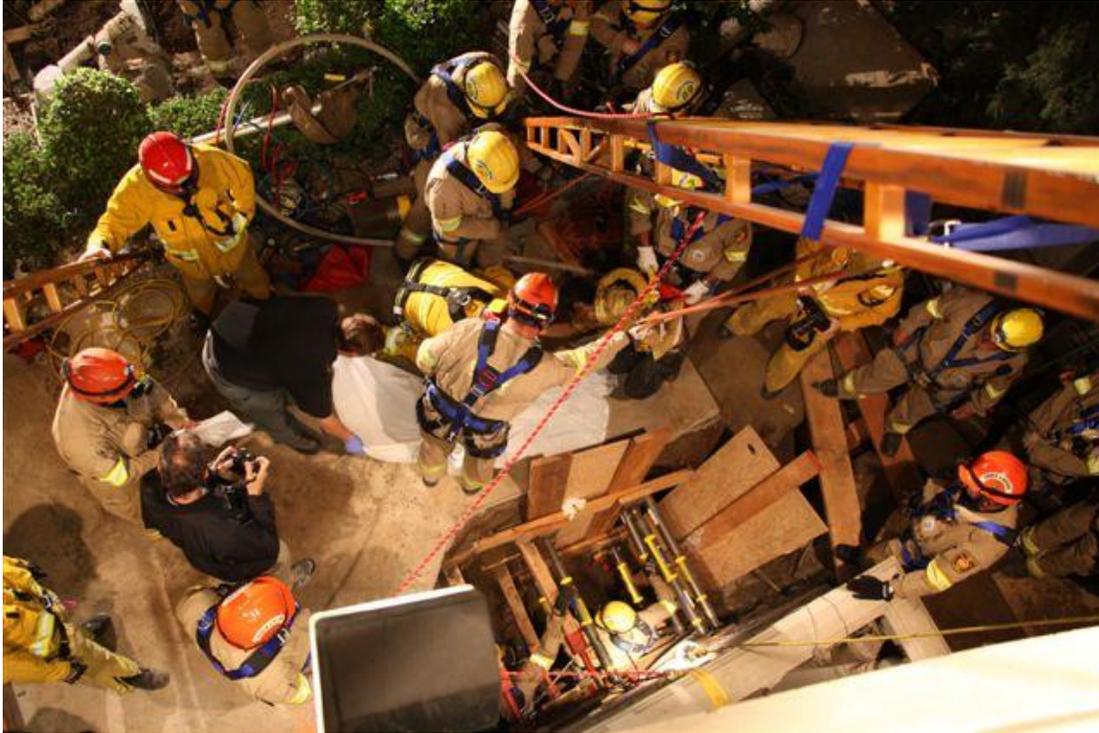
Exhibit 4. The worker recovery.
