FROM: Iowa FACE Case No. 2012 IA 001 Report Date: 11 September 2012

SUBJECT: Farmer engulfed in soybeans while operating grain vacuum in steel bin

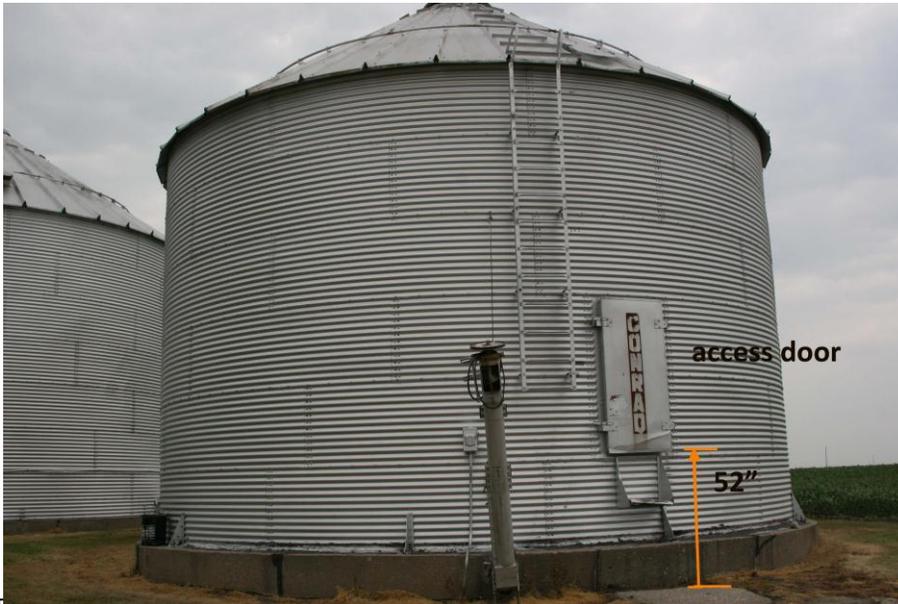
The fatality occurred in a 7600-bushel capacity grain storage bin at the farmer's rural residence that had been filled with seed beans in October 2011 (Exhibit 1). The bin was installed at the site in 1978 about 140 yards from the roadway, and was 27 feet in diameter and 16 feet high at the eaves. The bin had one side access door 52" above the ground that was divided into three door panel openings and a fill door at the roof. The entire side door was approximately 26" x 60", and the opening was divided into three framed openings each with clearance of about 25" x 17". The bottom opening had a swinging "bin hood" which reduced the 25" x 17" opening to a 12" x 9.5" opening, when the bin hood was used (closed position). The bin hood could be used to hold a grain vacuum tube in position, when inserted (Exhibit 2). The bottom door with the bin hood could also be swung open allowing access to the full 25" x 17" lower opening.

Exhibit 1: Grain bin where engulfment occurred

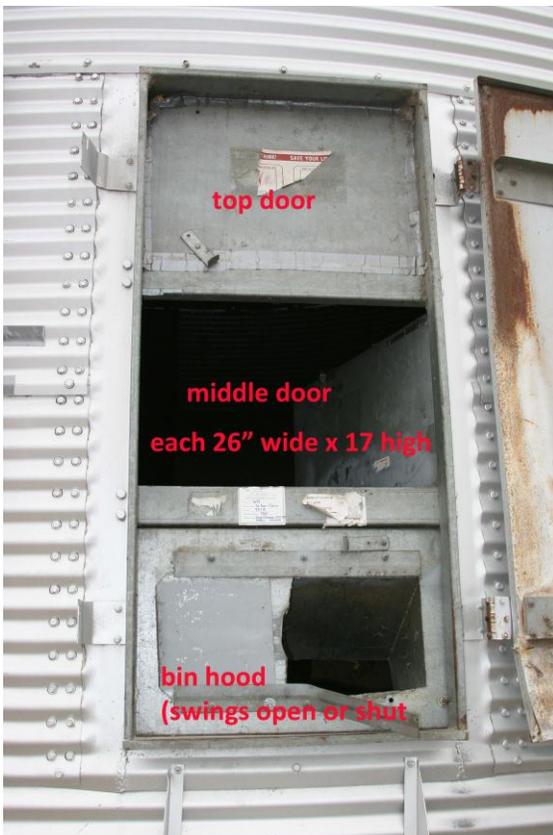
Exhibit 2. Side access door

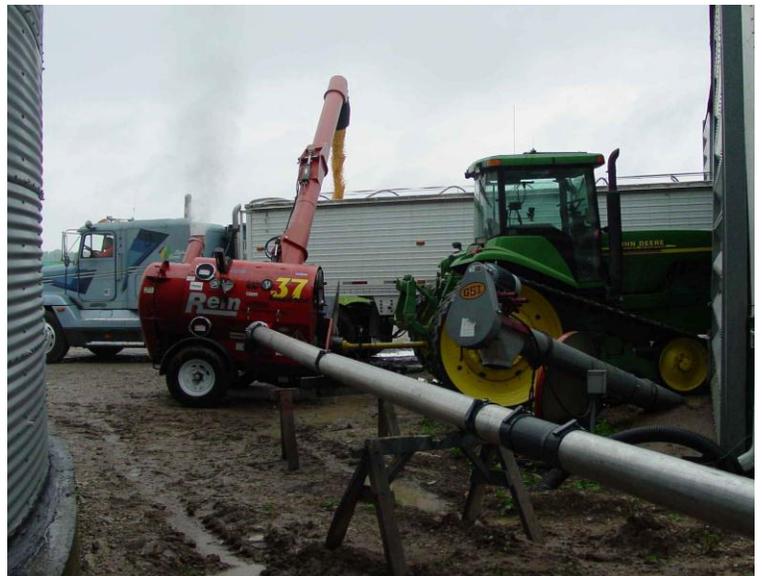
The night before the fatality, the farmer worked alone and emptied one or two semi loads of beans from the bin. He used an REM 3700 grain vacuum that was purchased new, two years prior to the incident (Exhibit 3).¹

Exhibit 3. Stock photo of REM 3700 grain vac loading grain into truck (image from www.rementerprises.inc.com)

¹ The REM 3700 grain vac was capable of moving 10,000 bushels per hour, depending on the length and type of tubing attached to it.

Initial reports claimed that the grain vacuum caught the farmer's leg and pulled him under. Our investigation does not support this on at least two accounts: 1) the grain vacuum tube was 7" in diameter at the end, too small to pull a boot in, and 2) there was no injury to the farmer's leg or foot which would be expected if it came into contact with the powerful grain vacuum.

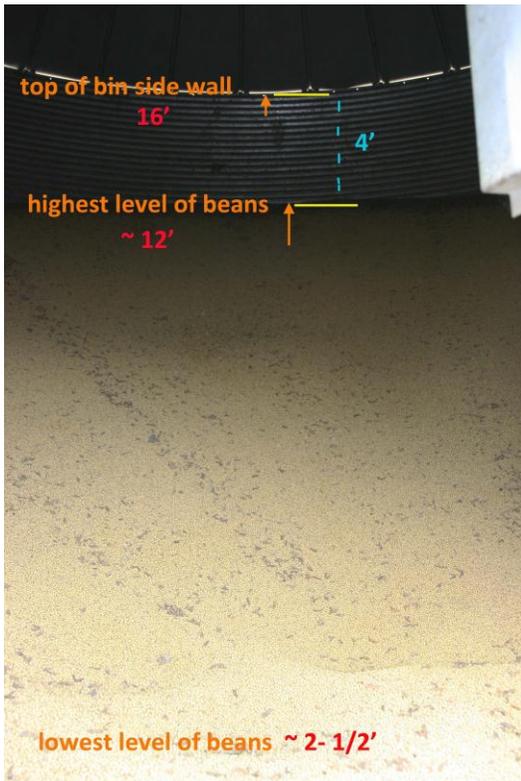
Exhibit 4: Inside view of bin following rescue

Examination of the bin contents following rescue attempts showed that the interior depth of beans was level with the bottom of the side door (2 ½ feet) and sloped up from the side door access point to a top height of about 12 feet (about 4 feet below the top of the side wall). Exhibit 4 depicts the scene inside the bin following rescue attempts, after an unknown amount of beans had been removed to free the farmer.

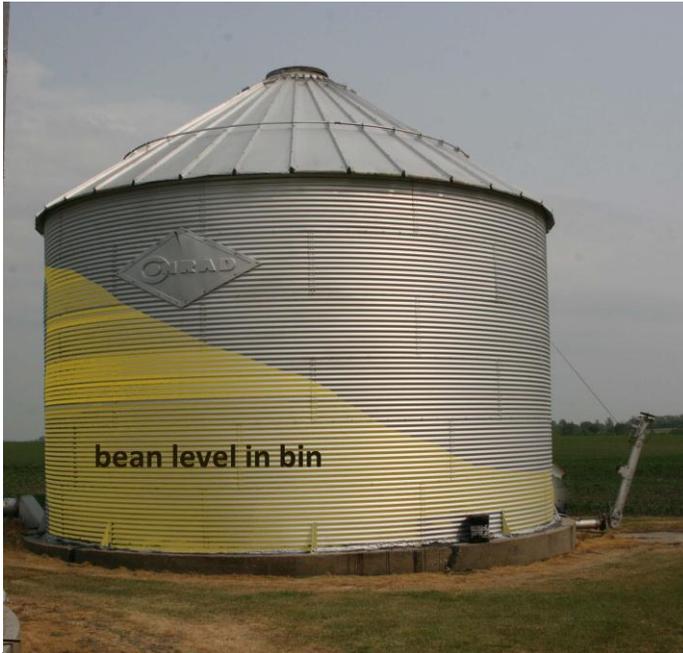
Exhibit 5: Schematic depiction of the level of beans in bin following rescue

Exhibit 5 shows a schematic depiction of the contents of the bin as viewed from the side, based on the depth of beans measured by counting bin rings.

he lost his balance, slid in the inclined slope of beans, or tried to reposition the grain vacuum tube, and consequently this movement, and/or the displacement of grain by the vacuum, caused the high sidewall of beans (likely higher than 12' high on the far wall prior to the rescue) to shift and cascade down on him. Beans in the bin had not gone out of condition (i.e., they were not sticky, crusted, or moldy) and flowed easily. A high-sloped surface of readily flowing beans presents a walking surface on which it is difficult to maintain footing and balance: walking on soybeans is like walking on small marbles. The farmer was found in a position leaning or lying toward one side, suggesting he may have slipped or slid, and then been knocked down by a volume of shifting grain.

Recommendation 3. Work in bins when lighting is adequate to assess potential hazards and gauge the level and slope of grain in the bin. Maintain a leveled surface of grain as grain is removed, to avoid sudden shifting and cascading of grain.

There was inadequate lighting outside and in the bin when the farmer was using the grain vacuum the morning of the incident (and possibly the evening before, as well). This may have contributed to him not fully recognizing the high sidewall of beans on the far wall of the bin across from the access door, and the potential for this volume of beans to shift suddenly. Vacuuming in a pattern that keeps the top surface of grain fairly level prevents sudden avalanche of grain, and keeps the worker above the surface where he or she can be within view of their work partners.

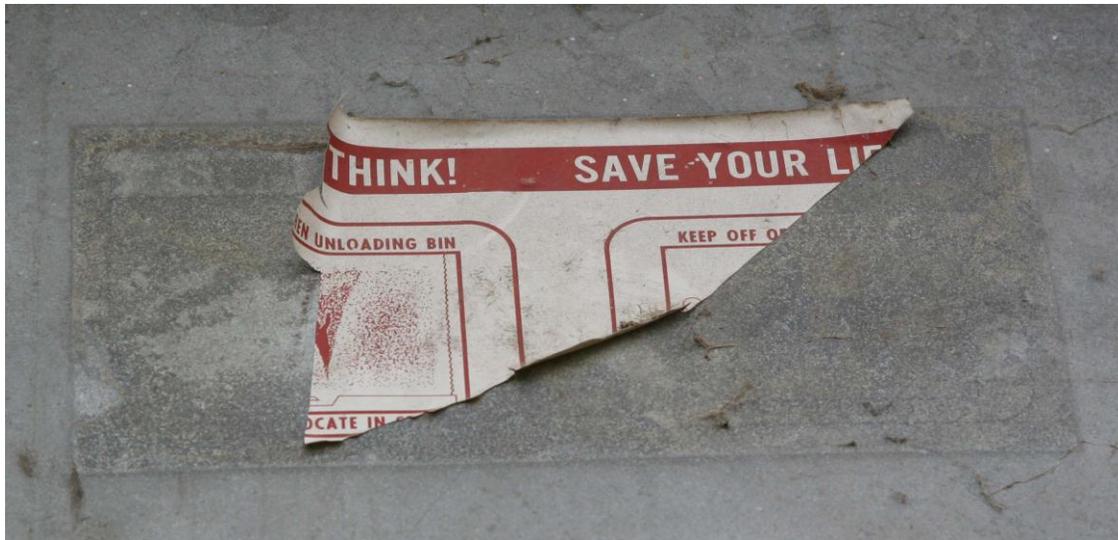
All grain bins should have clear signage stating NO ENTRY without following procedures noted above (working in teams, having a response plan, etc.). There was one remnant of a warning sign on the bin where the fatality occurred (Exhibit 6). This signage depicted a figure that represented being pulled down into grain being emptied from below on one side. The farmer in this case had emptied at least 60 bins per year during the 16 years his hired man worked for him. While the hired man was aware of dangers associated with entering bins (entrapment, air quality, flowing grain) the older farmer likely underestimated the dangers associated with bin entry based on his numerous uneventful prior experiences in the bins.

Exhibit 6. Warning sign that was on the top section of the bin's side access door

Recommendation 5. Put signage on grain bins notifying of the hazard of engulfment and asphyxiation, and warning against entry.
