MIFACE INVESTIGATION REPORT #12MI054

SUBJECT: Truck Porter Dies From Head Injury Complications When He Fell From Either the ICC Bumper or Deck of a Semi-Trailer

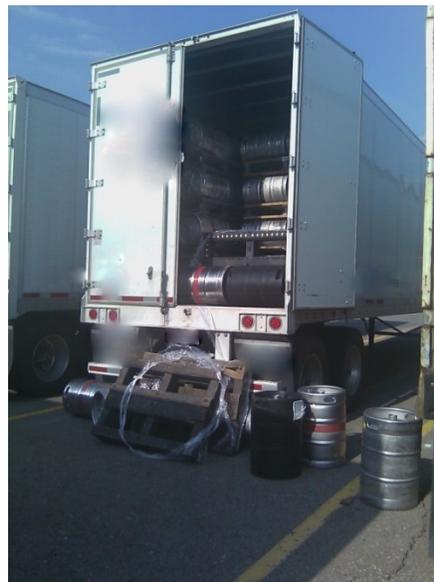
In summer 2012, a male truck porter in his 60s died due to head injuries sustained in an unwitnessed fall. The truck trailer had been loaded with empty kegs which had been shrink-wrapped and placed on pallets. The pallet-keg combination weighing approximately 470 pounds was loaded by forklift into the trailer. When the trailer was loaded, the decedent drove the semi-truck/trailer to the fueling area. The decedent opened the trailer door to place the shipping manifest in the semi-trailer. Although the injury sequence of events was unknown, the decedent most likely used the Interstate Commerce Commission (ICC) bumper to access the trailer deck. It is unknown if the decedent was on the ICC bumper or had stepped up onto the deck at the time of his fall. In an attempt to regain his balance, he grabbed the shrink-wrapped kegs and as he fell, the kegs and pallet were pulled down with him. The decedent was found by a coworker lying on his back on the ground with a wooden pallet on his legs and empty kegs strewn around him. The coworker ran to a nearby building and requested assistance. Emergency response was called, and the decedent was transported to a local hospital where he died several days later from the head injuries sustained at the time of the incident. The incident investigation found one shipping manifest on the deck of the trailer and the second manifest under the trailer.

Figure 1. Overview of incident scene

- Using the ICC bumper as an access to the trailer deck.
- Height of shipping manifest pocket on the trailer wall.

- Develop a written truck yard health and safety program that includes safe work procedures for truck porters.
- Ensure access ladders available to workers to climb onto trailer deck.
- Employers and/or trailer manufactures should consider mounting the shipping manifest pocket at a height easily accessed from ground level.

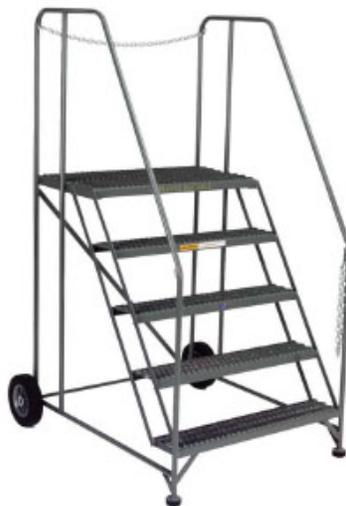
Accessing the trailer deck using the ICC bumper is not ideal. There are no handholds for support and limited foot support space. A safer solution to access the trailer deck would be an easily transportable access ladder that is lightweight and offers safe access to the trailer deck in all weather conditions (e.g., slip resistant steps, handrails). Solutions could include a rolling portable ladder (See Figure 2) or permanently mounted brackets for a portable access ladder.

Figure 2. [Example of trailer access ladder](#)

- Ensure access ladders are available to workers to climb onto trailer deck.
