# MIFACE INVESTIGATION REPORT #12MI218

## SUBJECT: Horse Breeder Falls 11-12 Feet From Hayloft When Throwing Hay Bale

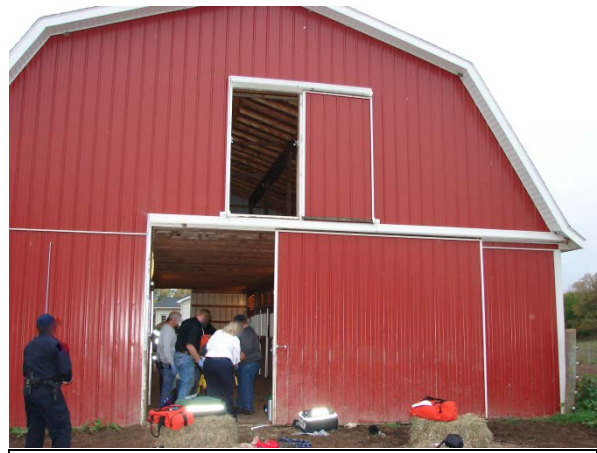
Figure 1. Overview of Incident Scene – Loft opening through which decedent fell

- Install removable guardrail(s) across the loft door when the loft doors are open.

Although the doors are normally kept closed when individuals are not in the loft, they may be open while work is being performed due to time of day, limited lighting in the loft, and work being performed. When the door is slid open and kept open for lighting or work purposes, MIFACE recommends that a removable guardrail be placed across/in front of the opening to prevent an unintended fall.

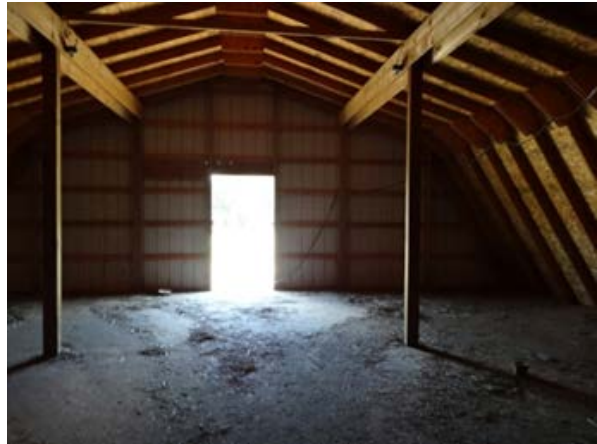
The hayloft could be accessed by stairs. Four lights were in the loft, two by each opening. Openings were located on each end of the hayloft by a sliding door. The door opening dimensions were 3 feet 9 inches wide by 7 feet high. The loft area was approximately 36 feet wide by 40 feet long. The door openings were approximately 12 feet above the ground.

Figure 2. Standing in loft area, loft opening through which decedent fell

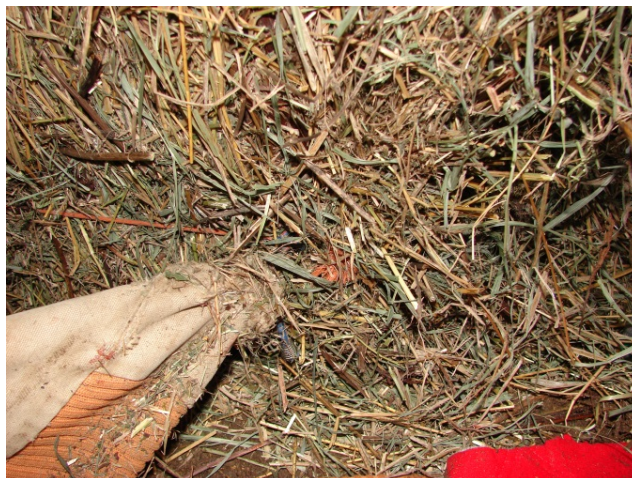
The decedent had thrown three bales, each weighing approximately 50 pounds, out of the loft without incident using a bungee cord to assist. The fatal unwitnessed incident occurred while he was throwing the fourth bale. While grabbing the bale, his coat sleeve became entangled in the baling twine of the hay bale and the bungee cord (See Figure 3). Several incident scenarios have been developed which may have caused the fall: 1) unbeknownst to him, his coat sleeve was entangled. As he threw the hay bale out of the opening, the bale's momentum pulled him out of the loft, 2) he purposely pulled down the sleeve of his coat over the palm of his hand. As he threw the hay bale out of the opening, the bale's momentum pulled him out of the loft.

Figure 3. Decedent's coat sleeve entangled in bale twine and bungee cord

- Wear gloves to protect hands from cuts and abrasions while handling twine-baled hay.

The decedent may have pulled the sleeve down around his hands to protect them from cuts/abrasions while throwing the hay bales out of the open loft door. Gloves would have protected his hands from the twine and may have prevented this incident.

- Do not wear frayed/torn clothing.

The decedent was wearing his favorite work jacket which was frayed and torn. This recommendation is a general safe work practice that should always be followed by where the risk of entanglement exists. The risk of entanglement in any work activity can be reduced if operators do not wear:
