Fertilizer Company Worker Crushed to Death by Falling Concrete Ecology Block

Investigation: #12WA00701

Release Date: August 29, 2016

SHARP Report: 52-36-2016

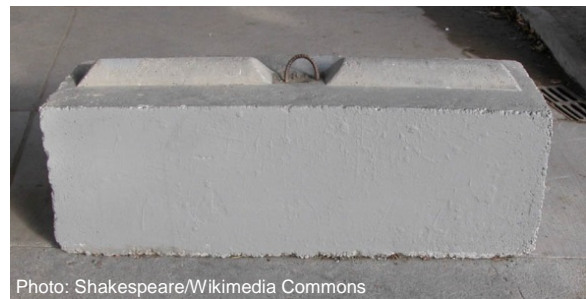
Ecology blocks are stackable concrete blocks designed with an interlocking tongue and groove system on the top and bottom, and sometimes sides, for stability (photo 1). Other names include Eco-blocks, bin blocks, and bunker blocks. They are manufactured from unused concrete left over from other construction processes. Common ecology block dimensions are 2' x 2' x 3', 2' x 2' x 4', and 2' x 2' x 6'. They typically weigh between 2000 and 4000 pounds. They are usually equipped with a rebar loop, or picking eye, on the top of the block for loading, unloading, and placement. Ecology blocks are marketed for use in retaining walls, storage of bulk materials, and other applications. Their modular nature makes them convenient to use when permanent structures would not meet the needs of the user.

Photo 1: Concrete ecology block

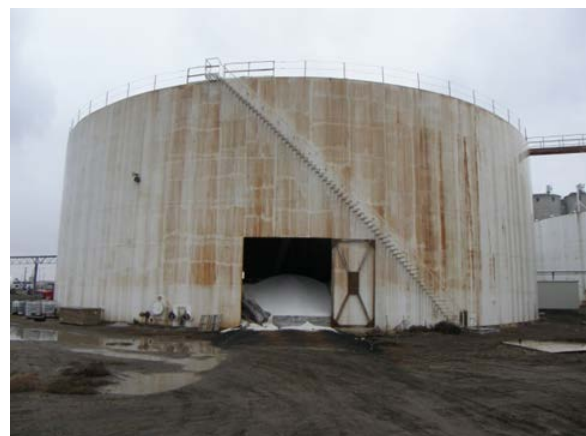
The incident took place in a large tank used for storing dry bulk fertilizer material (photo 2). The six-million-gallon steel tank had originally been used to store sugar beet

Photo 2: Steel tank used for bulk fertilizer storage

syrup, but had been converted for dry fertilizer material storage. The tank's original steel floor remained. The interior of the tank was partitioned into containment bays using stacked, concrete ecology blocks to create retaining walls approximately six to eight feet high. The ecology blocks used interlocked on the top, bottom, and sides. Two large doors had been cut on either end of the tank to create a corridor to allow semi-trucks and equipment to move in and out. At the time of the incident, extra space had been needed in the storage tank and one of the doors had been blocked off with a retaining wall to create another area for material storage. Most of the ecology block walls within the storage tank had been constructed by stacking the blocks in an offset manner: however, the rear wall of the section where the incident occurred was stacked without offsetting the blocks, with higher blocks directly on top of the lower blocks (figure 1).

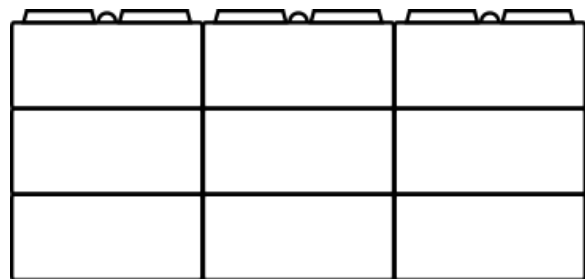
Figure 1: Offset vs. vertical wall assembly

Offset

Vertical

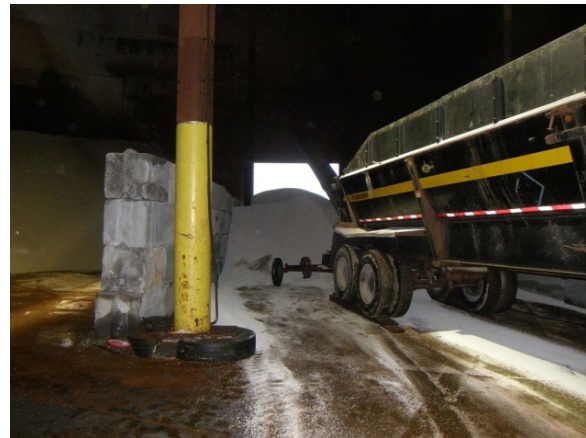
At approximately 5:00 p.m. on the day of the incident, the victim and another worker were in a large steel storage tank unloading a semi-truck trailer of granular bulk fertilizer into a containment bay partitioned by retaining walls assembled using concrete ecology blocks stacked four high. Each trailer contained approximately 25 tons of fertilizer. It was the last truck of the day; two trailers had already been unloaded into the containment area. The trailer had been backed into the containment area (photo 3) and connected to a mobile conveyer belt, or piler, operated by the victim's coworker. Fertilizer was offloaded from the trailer onto the piler, which would drop the fertilizer into the containment bay. The victim was operating a front end loader. As the fertilizer dropped from the conveyer into a pile, the victim would periodically use the front end loader to push the material further into the

Photo 3: Semi-trailer and "piler" positioned to unload product in the storage tank containment bay

bay, against the rear retaining wall. According to the employer and other workers, it was common for the bucket of the front end loader to run into the block walls during this process. The storage tank wall served as the back wall in most other containment bays, and other walls in the center of the storage tank had material on either side. The bay they were working in had previously been part of a corridor that consisted of two large open doorways on either side of the storage tank. When more area for material storage had been needed approximately two years prior, the bay had been created by blocking the large opening with an ecology block retaining wall. No inspection of the block wall had occurred before workers began unloading fertilizer on the day of the incident.

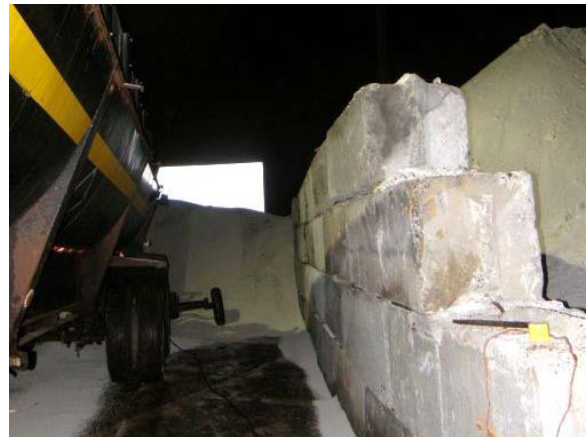
When the trailer had been approximately one-third of the way unloaded, the victim stopped the front end loader and left the machine. He climbed onto one of the sidewalls (photo 4) and walked on top of it toward the rear of the bay, presumably to check to see if material was leaking through the back wall. Shortly after, the victim's coworker heard several loud noises and yelled for the victim, but there was no answer. He ran to the top of the fertilizer pile and saw that blocks had fallen from the back wall. He ran to the outside of the tank. After pulling some of the fertilizer out of the way, he saw the victim pinned to the side of the storage tank wall by a fallen ecology block (photo 5). Another worker immediately called 911 and emergency responders arrived within five minutes. The victim was declared dead at the scene.

Photo 4: Ecology block wall that victim walked on top of to get to the rear of the containment bay

- Never attempt to brace or stabilize a leaning ecology block wall on your own.
 - Avoid walking on top of ecology block walls.
 - Avoid contacting ecology block walls with heavy or other equipment.

- Inspect ecology block wall storage areas before and after loading in material.
- Immediately stop work around ecology block walls showing signs of material leakage, leaning, moving, or other damage.
- Never attempt to brace or stabilize a leaning ecology block wall on your own.
- Avoid walking on top of ecology block walls.
- Avoid contacting ecology block walls with heavy or other equipment.
- Notify the proper person if structural integrity issues in an ecology block wall are found.

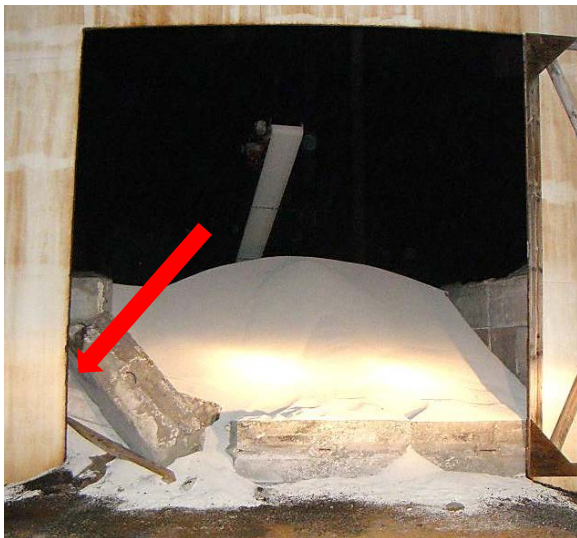
Photo 5: Arrow points to area where victim was pinned to tank wall by falling ecology block

Investigators and the employers believe that the victim saw that material was, in fact, leaking through the retaining wall and climbed down a ladder on the back wall of the storage tank to take a closer look. It appeared that he had been attempting to brace the wall with some long 2" x 6" pieces of lumber when it collapsed.

- Lack of proper design, construction, and maintenance of material storage areas
- Lack of training regarding the dangers of working around bulk material and ecology blocks
- Possible destabilization of block wall due to granular material leaking between the blocks
- Possible destabilization of block wall through contact with the front end loader bucket

Before assembling either temporary or permanent retaining walls from ecology blocks, employers should consult a registered professional engineer (RPE) for approval of the design. A registered professional engineer has the knowledge to ensure that the design takes into account any issues that may affect the structural integrity or safe use of the wall.

Discussion: At this worksite, ecology block retaining walls were often assembled and left in place for years, but inspections were not conducted to assess continuing structural integrity. In this case, it is possible that the wall that collapsed was compromised before workers began unloading material into the containment bay and pushing it back against the wall with the front end loader. Employers should develop a written plan that includes detailed inspection procedures and a thorough checklist. This should be done in cooperation with a professional engineer. The plan and checklist should be shared with employees as part of their training. The plan should also include how walls will be repaired or replaced if issues are found.
