Laborer Falls 55 to 75 Feet to the Ground While Spray Painting Grain Bins

Incident Number: 13KY061

Kentucky Fatality Assessment and Control Evaluation (FACE) Program

Subject: Laborer Falls 50 to 75 Feet to the Ground While Spray Painting Grain Bins

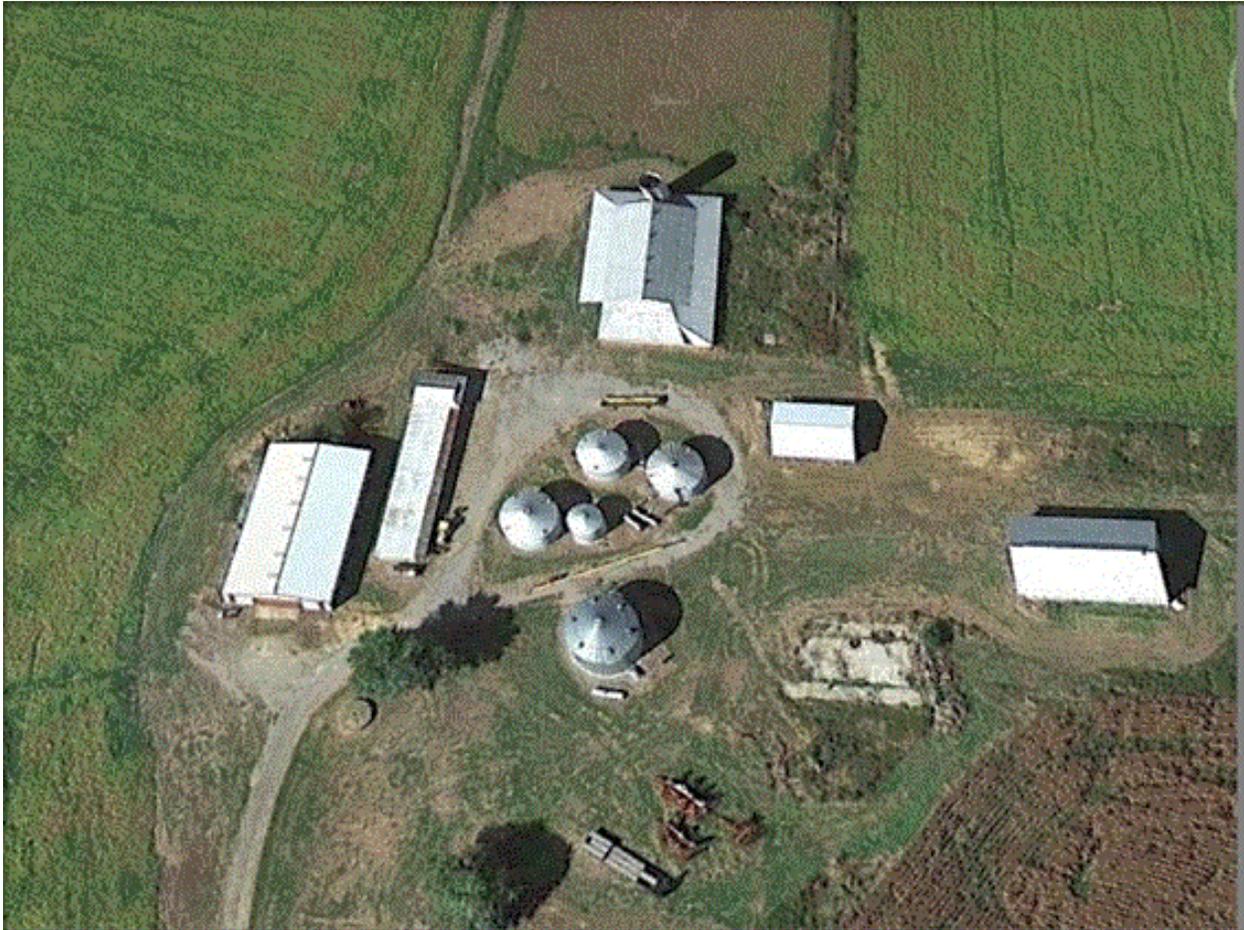
Photo #1 overall view of incident scene

The incident scene was a large farm (see photo #1). The site consisted of three 300,000-bushel bins, one 100,000-bushel bin, one 30,000-bushel wet bin, one 5,000-bushel load out-bin, a dryer bin, a feed mill and a control room/office. The grain elevator system ran from ground level to platforms 30 ft. above the bins. Downspouts running from the elevator delivered grain to the bins. The top of the elevator was approximately 130 feet high off the ground and the grain bins were 55 to 60 feet in height (see photo #2). The dryer bin was equipped with a walking platform with railings. The employee was sliding down a 10 inch diameter down spout above the dryer bin, when he fell to the ground below, landing on the ground between the dryer bin, a wet bin and the control office.

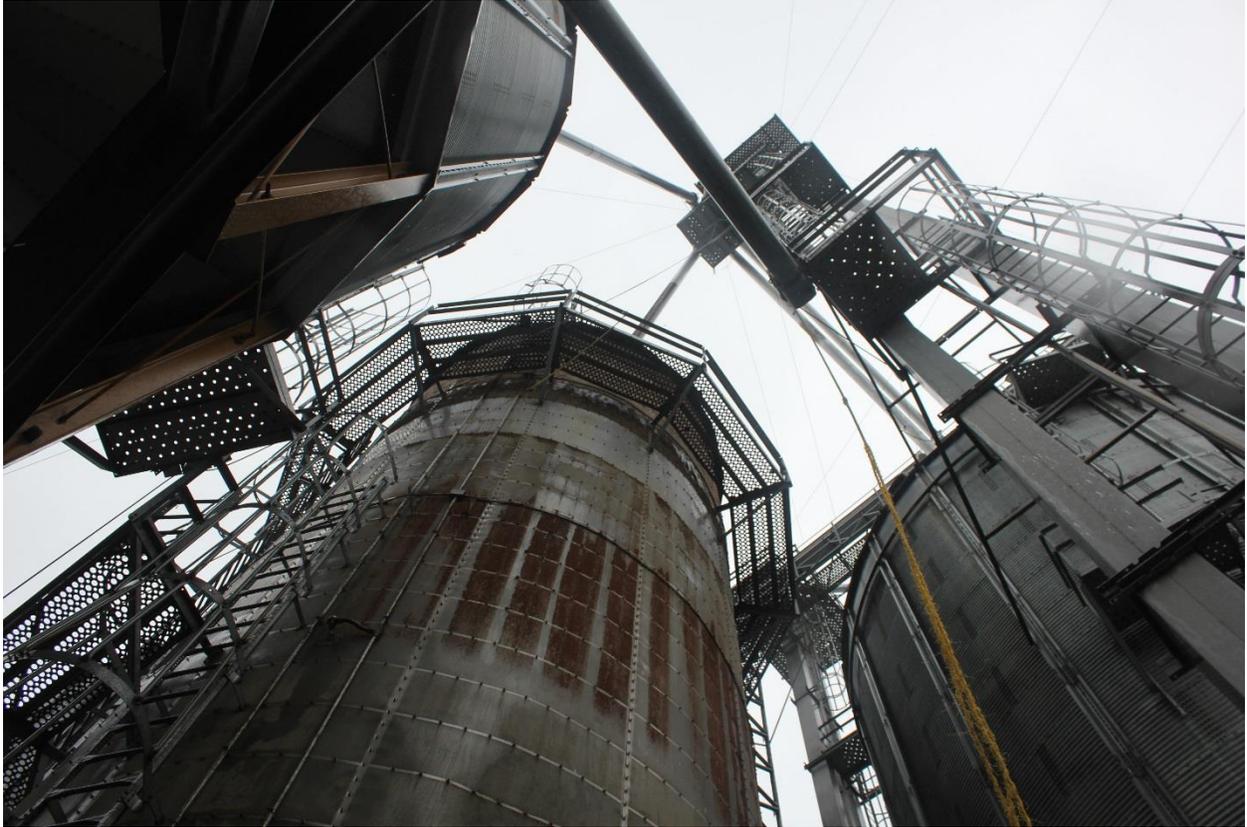
Photo #2 of the grain bin being painted.

It had been raining the previous day and was overcast the day of the incident; the surfaces of the grain bins were still damp. On November 21, 2013, between 7:00 and 7:30 a.m., the victim started painting the dryer bin, which was equipped with a walking platform with railings. It is unclear why the victim decided to hang from a 10 inch diameter downspout above the dryer bin without any type of fall protection. It was from this downspout that he lost his grip and fell 50-

Recommendation No. 1: Regardless of company size, the employer must furnish proper personal protective equipment to employees conducting hazardous work.

The victim did not wear any type of body harness or fall protection to protect him in the event he fell while painting. Had the victim been wearing full body harness fall protection and been properly tied off, his harness would have prevented him from falling to the ground below when he slipped.

According to 29 CFR 1926.501 (b)(1): Each employee on a walking/working surface(horizontal and vertical surface) with an unprotected side or edge which was 6 feet (1.8m) or more above a lower level shall be protected from falling by the use of guardrail systems, safety net systems, or personal fall arrest systems.

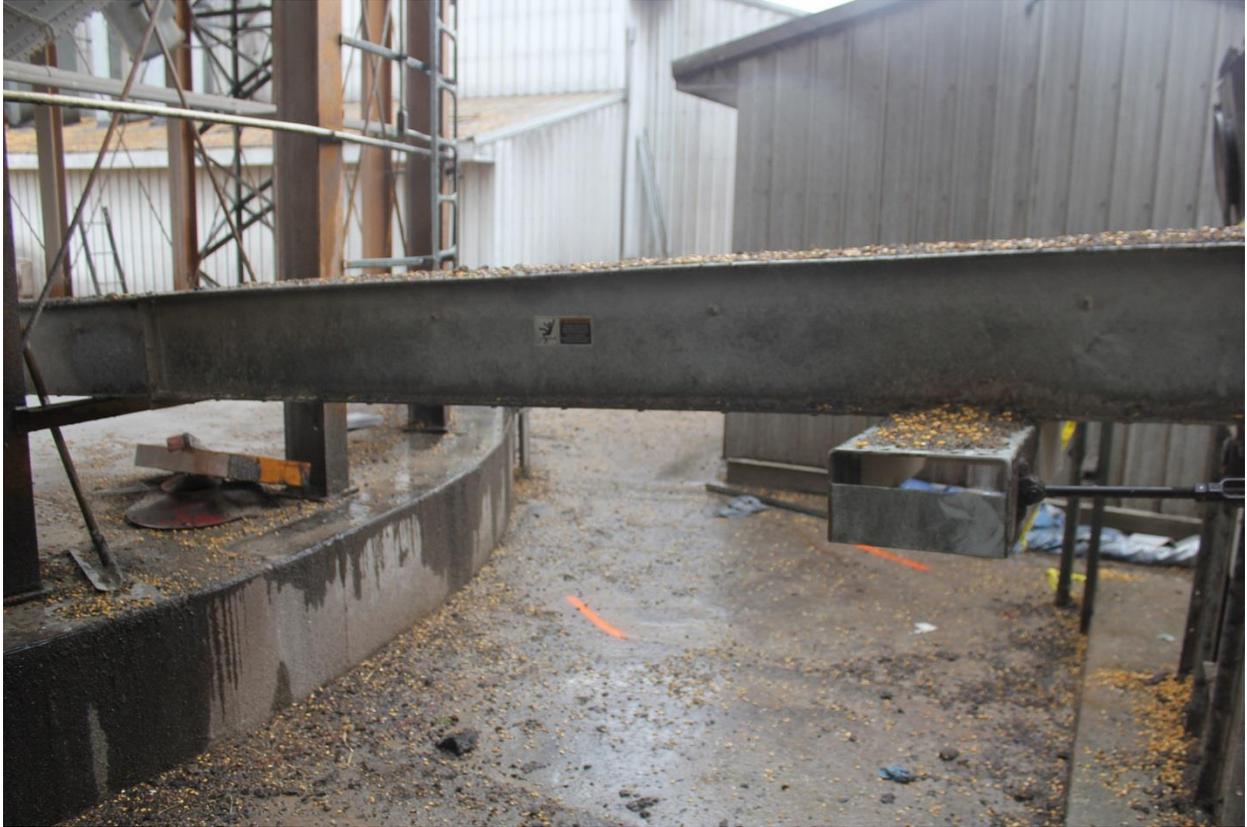
Photo #3 is where the victim landed.

75 feet below to the concrete, between the dryer bin, a wet bin and the control office (see photo #3).
