## Fatality Investigation Report

OR 2013-08-1

# Contract sanitation worker killed cleaning meat blending equipment

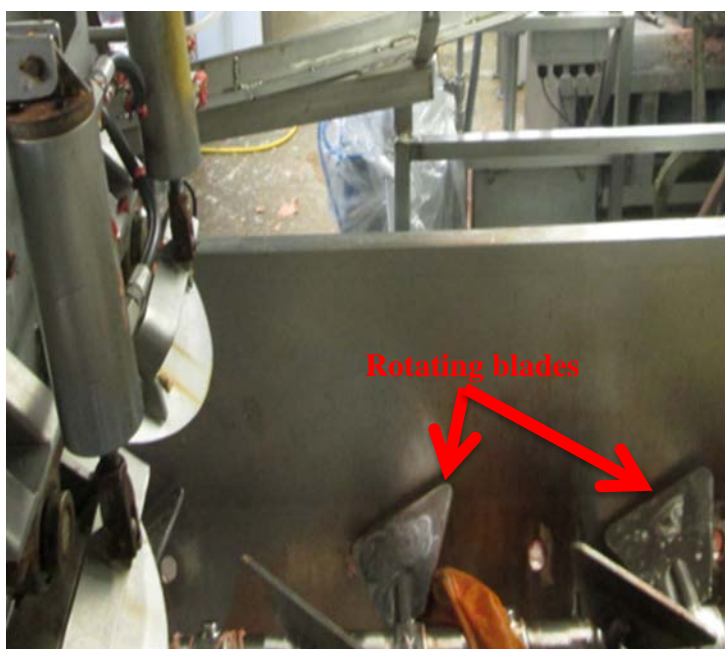
Figure 1. Open top of meat blender where the incident occurred.

was assigned to clean consisted of two horizontal shafts between 6 and 7 feet long and approximately 24 to 30 inches wide. Each shaft had blades/paddles that rotated in opposite directions (see Figure 1). The blender was used to adjust the fat content by mixing product (~3000 pounds) together until the desired content was achieved. It was the only blender in the room. The room was separated by walls from the rest of the processing area. The worker was working alone cleaning his assigned equipment. Other employees were in the building but none had a direct sight line to the worker.

- The top of the blender was open exposing blades/paddles rotating while the worker was on the platform cleaning from above. It is not known whether a guard such as that pictured in figure 5 was onsite and could have been installed. If not available, the equipment manufacturer could have been contacted for a similar retrofit. An online review of meat processing equipment showed advances in interlocked safety guards for grinding/blending equipment. The OR-OSHA report mentioned that moving feed augers and conveyor chain/sprocket were also exposed and running. Similarly, guards/screens could have been installed to prevent contact with these moving parts.

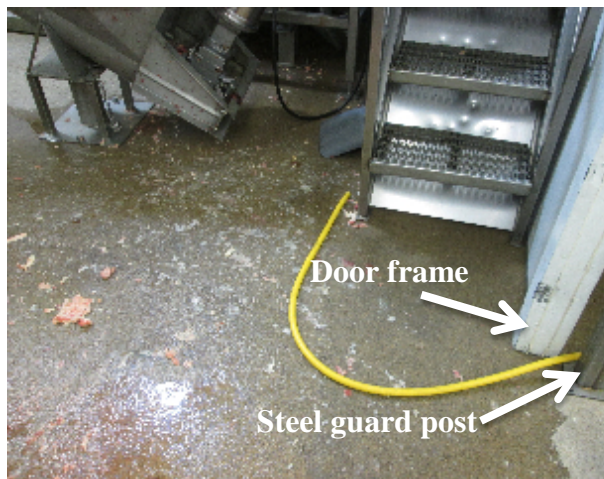
There was a galvanized pipe coupler that connected the hoses found inside the blender vat, which may have caused the unusual sound that brought the incident to the supervisor's attention. It appeared that the hose had been pulled into the room from the location of the spigot between an overhead door frame and a steel guard post, see Figure 4.

Although not known, it is believed that while the worker was on the platform, washing down the blender, the hose splice may have caught on the overhead door frame. When he pulled to free the hose, its sudden release allowed the slack in the hose to fall into the blender. During cleaning, the flowing hot water into cold blender vat would have created steam, preventing the worker from seeing the slack fall into the blender. It is likely that he was pulled into the blender when the hose that appeared to have been wrapped around his leg

Figure 4. Hose looped between door frame and steel guard post.

- In a routine hazard review, the unguarded moving parts and unsafe practice with hoses might have been identified, prompting facility redesign or procedure modification to prevent injuries.
  - Using prevention through design practices (see Renshaw) may have mitigated the risks of hose entanglement and falling into the blender vat. Spigots near equipment where washing was required would have reduced the length of hose and eliminated the need to pull hose through the overhead door frame thus reducing entanglement, tripping, and ergonomic hazards. Another method for mitigating these hazards would

be self-coiling, retracting hoses or overhead connections that would have reduced the slack in the hose.

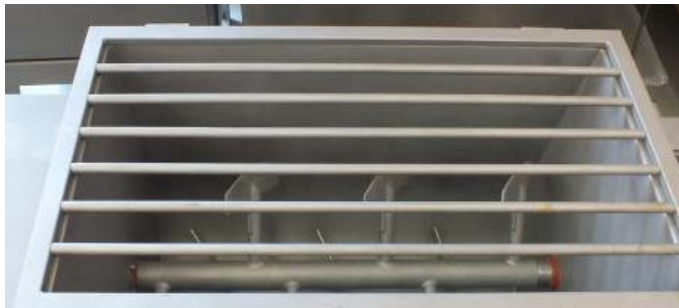
Figure 5. Example of guard for blender/grinder to prevent access to moving parts but allow cleaning.
