# **Roofer Dies After Gust of Wind Knocks Him And A Co-Worker Off Roof**

**Incident Number: 13KY059**

## **Kentucky Fatality Assessment and Control Evaluation (FACE) Program**

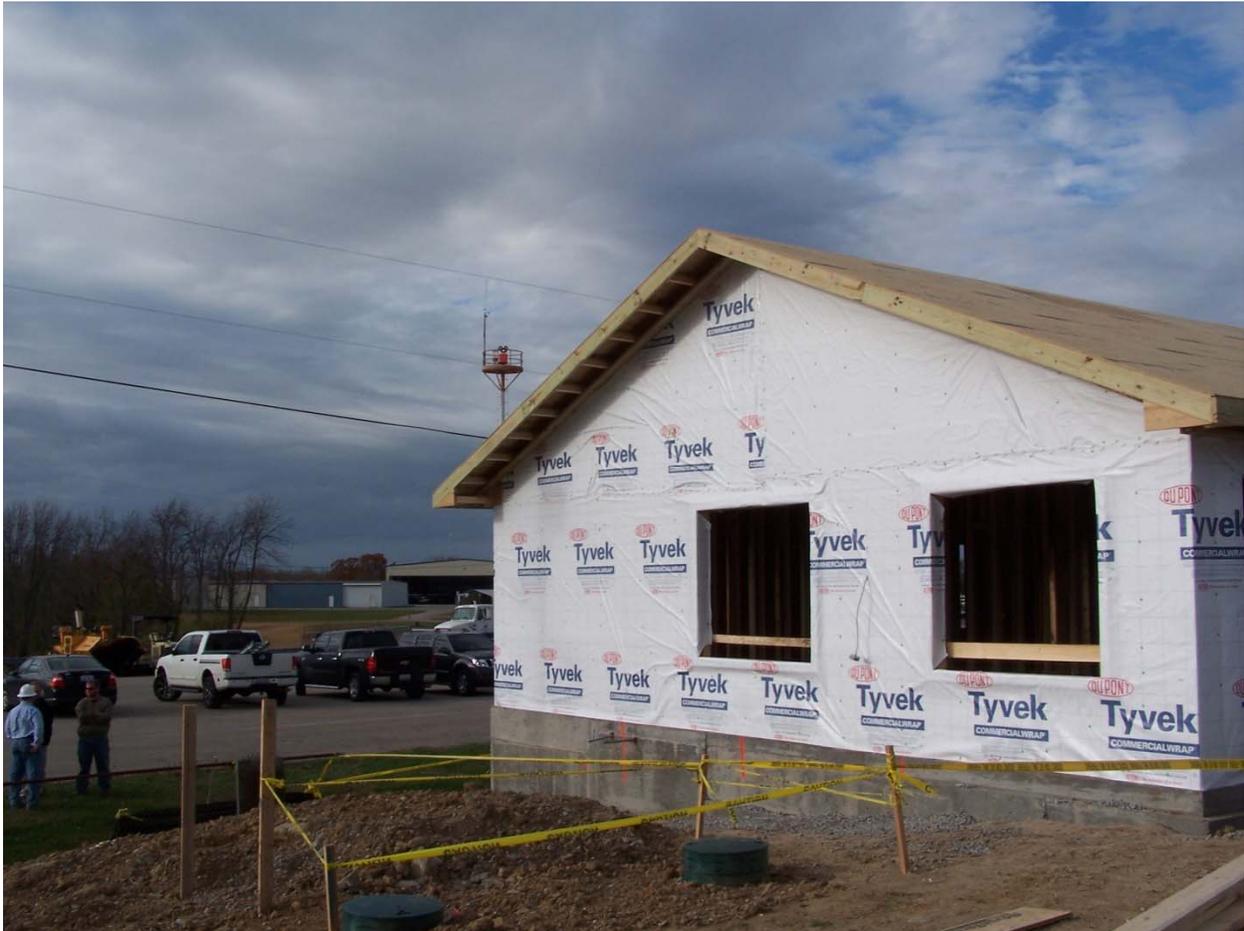
**The fall took place from this structure. Photograph property of KY FACE Program**

Around 11:00 a.m. on a windy fall day, a 73-year-old roofer and roofing coworker arrived at the commercial construction site to roof a newly constructed building. The two roofers climbed the extension ladder to access the roof of the one story commercial building, to decide where they were going to place their anchors to tie off. They had not yet put on their personal fall protection gear. While reviewing the backside of the commercial structure, a gust of wind around 33 m.p.h. made the two roofers lose their balance and fall from the roof. At 11:09 a.m., the 73-year-old roofer landed first and the second roofer landed on top of him. Both roofers fell 15 feet 6 inches and landed on a sloped grassy area next to the commercial building.

**Recommendation No. 1: Employers should not allow their roofers to access roofing areas in times of windy, wet, or icy or conditions to prevent falls.**

**Recommendation No. 2: A roofer should use a personal fall protection system during all phases of a roofing job.**

If the roofers had been wearing personal fall protection gear they could have placed their first anchor at the peak of the roof with a minimum of 6 feet from the edge and tied off immediately possibly saving them from the gust of wind that caused them to lose their balance and fall. It is unclear how much impact having one roofer land on the other roofer played into the fatal fall. It is not known if roofer #1 would have survived if this had not been a factor. However, it did add to the force of the trauma. Only one roofer should access the roof to install anchors limiting the exposure.

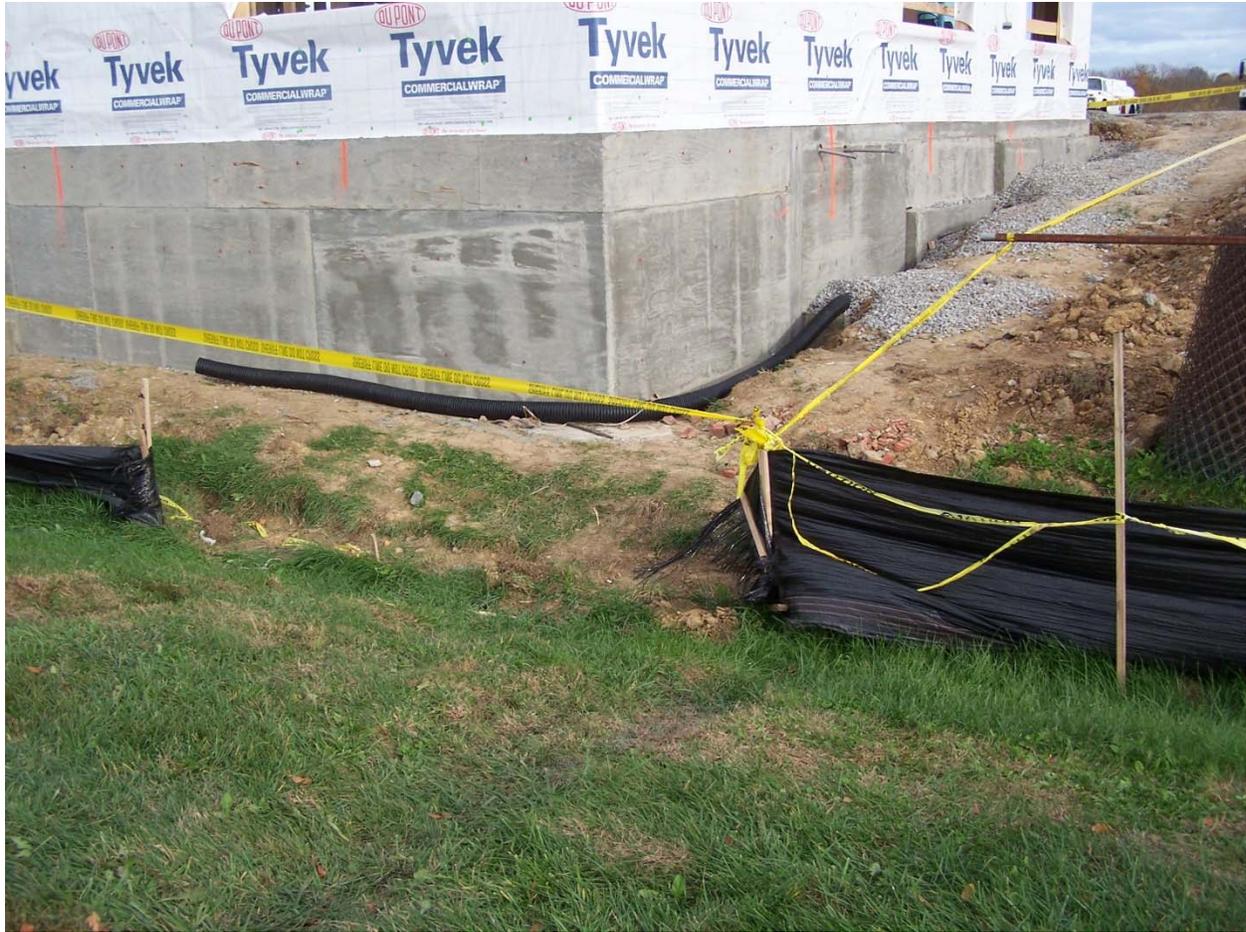
Area of impact where employees landed from fall. Photograph property of KY FACE Program
