Construction Flagger Struck and Killed in Two-Lane Highway Work Zone

Incident Number: 14KY002

Kentucky Fatality Assessment and Control Evaluation (FACE) Program
Incident Number: 14KY002
Release Date: May 23, 2014
Subject: Construction Flagger Struck and Killed in Work Zone

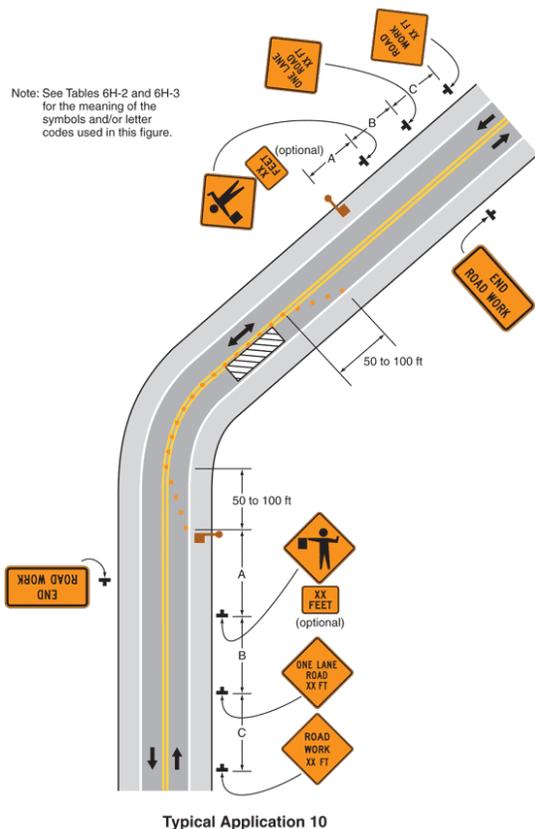
Figure 6H-10. Lane Closure on a Two-Lane Road Using Flaggers (TA-10)

1. For low-volume situations with short work zones on straight roadways where the flagger is visible to road users approaching from both directions, a single flagger, positioned to be visible to road users approaching from both directions, may be used (see Chapter 6E).
2. The ROAD WORK AHEAD and the END ROAD WORK signs may be omitted for short-duration operations.
3. Flashing warning lights and/or flags may be used to call attention to the advance warning signs. A BE PREPARED TO STOP sign may be added to the sign series.

4. *The buffer space should be extended so that the two-way traffic taper is placed before a horizontal (or crest vertical) curve to provide adequate sight distance for the flagger and a queue of stopped vehicles.*

- 5. At night, flagger stations shall be illuminated, except in emergencies.**

6. *When used, the BE PREPARED TO STOP sign should be located between the Flagger sign and the ONE LANE ROAD sign.*
7. *When a grade crossing exists within or upstream of the transition area and it is anticipated that queues resulting from the lane closure might extend through the grade crossing, the TTC zone should be extended so that the transition area precedes the grade crossing.*

Recommendation No 4. Companies should set up traffic control in accordance with the MUTCD.
