Hispanic Roofer's Fall Protection Failed Causing Him to Fall 29.91 Feet to His Death

Incident Number: 14KY030

Kentucky Fatality Assessment and Control Evaluation (FACE) Program
Incident Number: 14KY030
Release Date: March 9, 2015
Subject: Hispanic Roofer's Fall Protection Failed Causing Him to Fall 29.91 Feet to His Death

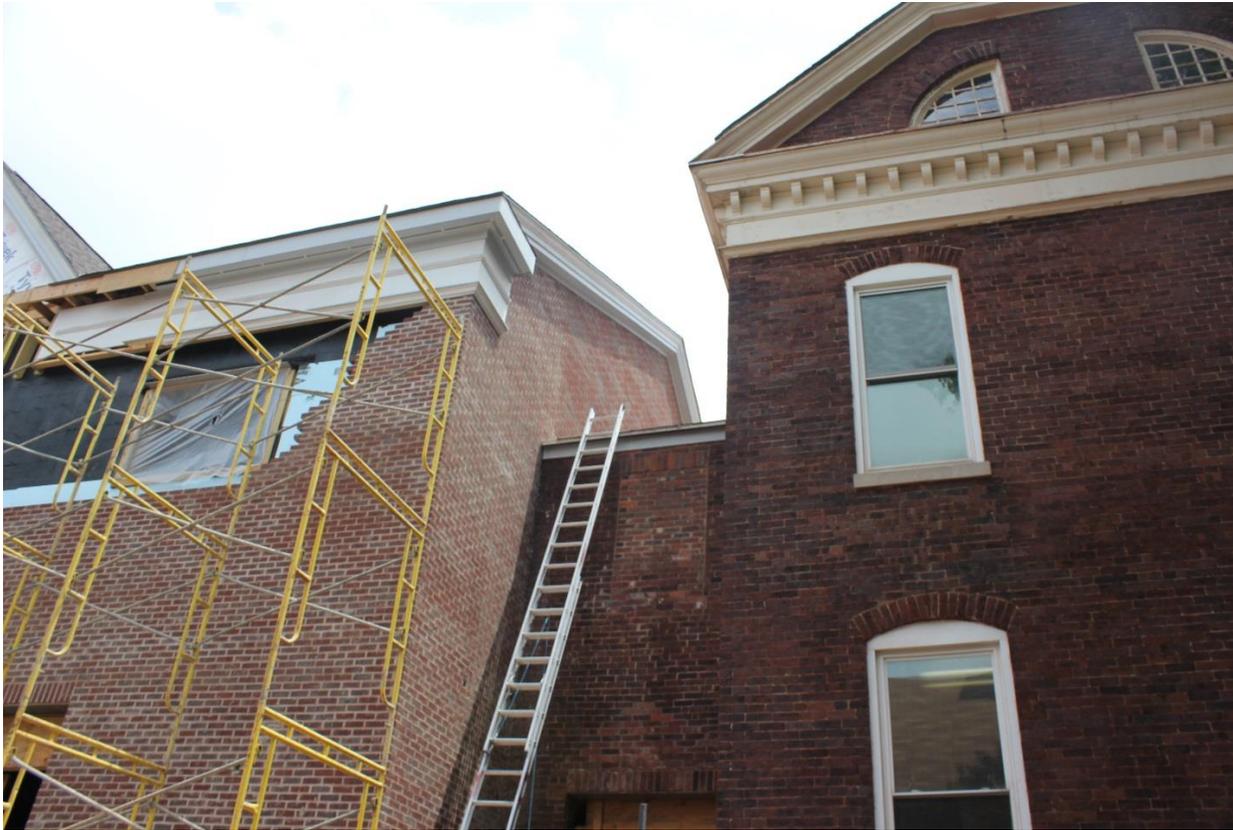
Photo #1 building with scaffold where victim was working

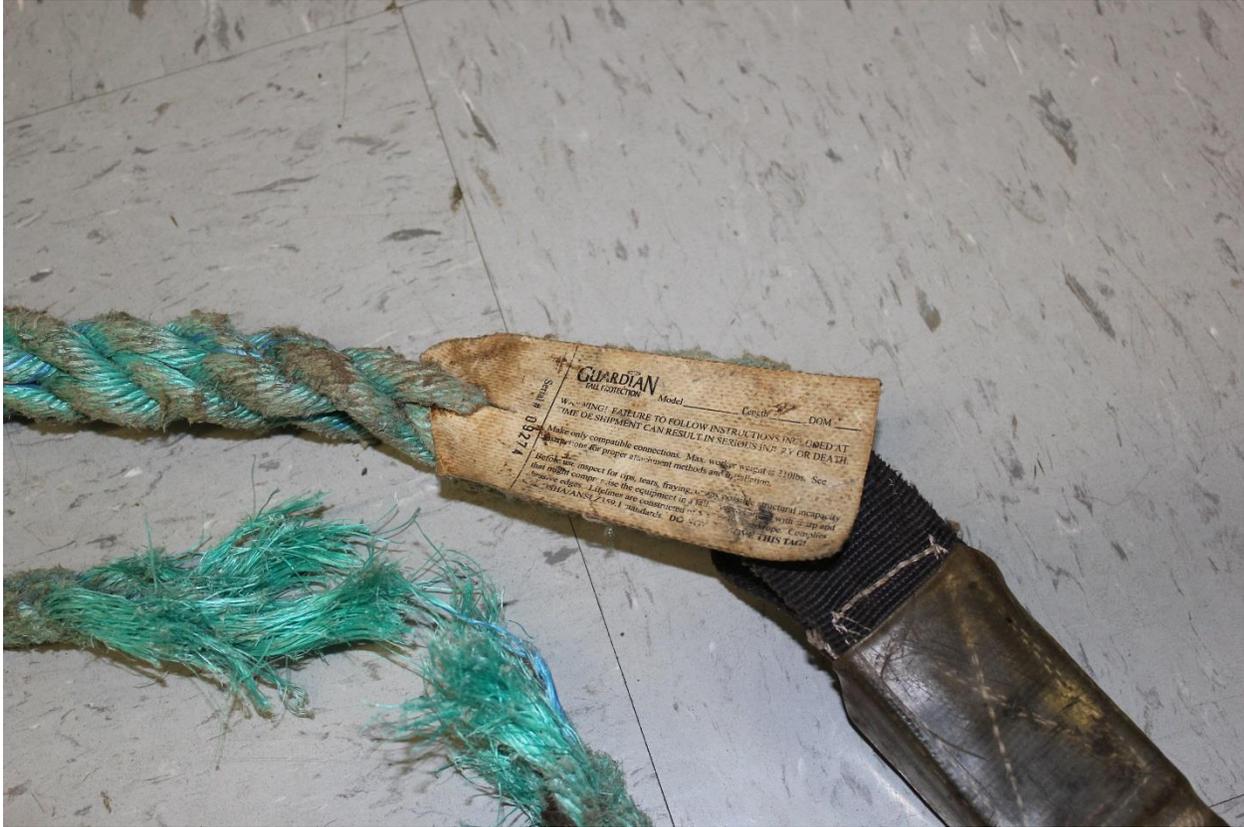
The victim's rope, which showed definite signs of aging and deterioration, appeared to have snapped approximately 12 inches from the rope positioning device (rope grab) (see Photo #2). The section of the rope where the break occurred was very dry and brittle and pieces were easily torn off with light pressure. The rope severed approximately 11 feet from the anchoring point. The positioning device and snap hook showed signs of rust. (See photo #3) Other ropes that were onsite also showed signs of wear.

Photo #2 where the lanyard broke

Inspection of the fall protection equipment before commencing work is imperative to ensure the safety of the employees using the safety equipment. Ropes, harnesses, and other fall protection equipment become worn and weakened over time and should be replaced upon first notice of any sign of damage. The victim's rope was clearly worn with a rusted positioning device and snap hook. The rope was very brittle and easily pulled apart. Daily inspection of the fall protection equipment would have identified the rope defects. There were no training records to verify any of the employees had received fall protection and during interviews the employees were not clear on how to wear the fall protection or the ratings for weight. Basic fall protection training was not provided nor were the OSHA standards for working on roofs. OSHA's 1926.503, PFAS subpart M, 1926.501 (b) (10) and 1926.501 (b) (11) explain the standards for working on roofs with low-slopes and steep roofs.

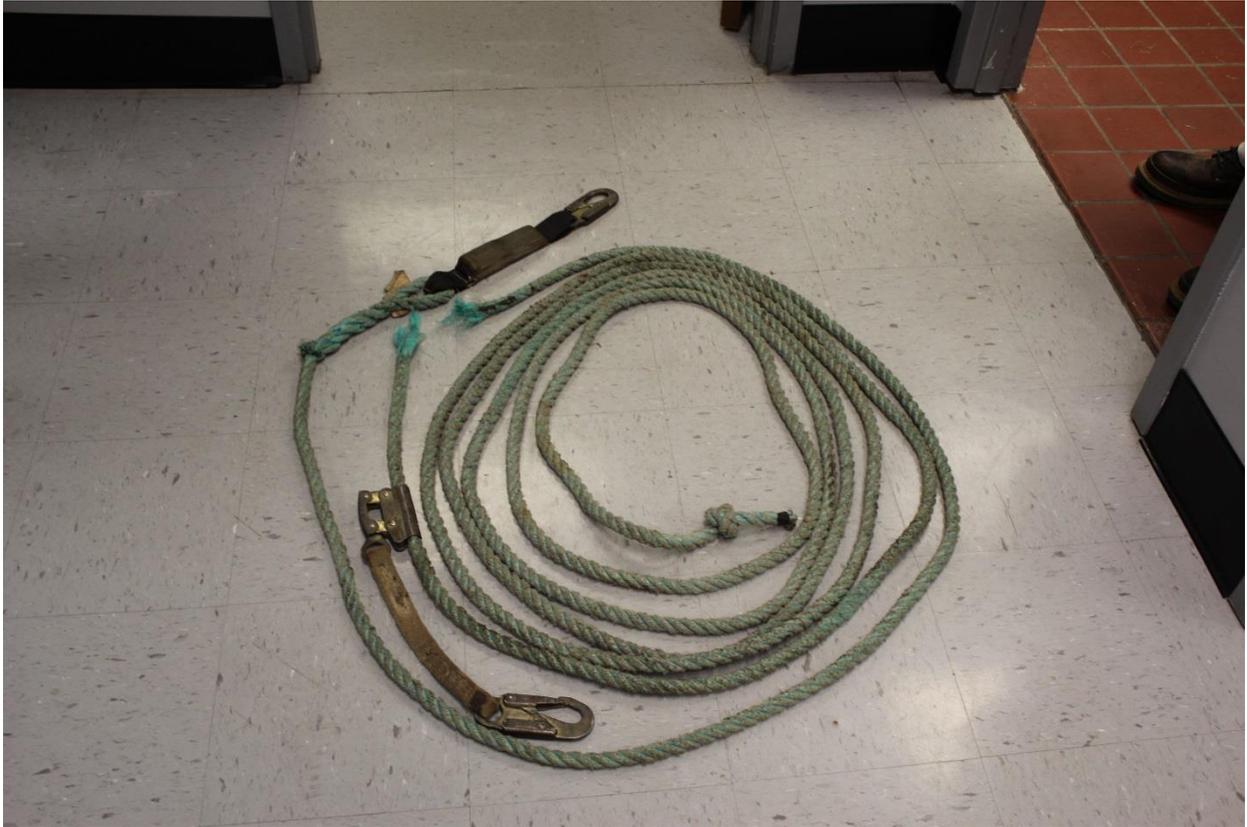
- Lack of proper maintenance, evident by the rusting position device and snap hook.
- Overstressed; the rope appeared frayed, as if it had been dragged across a sharp edge several times.
- A black mark adjacent to the cut location was also discovered, and its cause is unknown. (see photo#4)

Photo #3 the worn lanyard with rust.

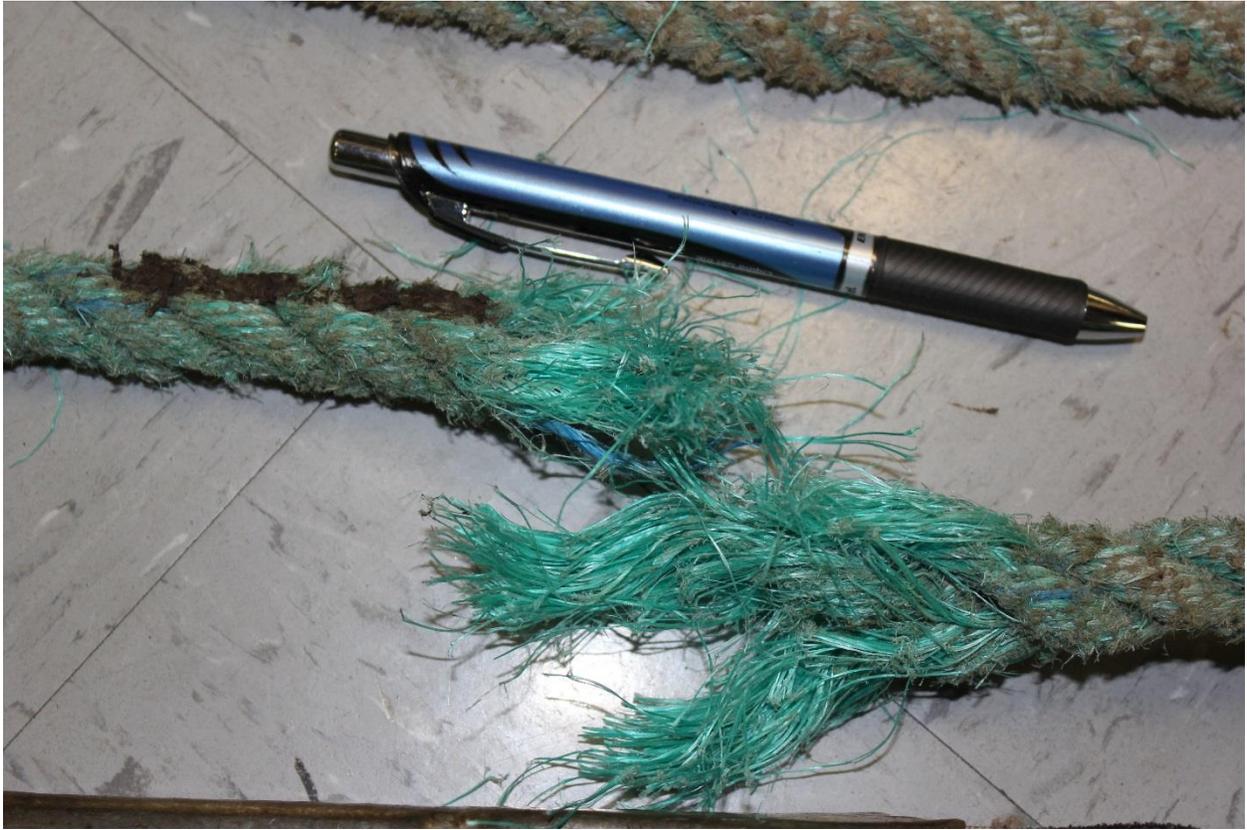
Photo #4 frayed rope
