Factory Manager Bypasses Lockout/Tag-out and is Electrocuted

Incident Number: 14KY031

Kentucky Fatality Assessment and Control Evaluation (FACE) Program
Incident Number: 14KY031
Release Date: October 17, 2014
Subject: Factory Manager Bypasses Lockout/Tag-out and is Electrocuted

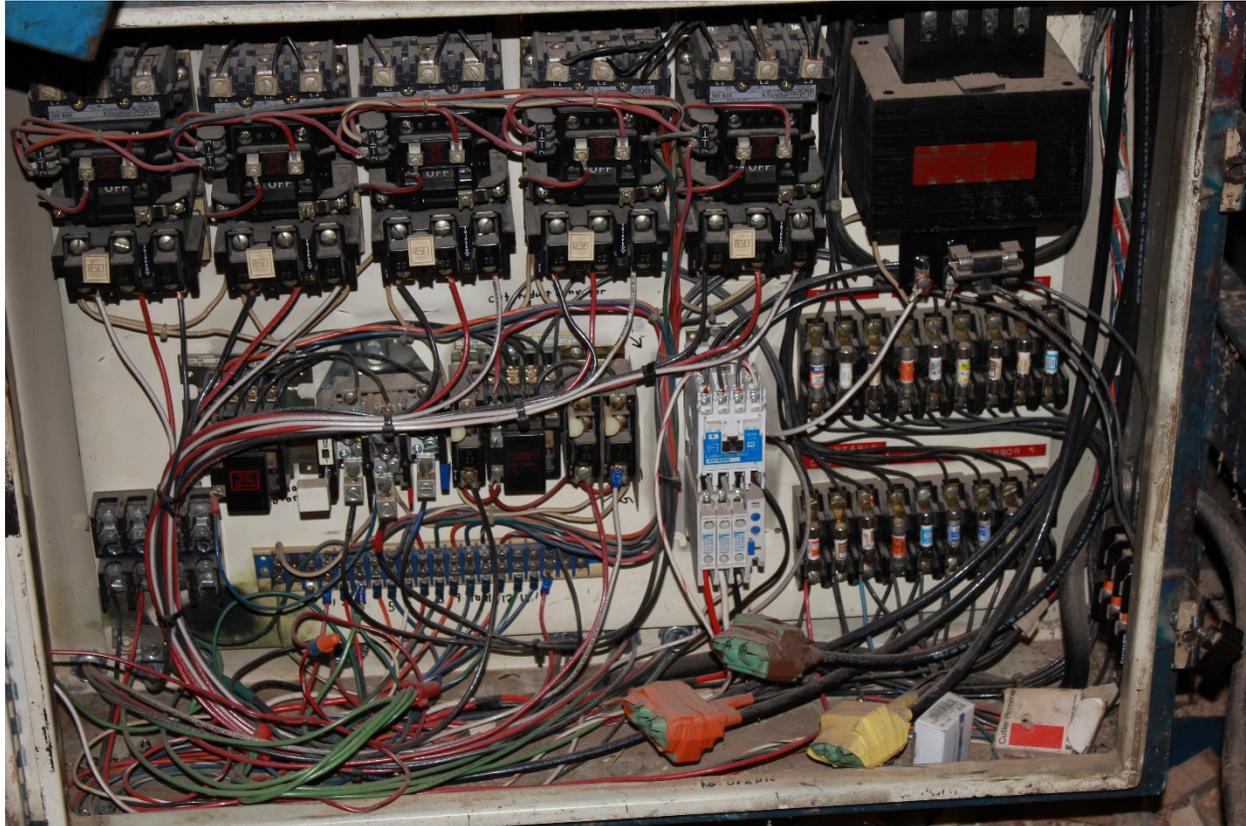
Control panel box of multiple blade saw

The Department of Housing, Buildings and Construction Electrical Division was contacted by the Fire Marshall, who requested an electrical inspection of the incident scene. An investigation was opened on June 13, 2014. The inspector spoke with employees, who reported seeing the victim bend down in front of the open door of the machine control panel without first de-energizing it. The saw was fed from panel A, and protected by a 100 amp 3 pole breaker. The conduit and wiring from the main electrical panel to a 100 amp rated 3 pole was traced. The inspector found no electrical violations or concerns with equipment or wiring. He concluded that faulty equipment or wiring was not to blame for the incident that occurred.

The employer had a LOTO policy and procedures, and employees had been trained by an outside contractor on September 5, 2013. The victim had attended this training, and was aware of the hazards, but safety procedures were not followed and he reached inside the control panel, resulting in electrocution. The OSHA standard for LOTO actions and procedures can be found in 29 CFR 1910.147. “This standard covers the servicing and maintenance of machines and equipment in which the unexpected energization or startup of the machines or equipment, or release of stored energy could cause injury to employees. This standard establishes minimum performance requirements for the control of such hazardous energy.”

Recommendation No. 1: Employers should ensure that all employees servicing or maintaining electrical equipment practice proper lockout/tag-out (LOTO) procedures.

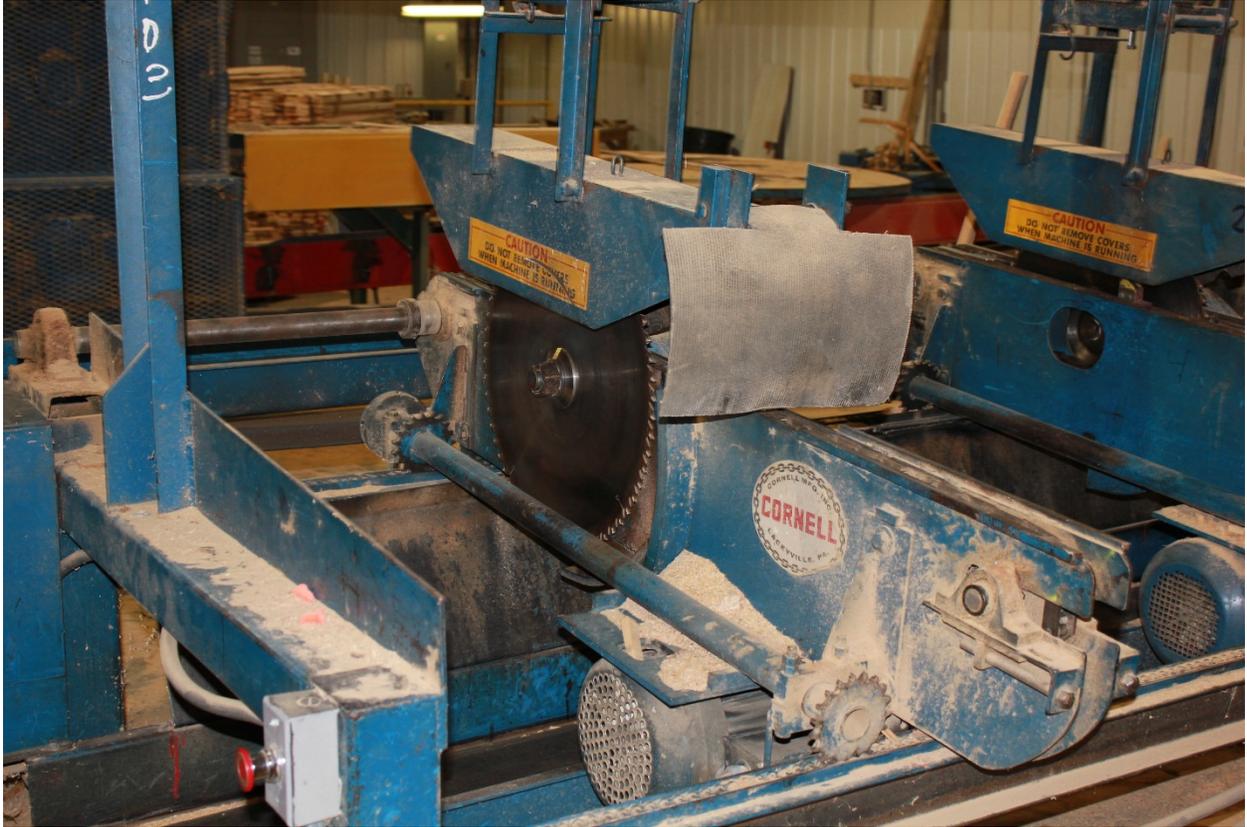
The incident occurred inside a fabricated metal building. The victim was by the control box of a five blade multiple trim saw. The saw was manufactured by Cornell Manufacturing, Inc. and was a model MSTB, Serial #294-4-86.

Multiple blade saw

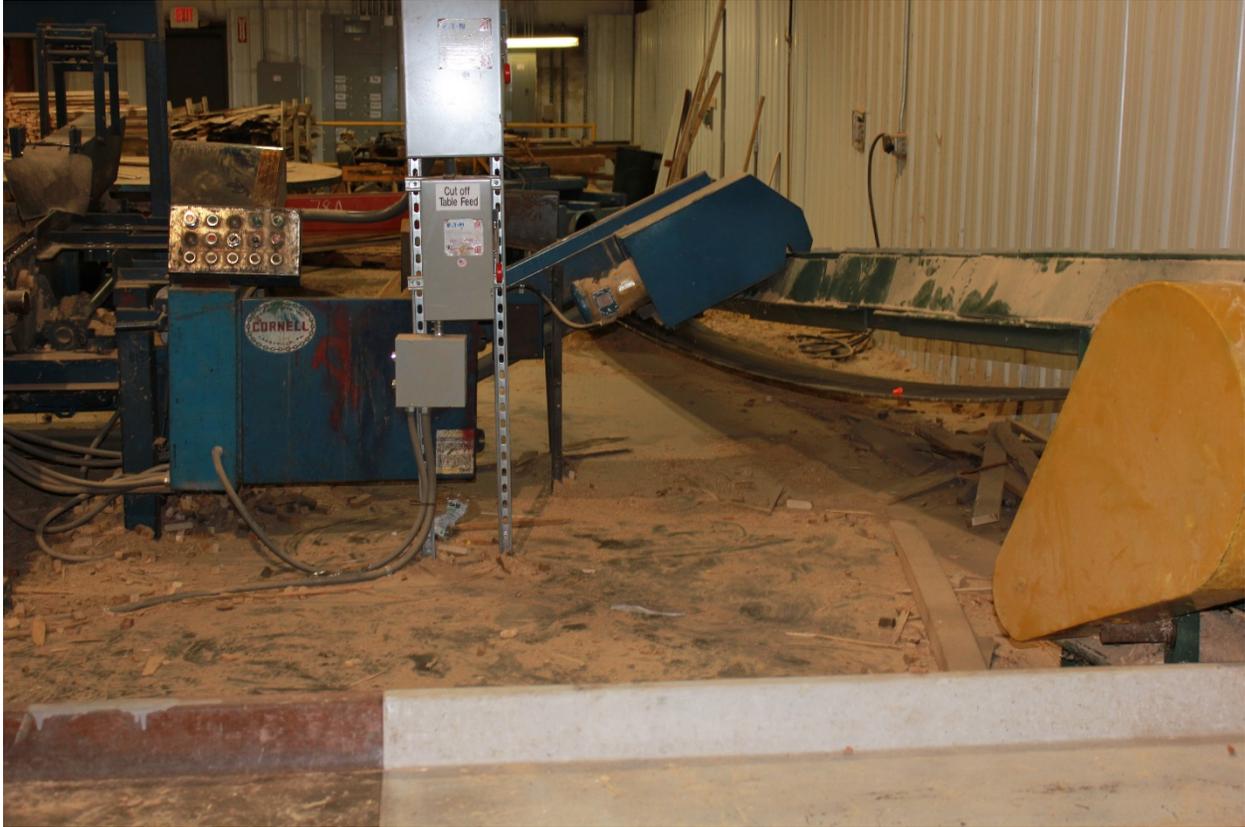
Incident Scene

Work area where victim was electrocuted.
