Occupational Fatality Report

Municipal Crossing Guard Fatally Injured When Struck by a Motor Vehicle – Massachusetts

Release Date: May 9, 2016
Investigation: # 14-MA-036-01

Massachusetts Department of Public Health
Occupational Health Surveillance Program

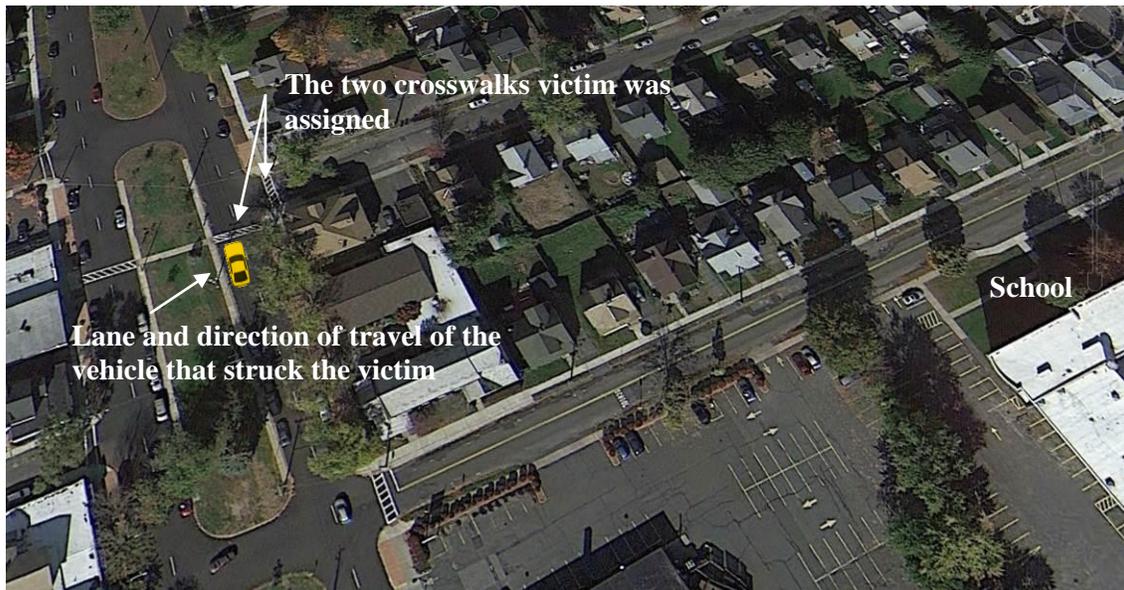
The victim's assigned location was within the busy downtown area on the main roadway, which ran north and south. This area consisted of a four lane median divided asphalt roadway that was straight and flat in this area. The median was a wide grassy area with some trees. Both the northbound and southbound travel lanes had the same design: two same direction travel lanes divided by painted dashed white lines. Along both the outer right and left-hand sides of the roadway was parallel parking with white roadway marking designating each parking space. On the outer edge of each parking lane there was granite curbing and then sidewalks (Figure 1).

This intersection with the two crosswalks was unsignalized and the crosswalks formed an L-shaped area that the victim was responsible for (Figure 1). Each crosswalk was made up of two white painted parallel lines with white diagonal center lines. These painted crosswalk markings were fading and in the need of being repainted. The speed limit for the main roadway was an unmarked 30 miles per hour (MPH), which is in accordance with Massachusetts General Laws, Chapter 90, Section 17, Speed Limits for a thickly settled business district.

Figure 1 – Aerial view of the incident location and surrounding area

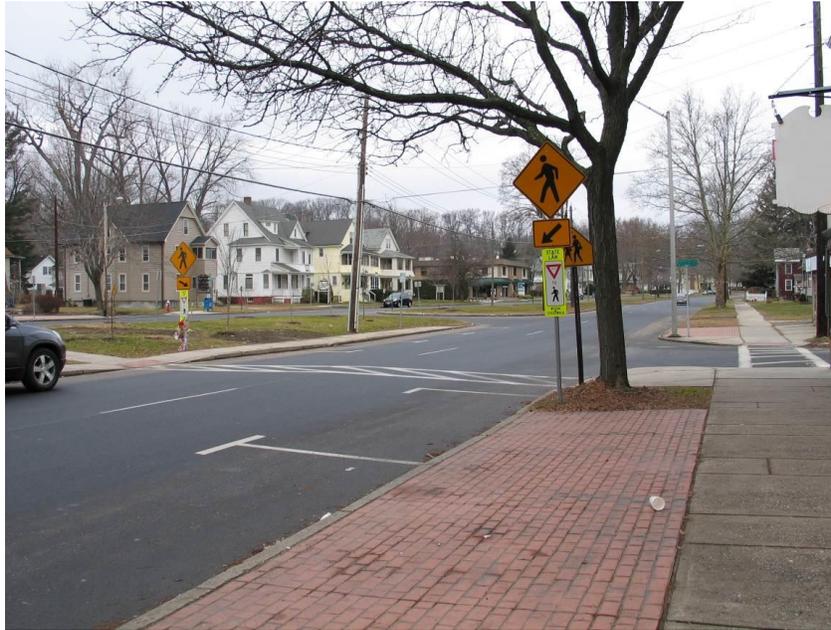
One of the two crosswalks to which the victim was assigned traversed the two northbound travel lanes and the two parking lanes making up the main roadway. These parallel parking spaces on the main roadway abutted the crosswalk (Figure 2). The second crosswalk the victim was responsible for traversed a side street that perpendicularly intersected the main roadway (Figure 3). This side street was parallel to and one block north of the side street on which the school was located.

The crosswalk that traversed the northbound lanes of the main roadway contained the following signage on both sides of the roadway: a non-fluorescent yellow diagonal pedestrian crossing sign with a yellow downward pointing arrow, and a florescent yellow-green state law yield to pedestrian within crosswalk sign. In addition, the right-hand side of the roadway also contained a non-fluorescent yellow school zone sign behind the other sign assembly (Figure 2). There was no signage to warn of the crosswalk that traversed the side street at this intersection.

Figure 2 – Street view of crosswalks within the intersection where the victim was struck

In this case, prior to the incident, traffic control signage was present at the crosswalk location, although not all of the signage was in compliance with the MUTCD. Some of the signage was in compliance and had the fluorescent yellow-green background and some of the signage was not in compliance and had a non-fluorescent yellow background (Figure 3). The crosswalk roadway markings were fading. On-street parallel parking was allowed within 20 feet of the crosswalk and on both sides of the roadway (Figure 3), which is prohibited by the MUTCD. These conditions would possibly contribute to a motorists' decreased visibility of the crosswalks.

- Prohibit parking and standing of any motor vehicles within 20 feet of both sides of crosswalks. No parking and no stopping signs and roadway markings should be used. As in this case, when vehicles are allowed to park or stop on both sides of the street and on both sides of the crosswalk, these vehicles can block both the pedestrian's view of oncoming traffic and the motorist's view of pedestrians trying to enter the crosswalk. In addition, vehicles parked immediately after a crosswalk might distract the motorists as they drive through the area.

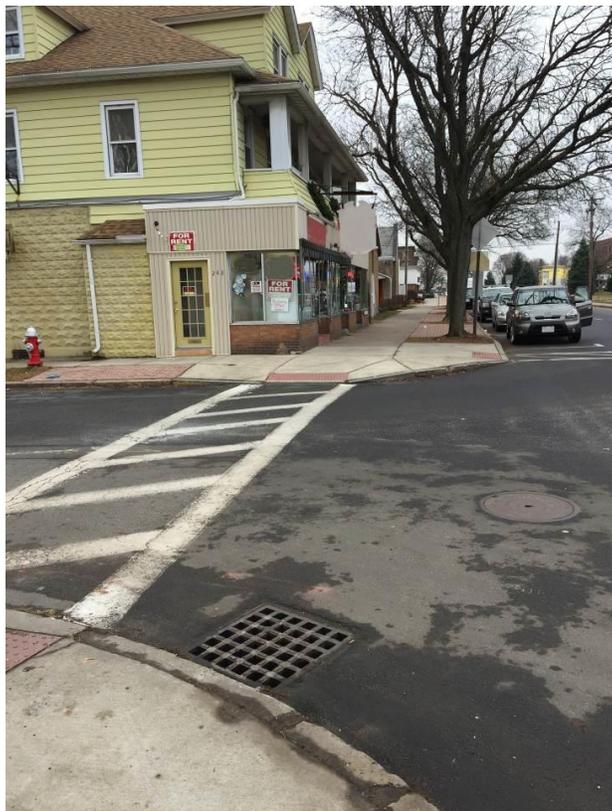
Immediately before the incident, the victim was standing on the north side of the side street when a student walked up to her to cross the side street. The victim stepped into the side street and an approaching car that was traveling west on the side street stopped as she crossed the student within the crosswalk (Figure 3). Once the student was across the side street and on the side walk,

Figure 3 – Street view of side street crosswalk that the victim crossed with the student before the incident

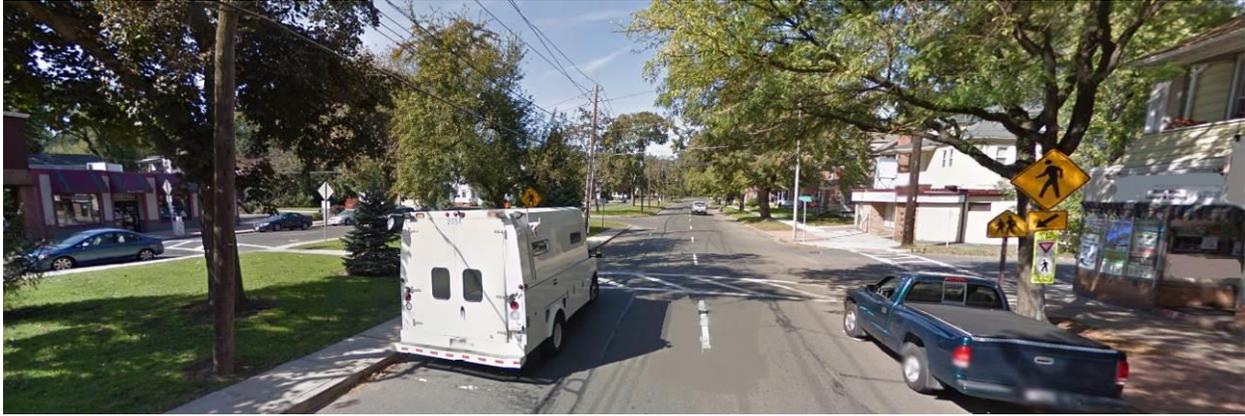
A convenience store was located at the intersection, next to both the crosswalk on the northbound travel lanes of the main roadway and the crosswalk for the side street. During the site visit, multiple vehicles stopped and parked to patronize this location (Figure 4).

Figure 4 – Street view of intersection where victim was struck with vehicles parked on both sides of the street

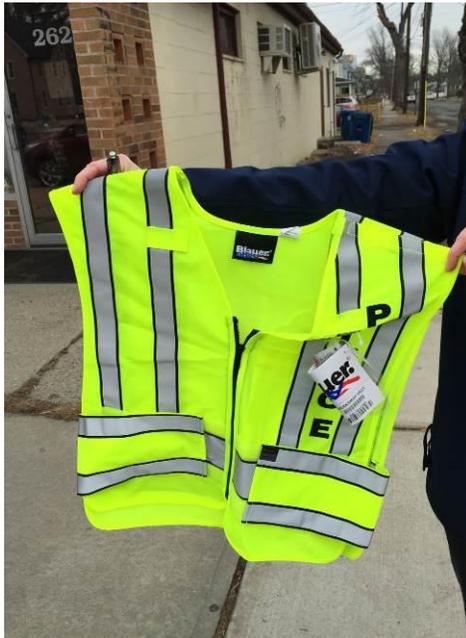
The incident occurred around 7:50 a.m. on a Monday. At the time of the incident it was 29 degrees Fahrenheit, overcast and there was no wind. The victim arrived at her assigned location and parked her car on the main roadway, within the parallel parking on the left-hand side of the northbound travel lane. The victim was wearing a yellow-green ANSI Class 2 high-visibility vest and was also wearing yellow-green high-visibility mittens while performing her job (Figure 5).

Figure 5 – Example of an ANSI Class 2 high-visibility vest

Discussion: One of the hazards crossing guards face while working is being struck by a moving vehicle. Their work positions them in and around roadways, bringing them in close proximity to motor vehicle traffic usually with no barriers between them and the moving vehicles. Crossing guards should be provided with the appropriate personal protective equipment (PPE), such as the vests that were provided to the victim and other crossing guards in this municipality. The ANSI Class 2 high-visibility garments are intended for use where greater visibility is necessary during inclement weather conditions and when activities occur near roadways where traffic speeds
