SUBJECT: A Floorhand Dies When He Falls Off a Mobile Oil Well Servicing Rig

SUMMARY
California FACE Report #14CA001

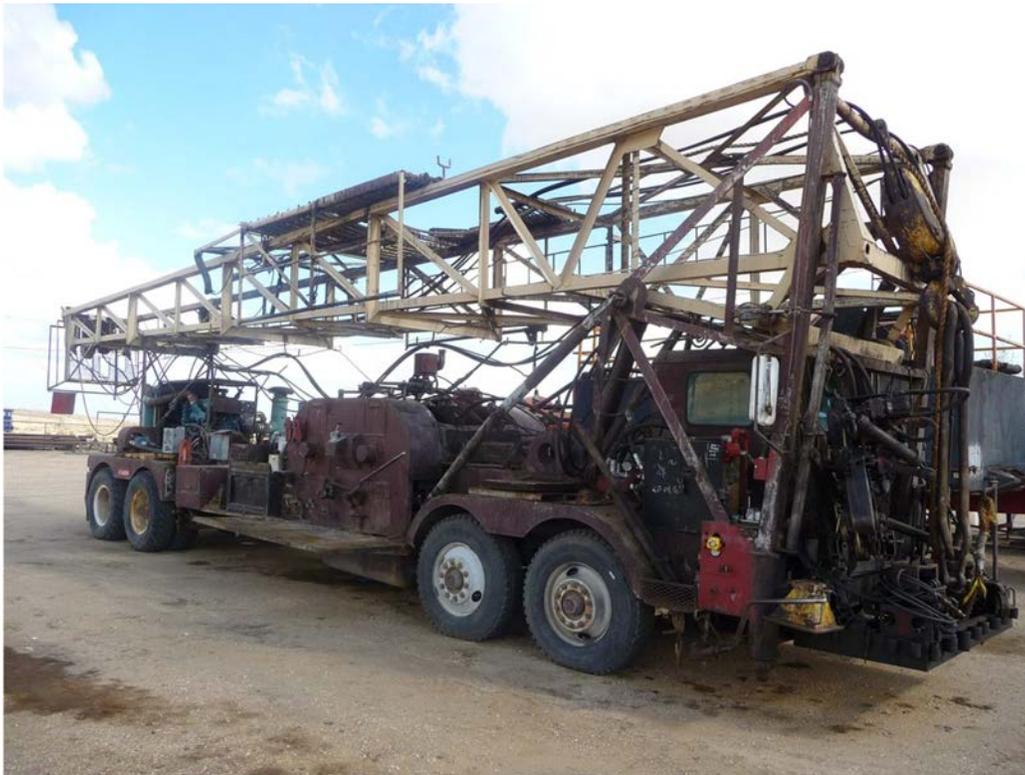
Exhibit 1. The mobile oil well servicing rig involved in the incident.

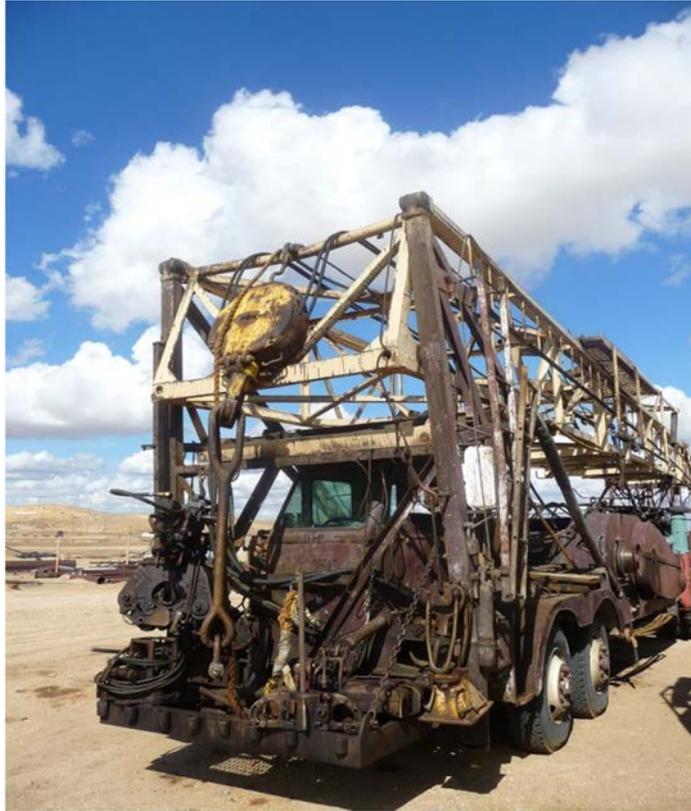
Exhibit 2. The front of the rig involved in this incident.

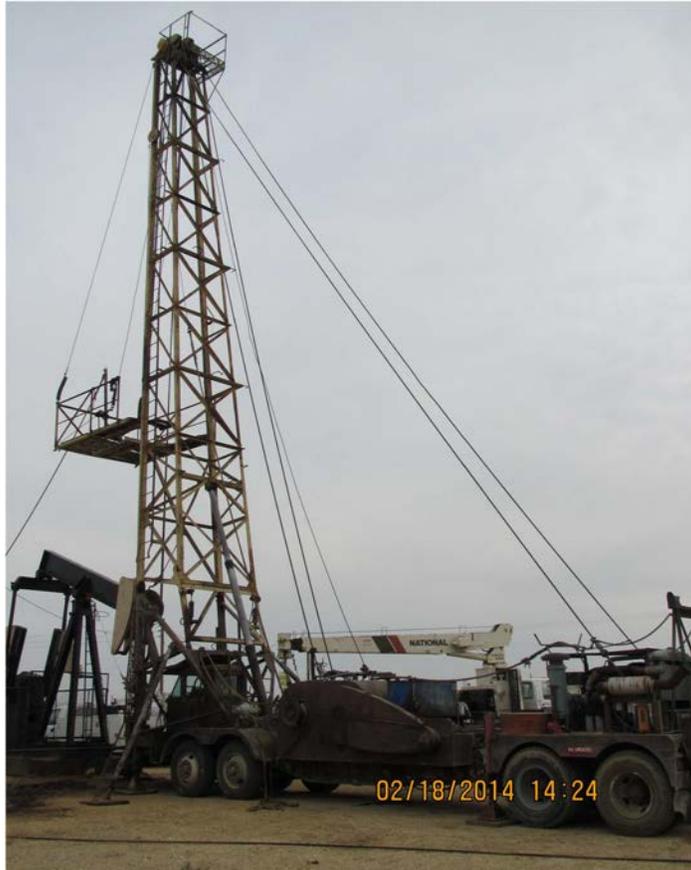
Exhibit 3. The rig at the incident scene with the boom extended.

Discussion: In this incident, the victim was standing on a deck without guardrails, as this would interfere with the boom position during travel. As an older piece of equipment, the deck of this rig was not designed with tie-off points or anchors that allowed for a fall restraint system. Some newer mobile oil well servicing rigs are designed with features that can be used for this purpose. Alternatively, the deck could be retrofitted with anchor points. Although the victim and likely many other employees had worked off this deck many times in the past without incident, the risk of severe injury from a fall was nonetheless present. Had the employer ensured that this mobile rig had anchors for a fall restraint system, the victim may have tied off and prevented his fall.

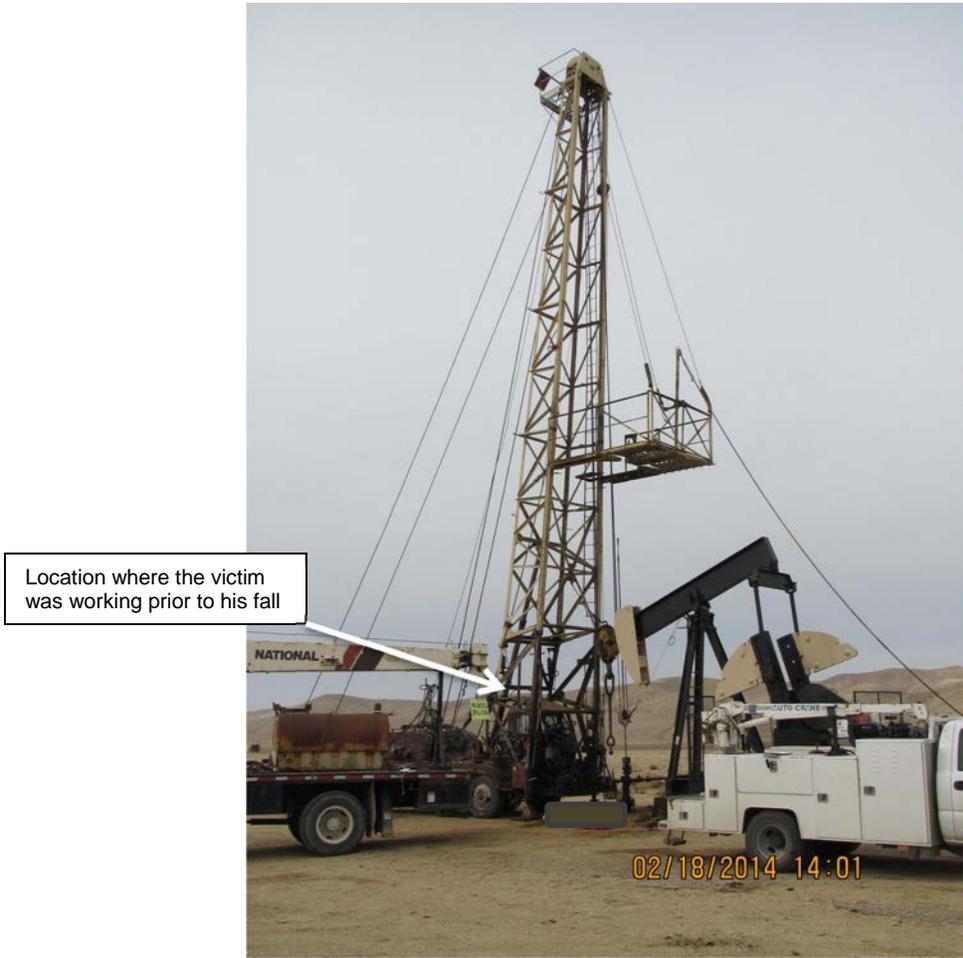
Exhibit 4. The location where the victim fell from.

Discussion: In this incident, the victim was standing on the deck of the cab, approximately eight feet above ground level, and did not attach his personal fall restraint system. A fall from more than six feet can result in severe injury including fracture, internal bleeding, and possible death from spinal injury. The California Petroleum Safety Orders require that a safety belt and lanyard be used as a restraining system for each employee working on a derrick or mast at a height more than ten feet (10') above the derrick, mast floor, or ground level. Federal OSHA requires fall protection for any height greater than six feet for most industries. Severe injury can occur if an employee falls from a height of greater than six feet. This system consists of anchorages, connectors, and a body belt or full body harness. Had the victim in this incident attached his personal fall restraint system to an anchor point, the fall may have been prevented.
