**REPORT#: 14MI119**

## Construction Owner Died in Trench Wall Collapse

## Michigan Fatality Assessment and Control Evaluation (FACE) Program

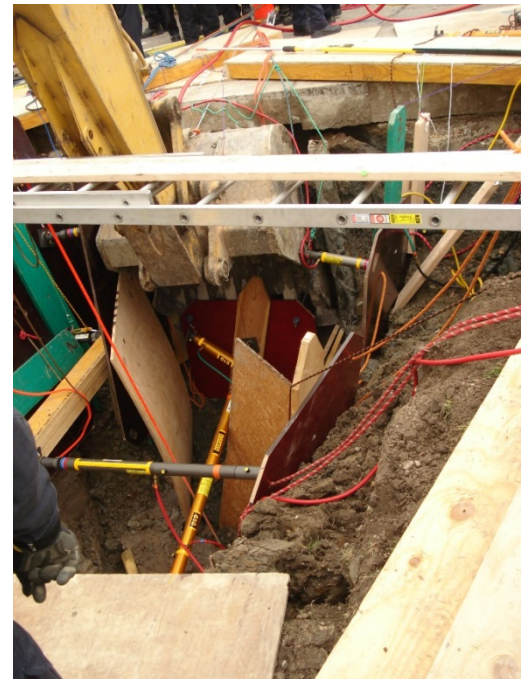
*Figure 1. Recovery operations trench wall support*

While recovery efforts were ongoing, city personnel contacted another contractor to assist. Recovery operations (Figure 1) were suspended early in the morning on the next day at 0130 hours until daylight hours. Later that morning, the contractor arrived and removed a portion of the street near the south side of the excavation. When this was completed, one of the responders removed a portion of their shoring equipment from the excavation. The contractor placed a trench box and stabilized the excavation. The responders recovered the rest of their equipment (See Figure 2).
